Nunnallee Inspections
PROPERTY INSPECTION REPORT

By: **William Kyle Nunnallee TREC # 6371**
(Name and License Number of Inspector) (Date)

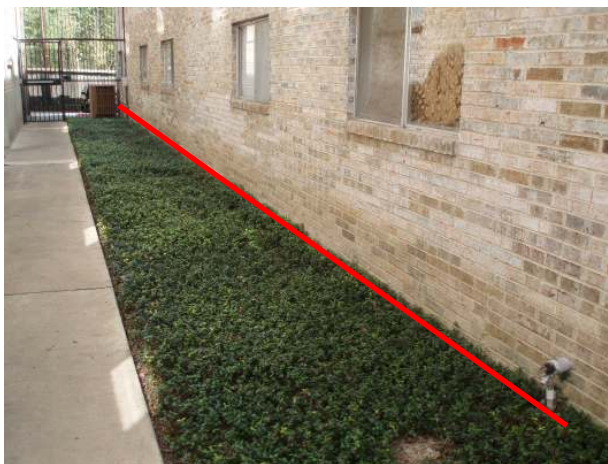
The soil line is too high at the rear of the front building. This condition can promote water infiltration and is in need of repair. Under today's building standards, there should be at least four (4) inches of foundation visible below masonry veneer and six (6) inches of foundation visible below wood veneer.

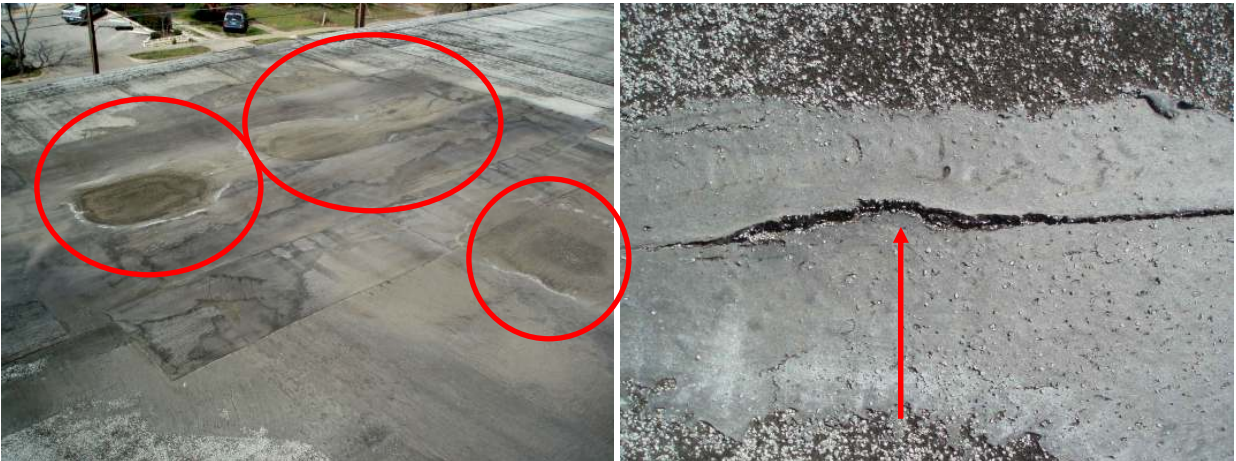
The roofing in three of the four sections was found to be in poor condition and should be replaced. The items observed to support this opinion are listed but not limited too: the condition revealed in the photos is consistent throughout the roofing sections.

- Blistering
- Seam failure
- Granular loss
- Water ponding

There are low areas on the newer roofing as well which will lead to a shortened life and eventual leaks.

In the event the roofing is replaced it should also be assumed the facia and gutters will need to be replaced as well.

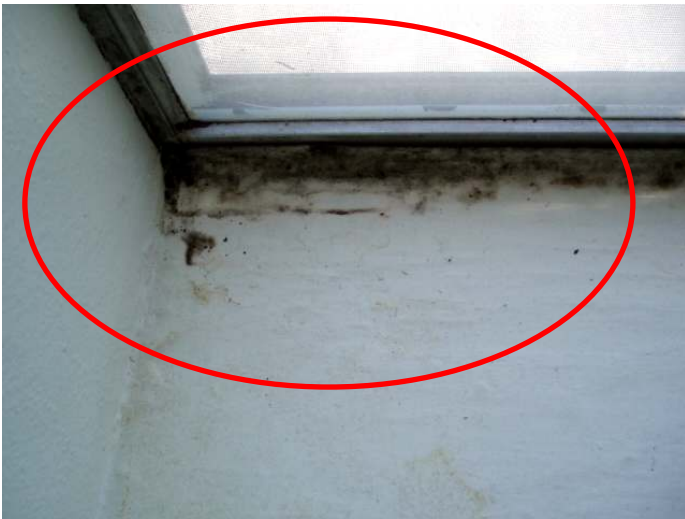
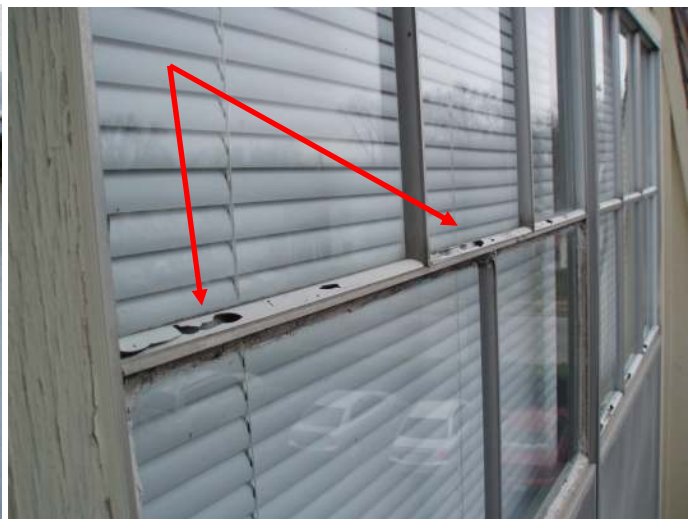
A black mold like substance was observed at the windows in the majority of the bedrooms. The cause of this condition can probably be contributed to the fact that these are metal windows which sweat with the change of temperature inside and outside of the unit. This appears to be primarily cosmetic in nature although may provide the potential for a health hazard.

Damaged glazing in many locations throughout the complex was observed at the time of inspection.

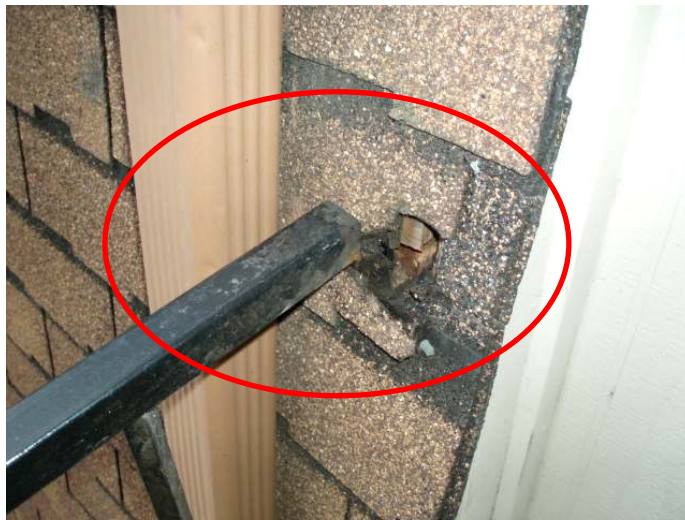
The handrail in front of unit #329, #225, 203, #208 and adjacent unit #317 is loose and should be repaired.

The openings in the railing are large enough to allow an object larger than four inches to fall through. *This item may have not been required at the time of construction although; per TREC standards (Texas real Estate Commission), I am required to report the lack of this item as in need of repair.*

The nailer or hanger for the stairs in front of unit 320, 220, 238 are damaged and should be replaced.

It appears the second story cat-walk may need additional support in various locations.

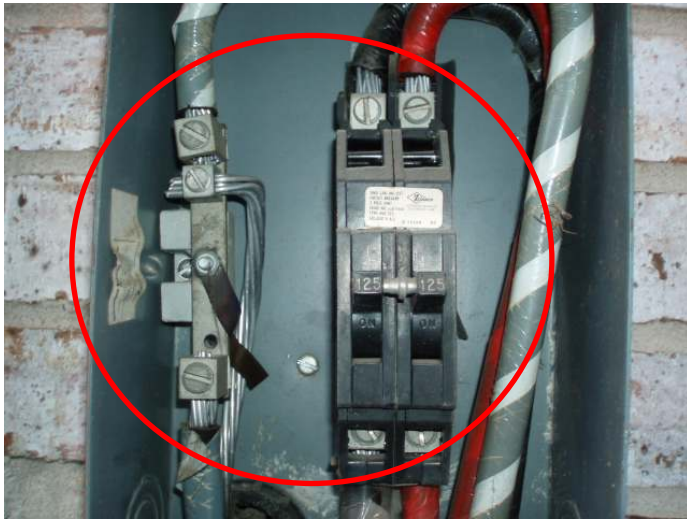
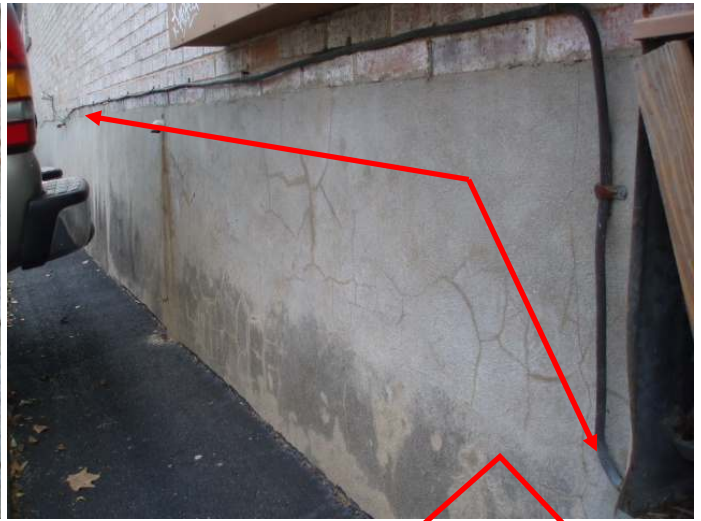
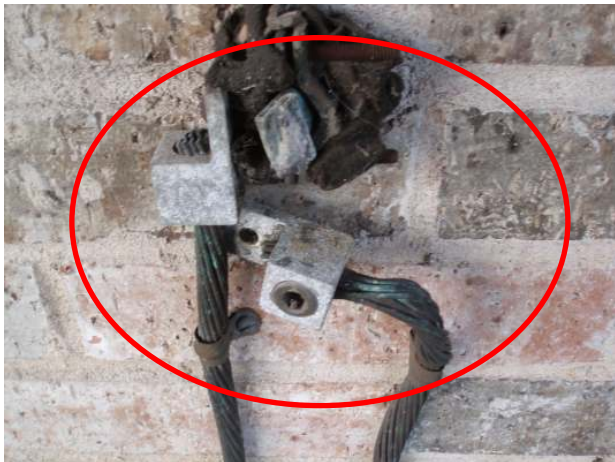
be bonded to the metal enclosure (panel). Recommend further review by a licensed electrician. (Storage room on the second floor, south end rear building)

The services should have two points of ground. No driven ground rod was observed. The electrical system should be reviewed by a licensed electrician to ensure current safety measures have been taken.

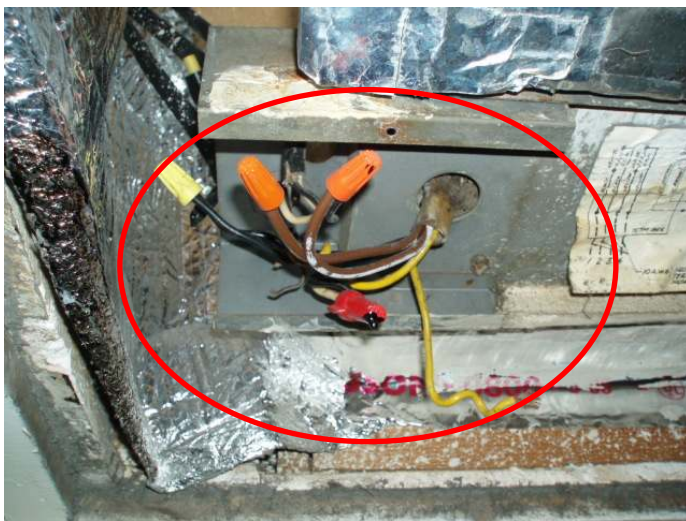
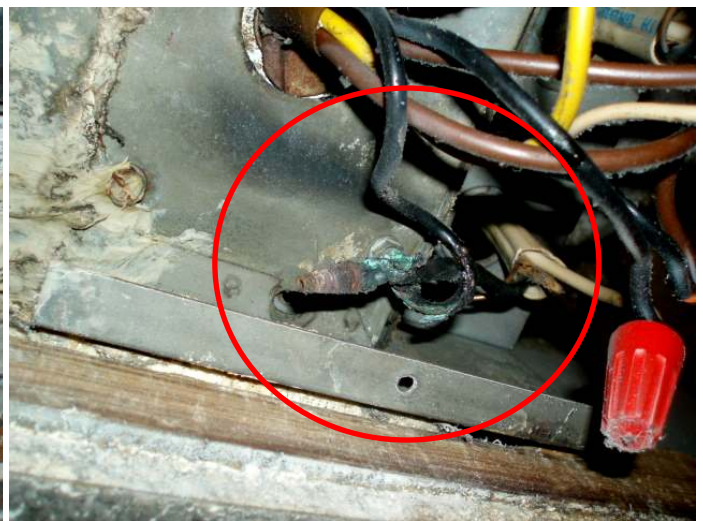
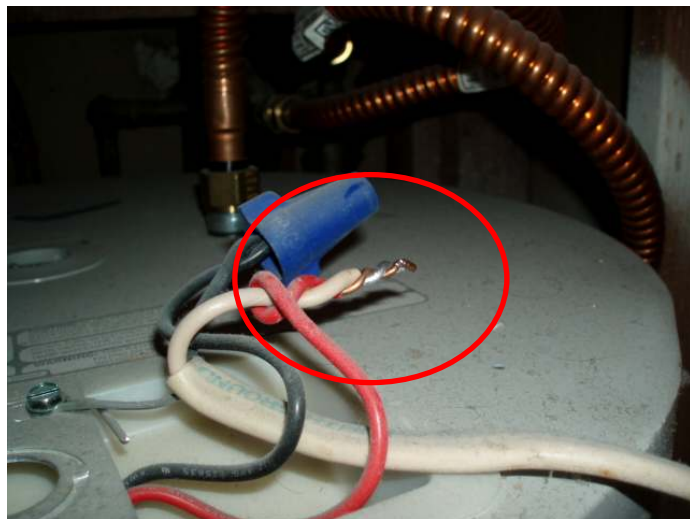
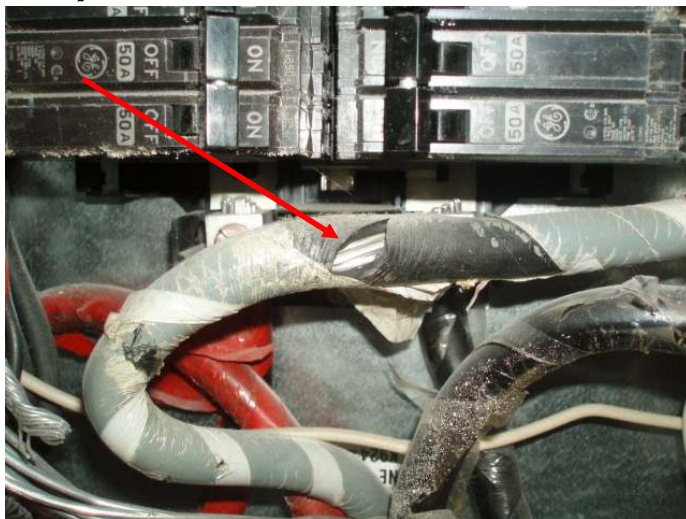
Improper electrical connections at the air handlers should be improved. All electrical connections should be made inside junction boxes fitted with cover plates.

Overheated wiring at the air handler in unit #220 and the water heater #110 should be repaired or replaced as necessary.

Improper copper/aluminum connections observed at the water heaters. This should be addressed by a licensed electrician.

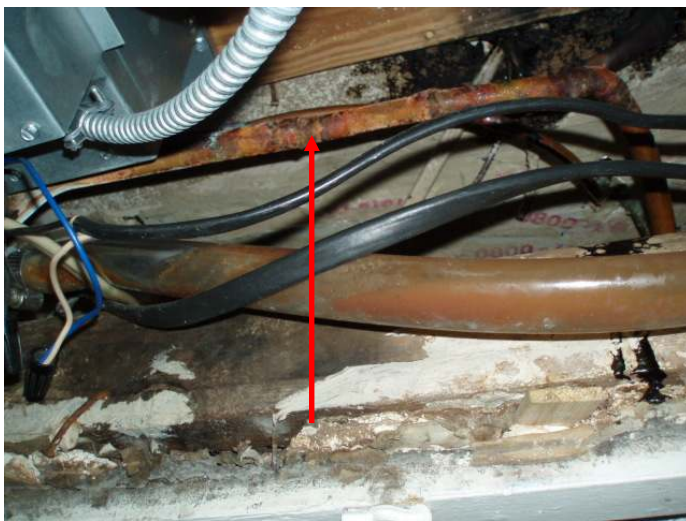
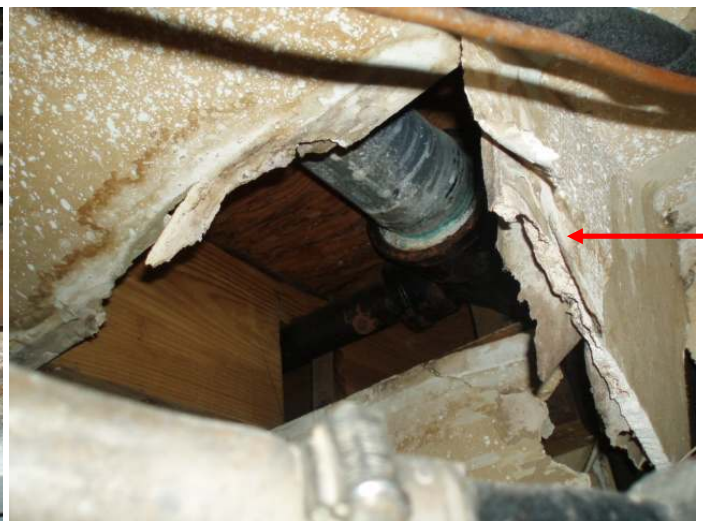
There was no insulation observed on the primary condensate drain line and or refrigerant lines that runs off the coil housing in all of the units. Insulating the drain line, this will help prevent moisture from building on the exterior of the drain line and leaking onto the floors or ceilings. The lack of these items will cause water damage to the ceiling.

The air conditioning units should be provided with an auxiliary drain or a device that will shut off the unit in the event the primary drain line becomes obstructed. A shut off device is cost effective and will prevent damaged to the sheetrock in the event the drain line becomes obstructed.

The temperature drop measured across the evaporator coil of the air conditioning system is lower than considered typical. This usually indicates that servicing is needed. A qualified heating and cooling technician should be consulted to further evaluate this condition and the remedies available for correction.

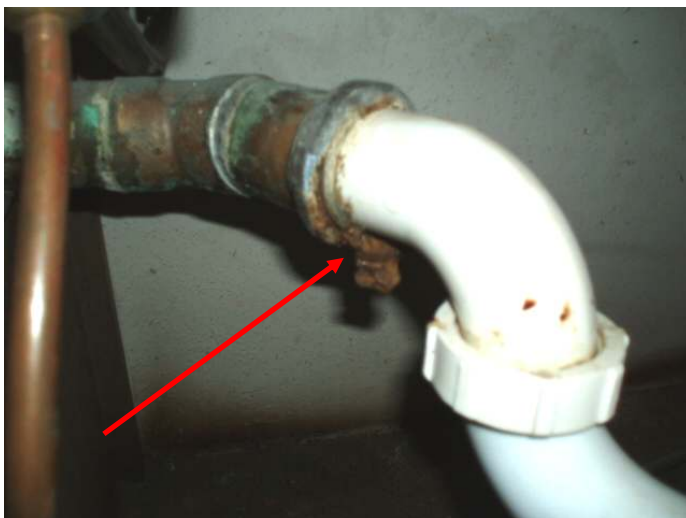
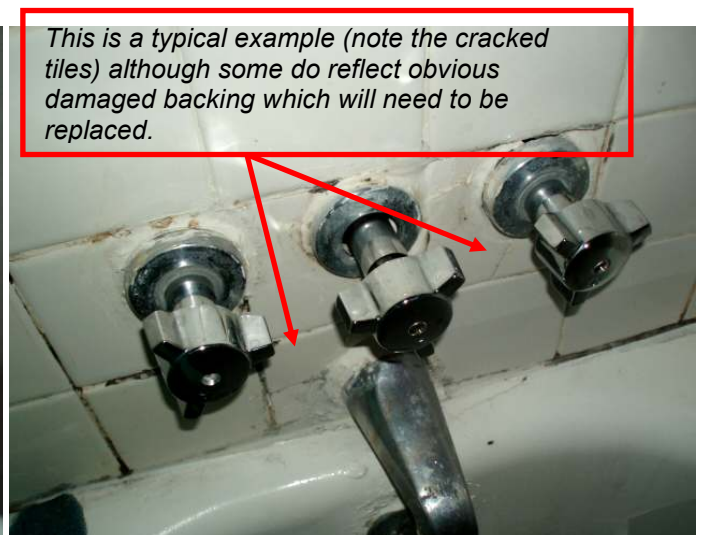
It should be assumed that all bathtubs will need resurfacing. In approximately 10% of the units, there is considerable corrosion at the drain and vent. It may be more cost effective to replace these units although that has yet to be determined.

The base of the toilet in these units is cracked and should be replaced. 321, 305, 306, 307, 308

The strainer for the bathtub in these units is rusted out.

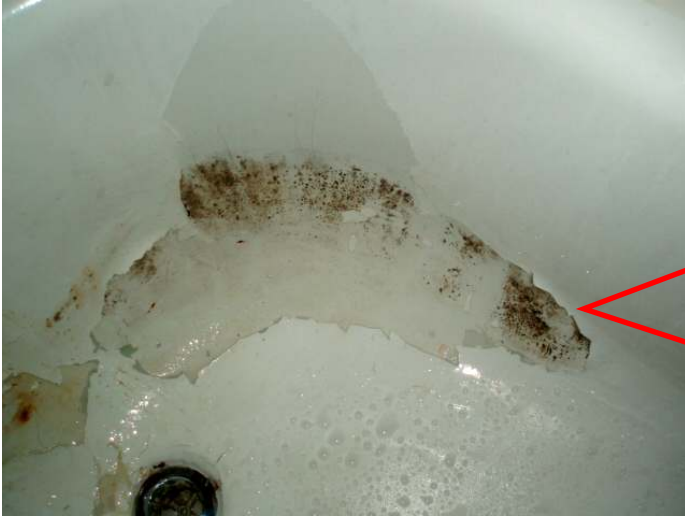
This is an example of the peeling re-finish. Although this may be one of the worse it is safe to assume the others are sure to follow. The result you see is a consequence of poor surface preparation. Even the tubs which are not peeling as of yet look good at first glance although a closer look reveals ripples and marginal workmanship.

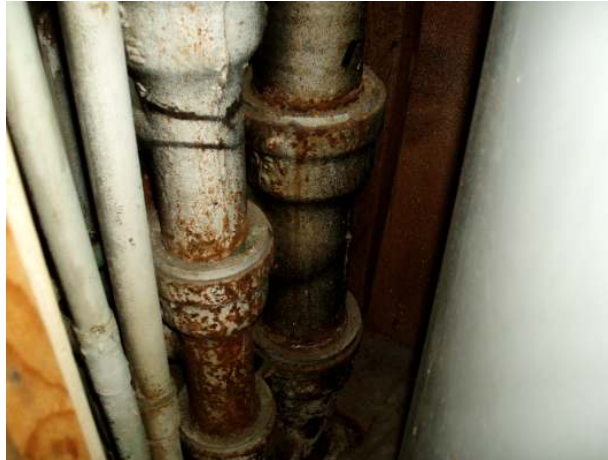
Corrosion on the cast iron drain piping within #108 was observed.

The drain under the kitchen sink, 333, does not have sufficient slope for proper drainage. This condition should be repaired.

For the most part, the waste piping is older. It may be prone to unexpected problems. Improvement is recommended on an as needed basis.

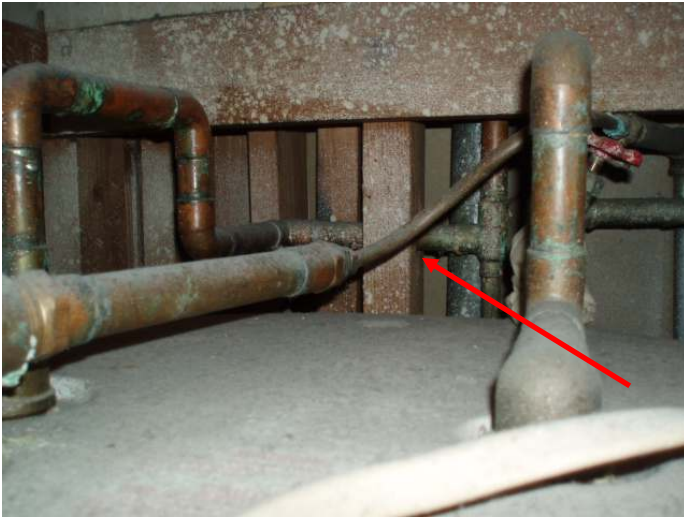
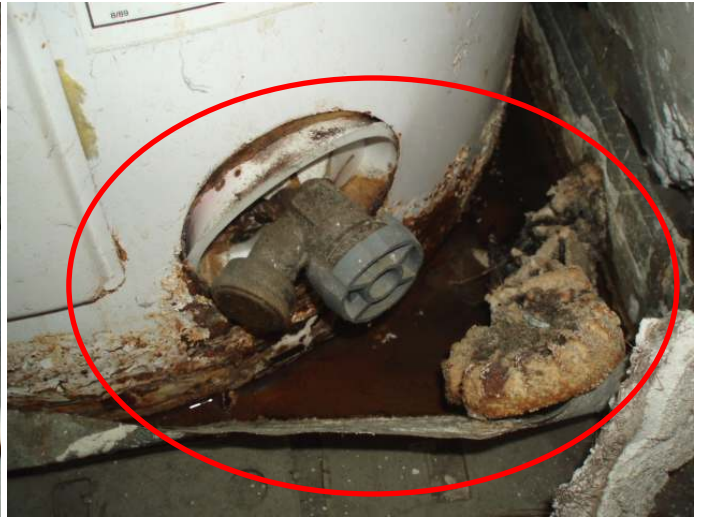
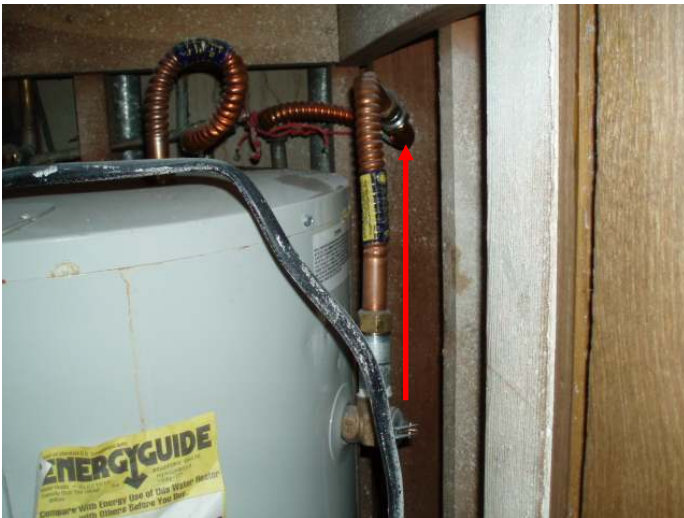
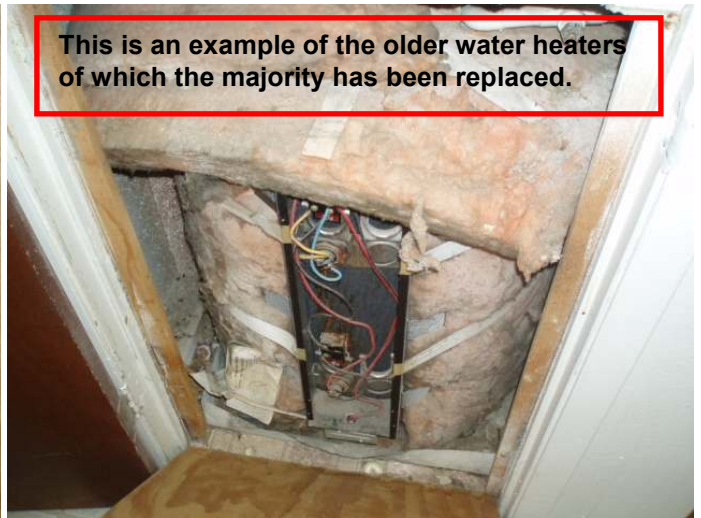
No drain line for the T&P valve was present in these units and will need repair.

No safety pan and drain was found for a majority of the water heaters. This should be repaired by the installation of a pan with a drain by a qualified professional

An inappropriate material is being used to terminate the T&P drain line for a majority of the units. This will require repair.

Nick, to sum it up, a majority of the water heaters have been replaced although it should be accounted for, that even the newer units will need improvement.

- T&P drain line
- Service disconnect
- Electrical connections
- Drain Pans

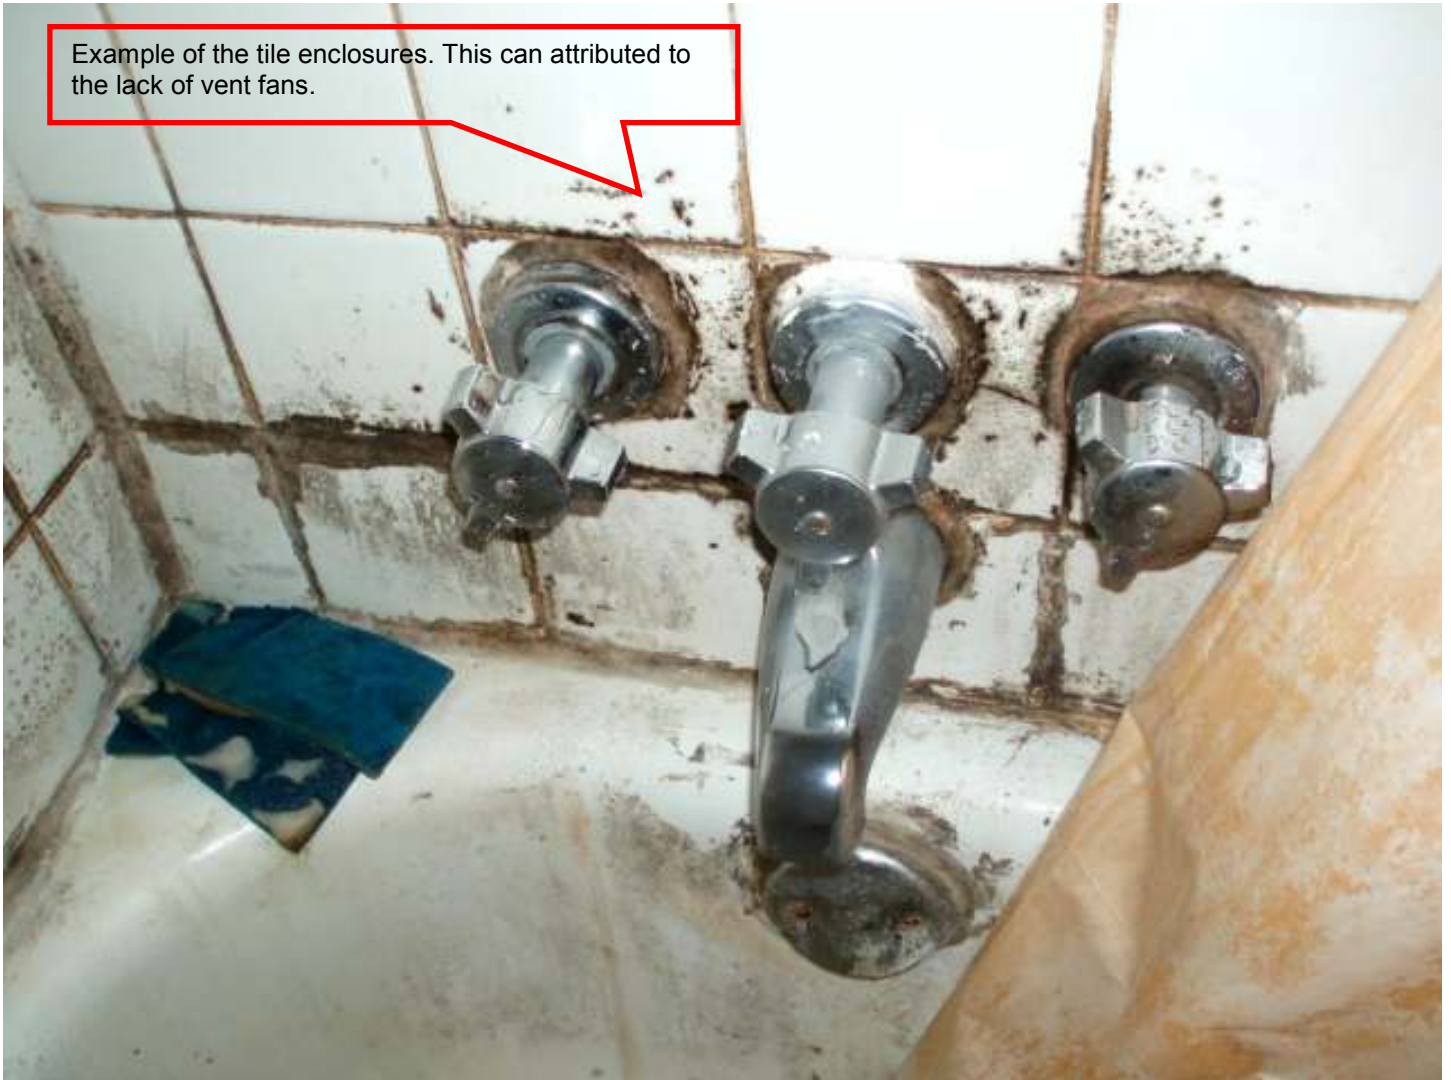
Example of the tile enclosures. This can attributed to the lack of vent fans.

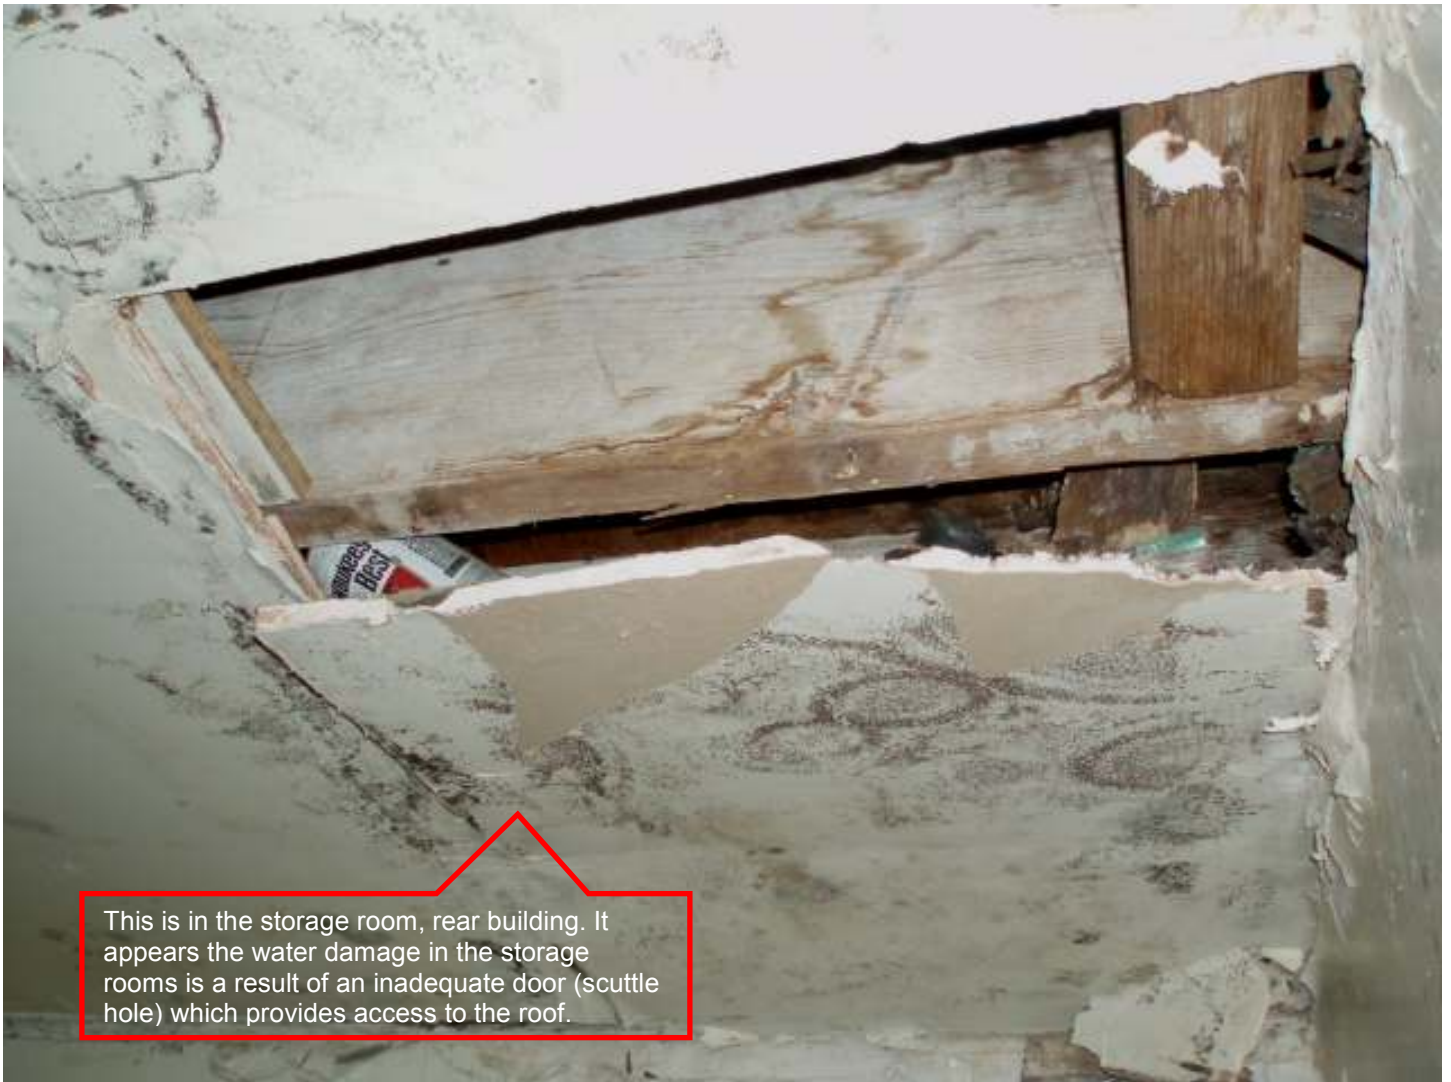
This is in the storage room, rear building. It appears the water damage in the storage rooms is a result of an inadequate door (scuttle hole) which provides access to the roof.
