# PROPERTY INSPECTION REPORT

**Concerning:** Austin, TX 78757  
(Address or Other Identification of Inspected Property)

**By:** Kyle Nunnallee TREC #6371 Feb 01, 2010  
(Name and License Number of Inspector) (Date)

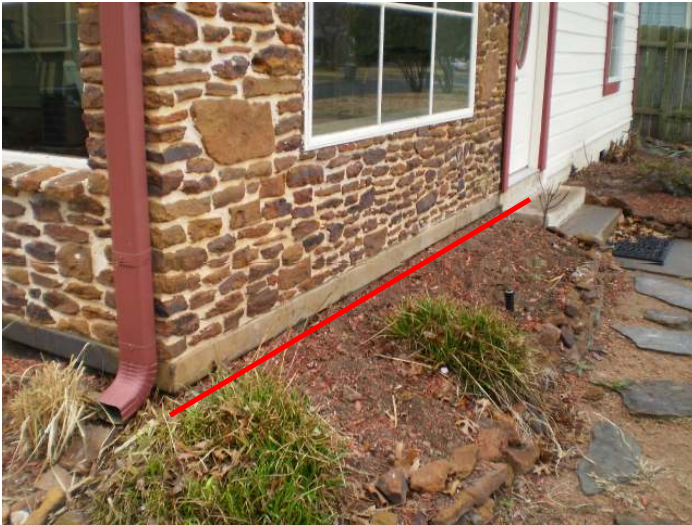
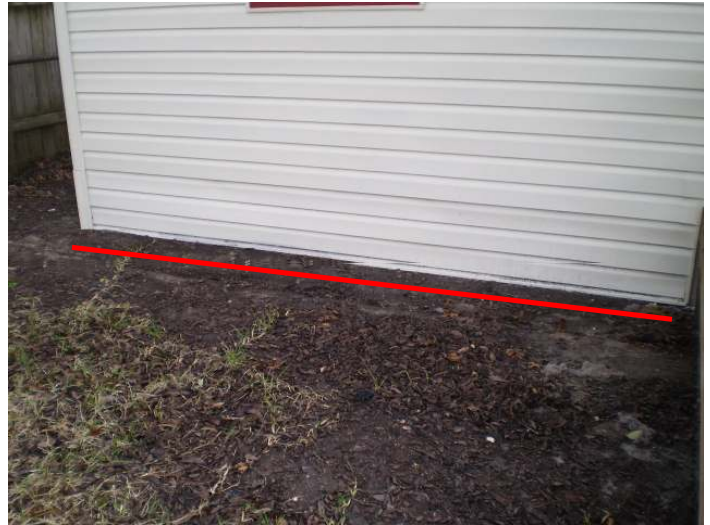
The soil line is too high on the north and south sides of the house. Under current building standards there should be at least 4-inches of foundation visible below masonry veneer and 6-inches of foundation visible below wood type veneer.

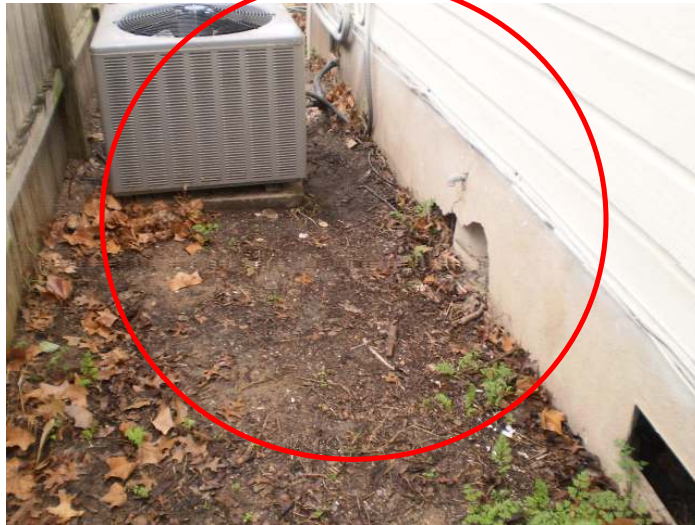
Poor to negative site drainage was observed on the east side of the house. Proper drainage is needed to help prevent water from entering the crawl space.

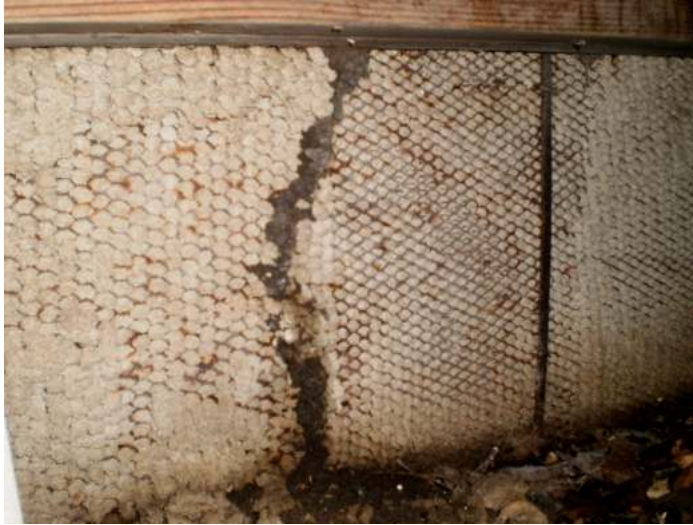
Evidence of active activity of a wood-destroying insect was detected at the time of this inspection. Full evaluation of the amount of damage caused by the insects cannot be detected without defacing the property and cannot be addressed in this inspection report. With the detection of active and/or previous activity of a wood destroying insect, it should be assumed that some degree of damage is present.

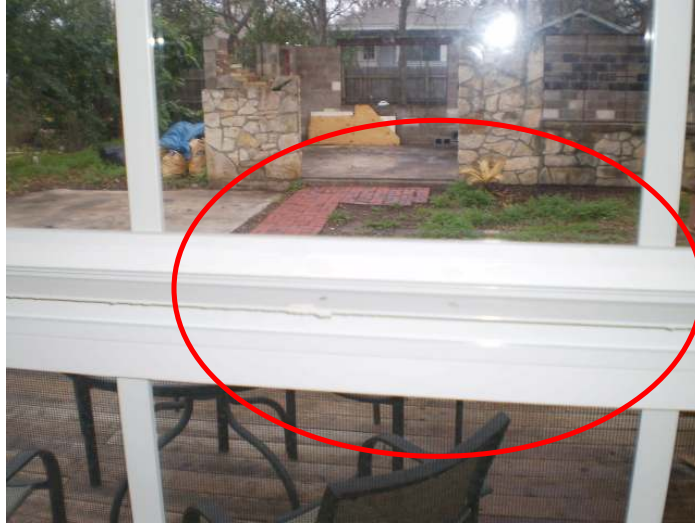
Cracked and/or broken window glass was observed in the front entrance area.  
Window lock(s) were observed to be damaged and/or missing in the laundry room.

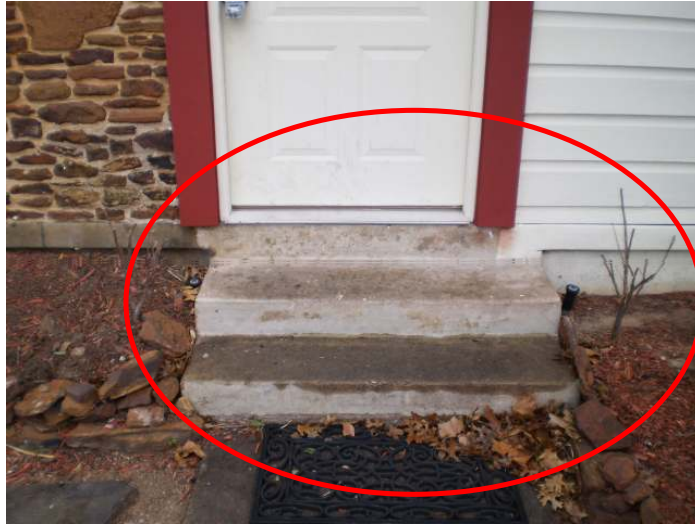
Under current building standards, a landing should be present for the stairs at the front entry door.

There shall be a floor or landing on each side of each exterior door.

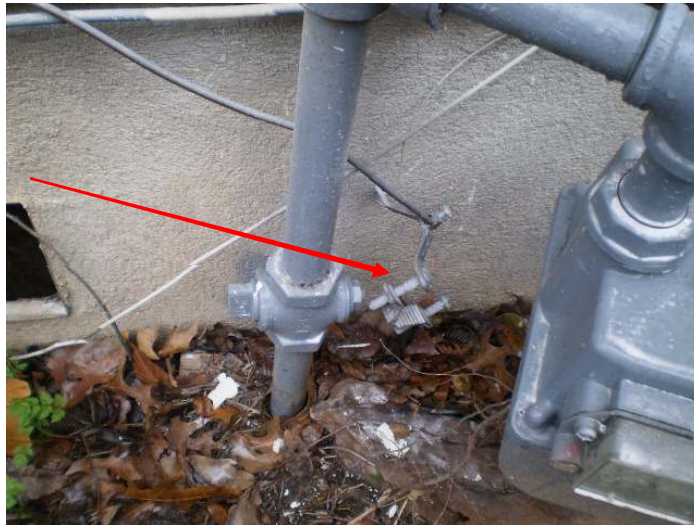
Under current building standards, the gas piping shall be bonded to the grounding electrode system. *The bonding jumper has been removed.*

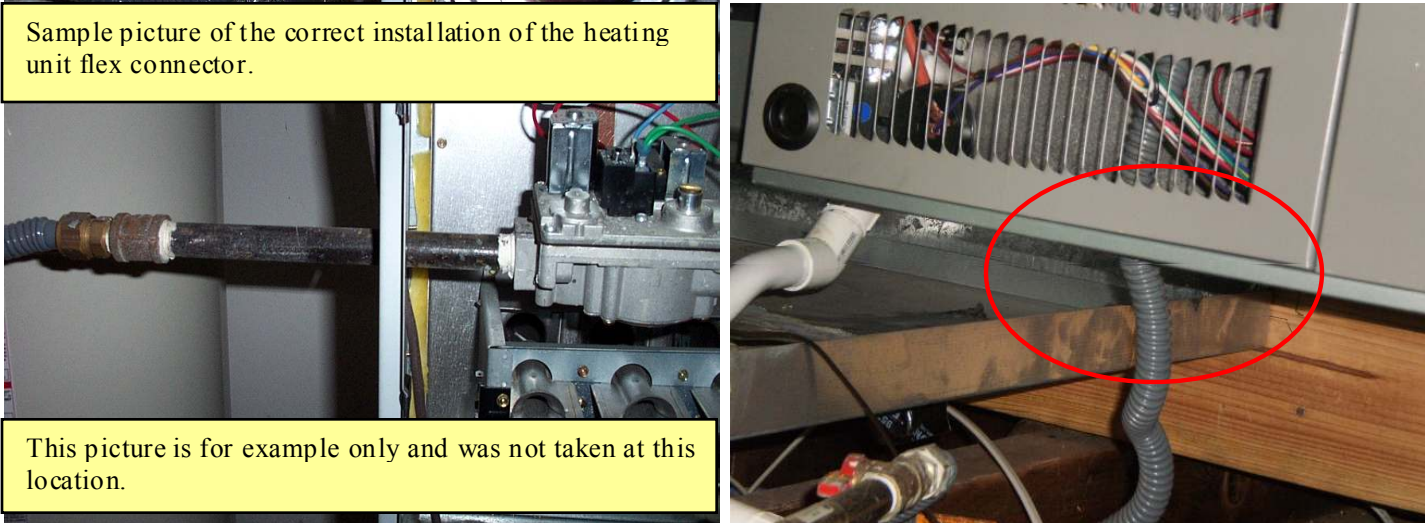
The gas supply flex connector was observed to be passing through the heating unit cabinets. Under current mechanical installation standards, this is no longer an accepted practice. Only rigid black gas pipe is allowed to pass through the heating unit cabinet.

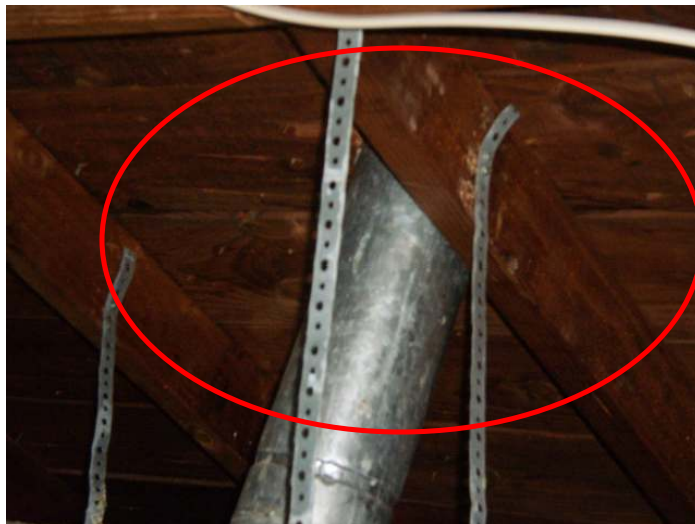
The heating unit flue (vent pipe) has inadequate clearance from combustible materials. Double walled vent pipes should have at least 1-inch of clearance and single walled vent pipes should have at least 6-inches of clearance from combustible material.

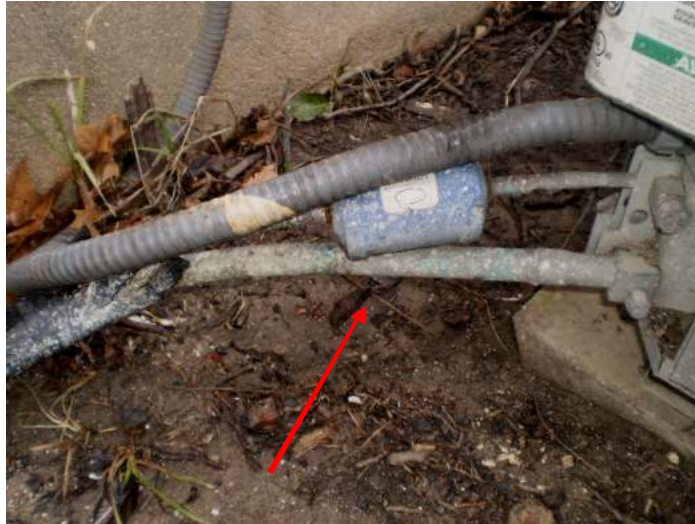
Damaged, deteriorated and/or missing insulation on the refrigerant lines should be repaired or replaced at the outside condenser.

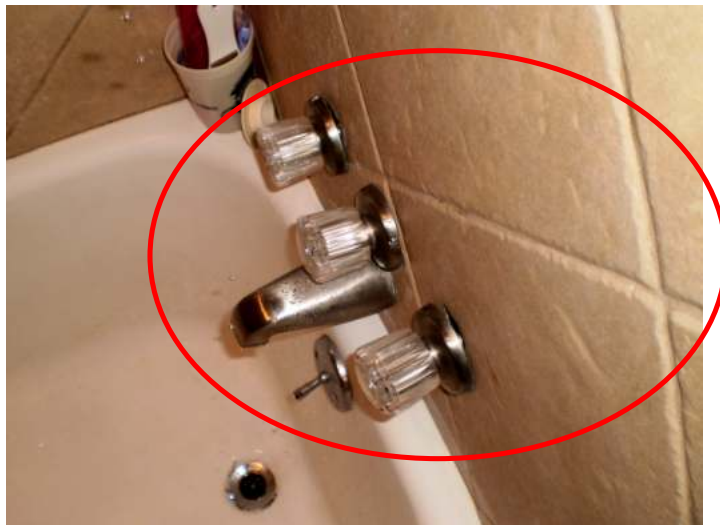
#### Hall Bathroom

Seal fixtures to the tub enclosure.

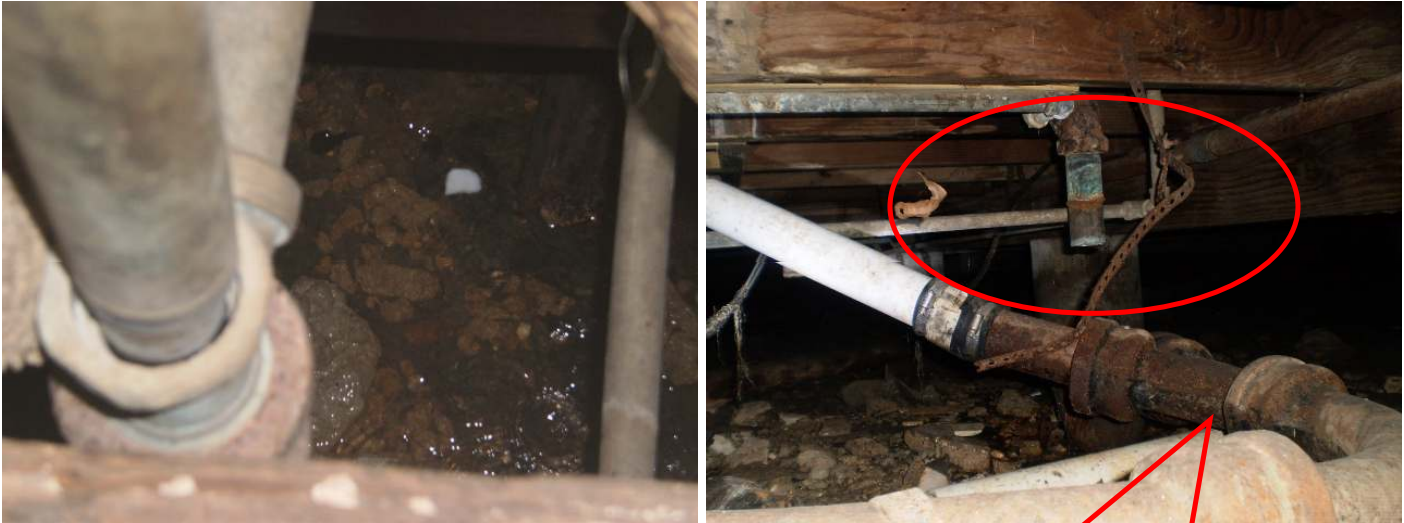
The drain for the bathtub is detached and draining into the crawl space. This is in need of repair immediately.

This section of piping has fallen from the support straps; which has pulled loose the drain.

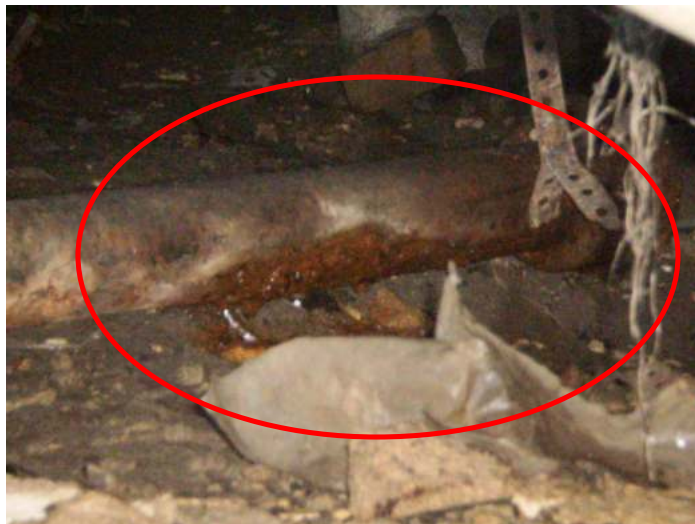
Original cast iron piping is in place which is common for older homes. This material is prone to unexpected leaks due rusting/deterioration and is typically replaced in sections as needed. I did observe one area (observed from the east side) which appears to be leaking. Repair as necessary.

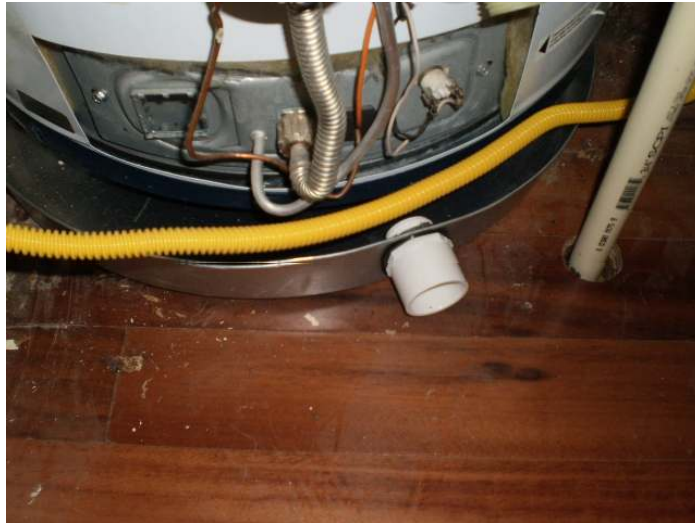
There is no drain line installed for the water heater pan. The pan should have a drain line installed that should terminate over a suitably located indirect waste receptor or shall extend to the exterior of the building and terminate not less six-inches (6”) and not more than twenty-four inches (24”) above of the ground.

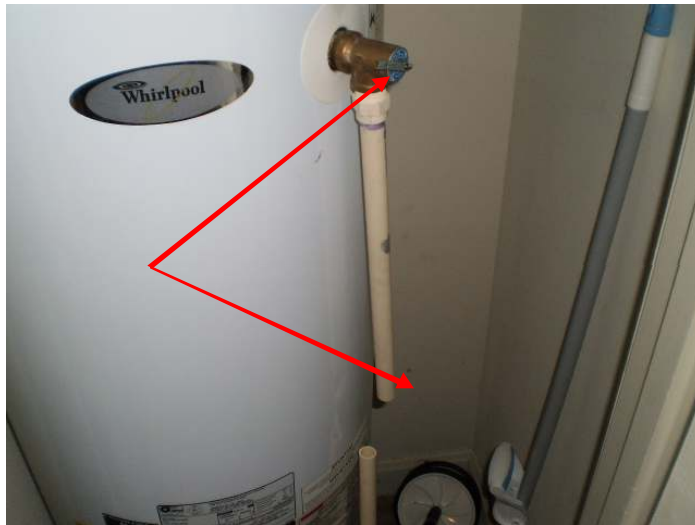
The temperature and pressure relief (TPR) valve discharge pipe was not re-connected to the pressure relief valve at the time the current water heater was installed or repaired. For safety reasons, it is recommended that the discharge pipe be reconnected to the relief valve.

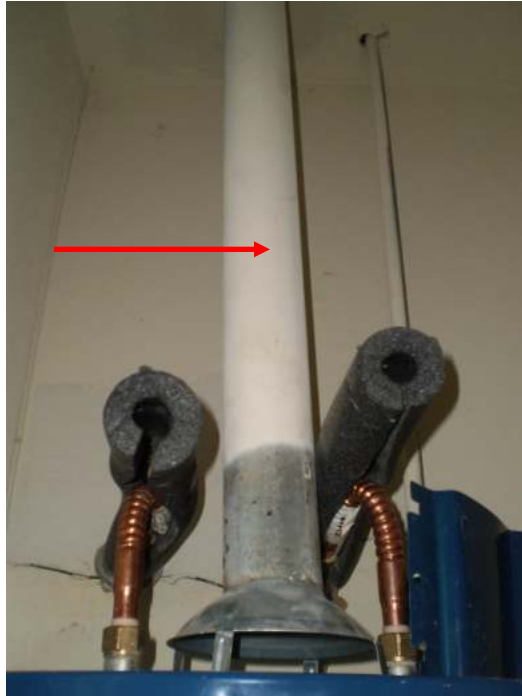
The water heater flue was observed to be an older single wall type. Under current mechanical standards, the exhaust flue should be a Type-B double wall flue.

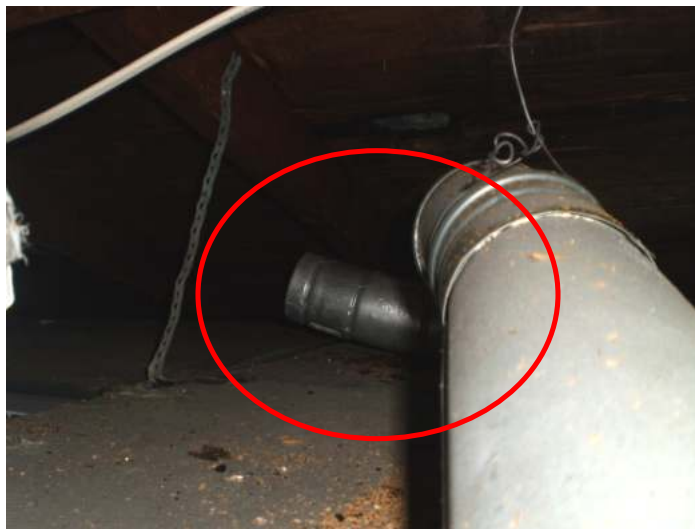
The water heater vent pipe is terminating into the attic. This configuration will emit Carbon Monoxide into the attic area, which is a known safety hazard.

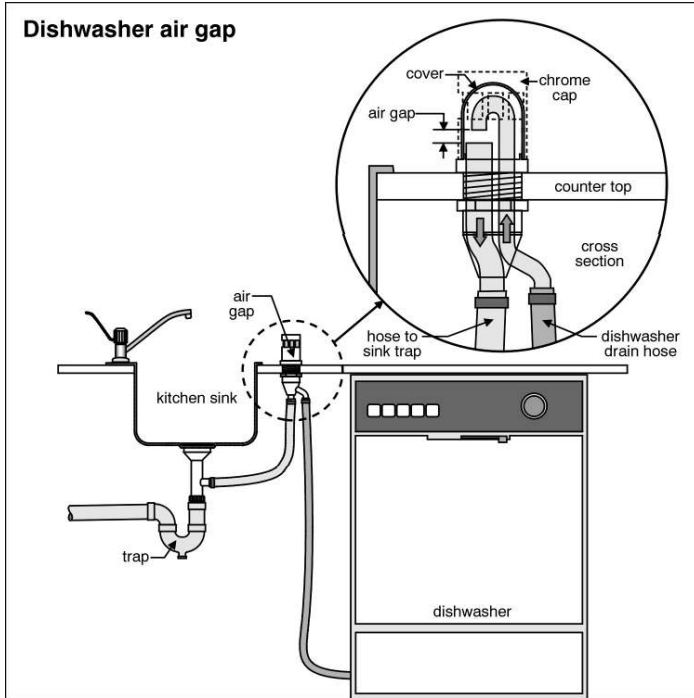
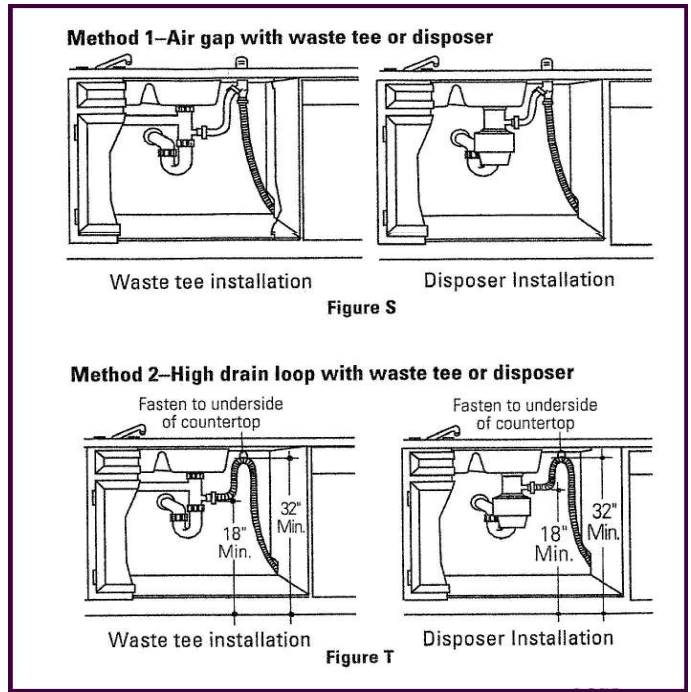
The dishwasher drain hose is not properly installed to prevent back flow or anti-siphoning. It is recommended that an air gap device or high drain loop be installed in the drain line.
