# *Nunnallee Inspections*

# PROPERTY INSPECTION REPORT

**Concerning:** TX 78734  
(Address or Other Identification of Inspected Property)

**By:** Kyle Nunnallee TREC #6371 Jan 07, 2010  
(Name and License Number of Inspector) (Date)

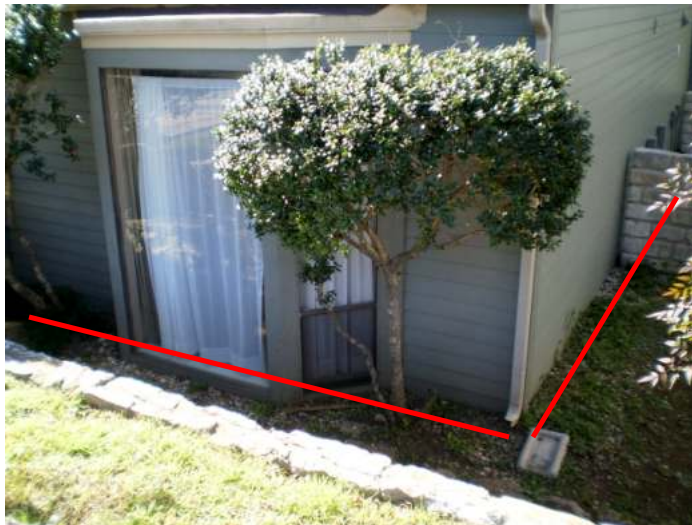
The soil line is too high on the north and east sides of the house. Under current building standards there should be at least 4-inches of foundation visible below masonry veneer and 6-inches of foundation visible below wood type veneer.

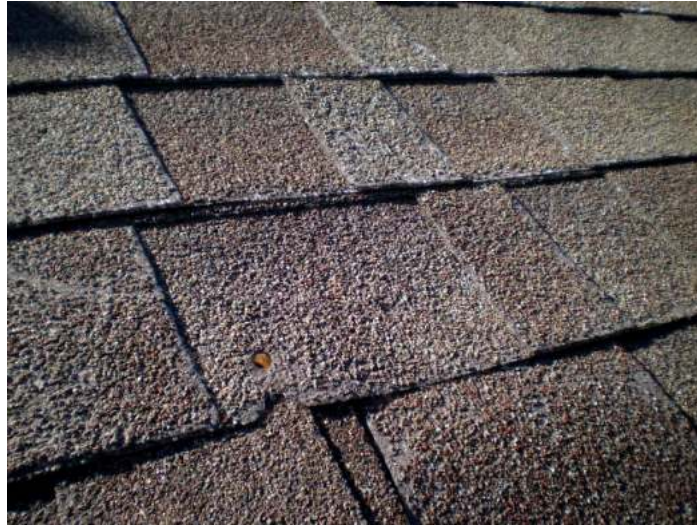
The roofing material observed to have impact damage in various locations. The impact damage may have been caused by a previous hailstorm and should be further evaluated.

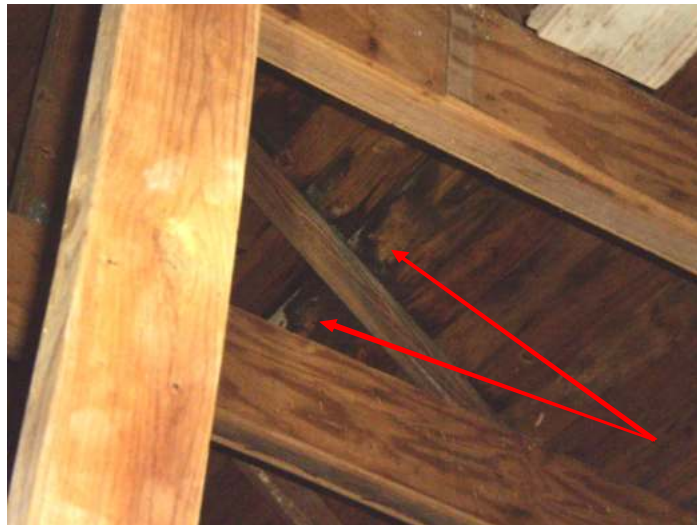
**Note:** There are visible water stains on the roof sheathing (decking) in one or more locations.

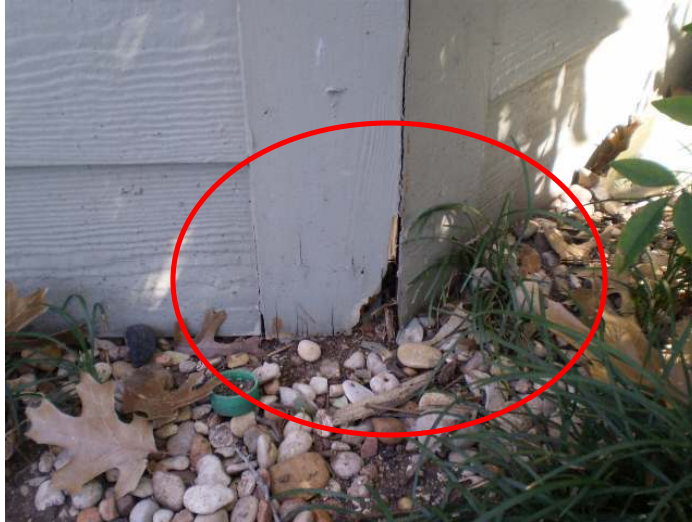
The wood veneer trim has some deterioration or damage on the west side of the house.

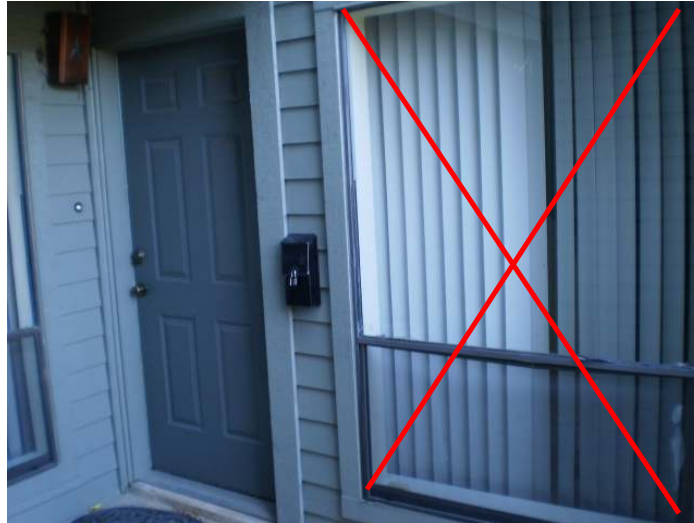
(Under current building standards the following are considered hazardous locations that require safety glass.)

Glass in individual fixed or operable panels within 18-inches of the floor.

Glass in an individual fixed or operable panel adjacent to a door where the nearest vertical edge is within a 24-inch arc of the door in a closed position and whose bottom edge is less than 60-inches above the floor or walking surface.

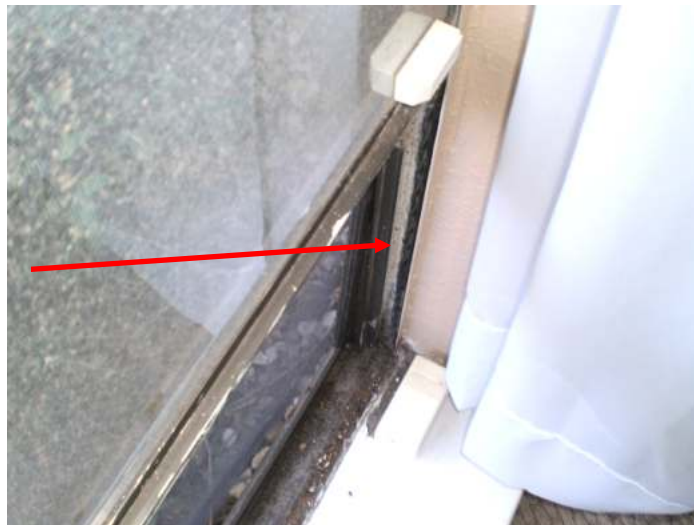
The window sash guide is damaged in the main floor bedroom.

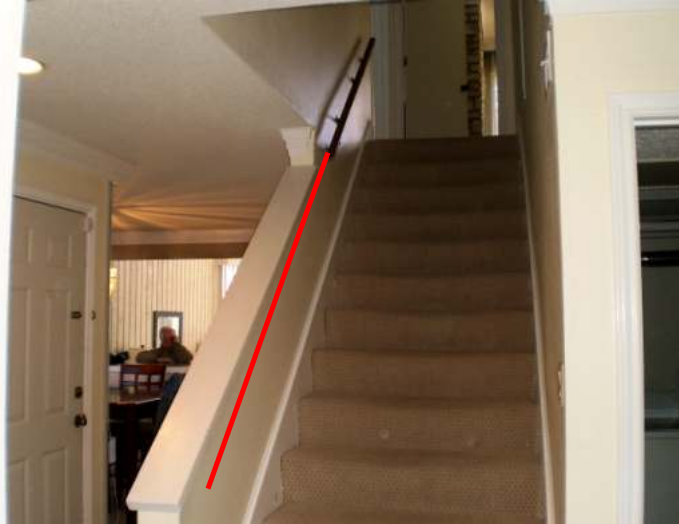
The stairway handrail does not run continuous from the bottom of the stairwell to the top of the stairwell so to cover all of the steps (treads). Under current building standards all handrails for the stairway should run continuous for the full length of the flight. The handrail should start directly above the lowest step and run continuously to end directly above the top step.

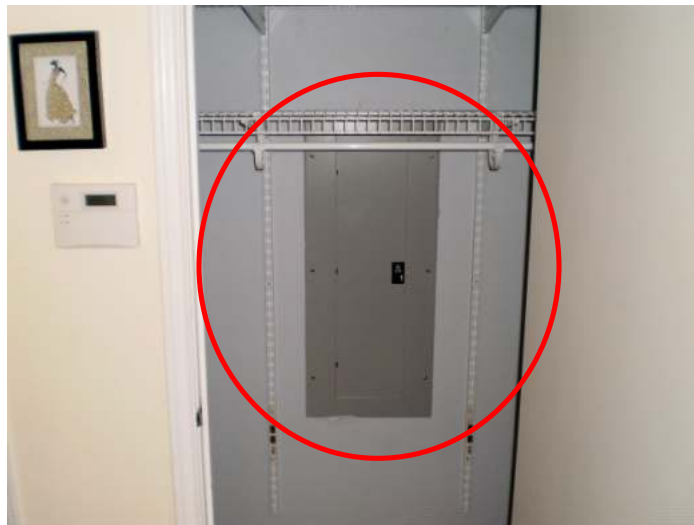
The electrical panel is located in a clothes closet. Under current electrical standards, this is no longer an accepted practice. This is an **"as-built"** condition but Per TREC standards of practice we are required to report this condition as a deficiency.

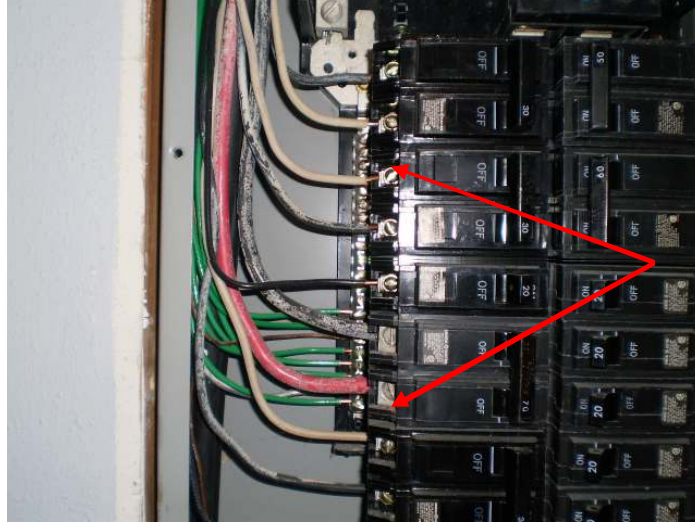
White wires in the main panel being used as a hot lead should be properly marked. This is usually achieved using colored electrical tape. Color coated wires is universal and helps electricians identify hot, neutral and ground and does effect the manner or procedure in which they work. This condition should be improved.

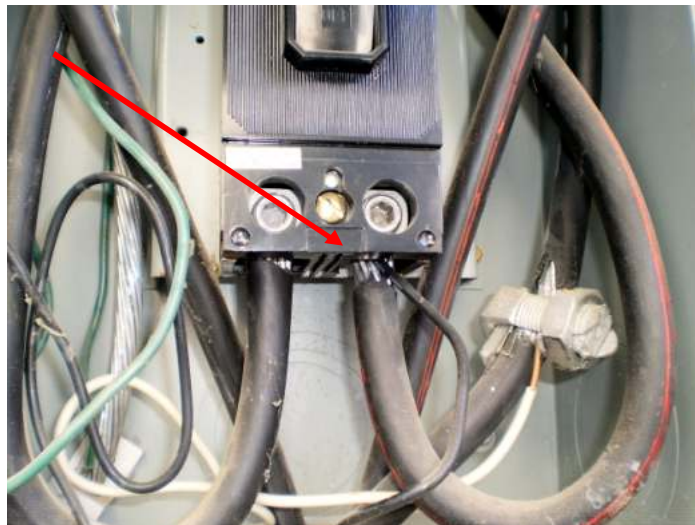
One or more of the breakers in the electrical cabinet were observed to be double lugged (i.e. two wires under one screw). The breakers in place are not listed or labeled for this type of installation and should be corrected as necessary.

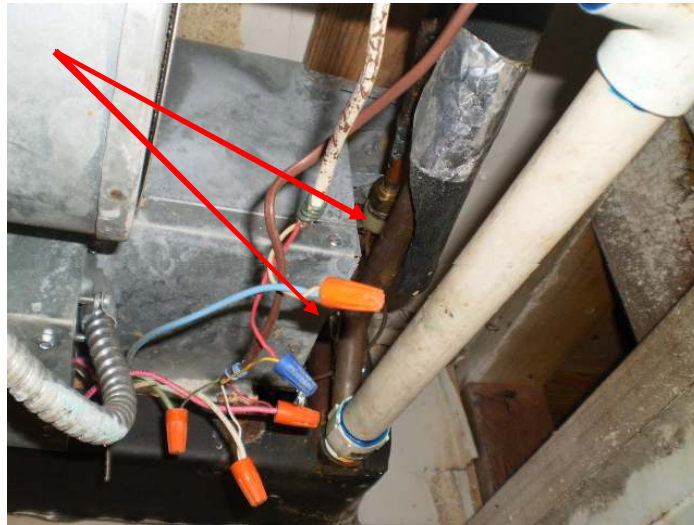
Damaged, deteriorated and/or missing insulation on the refrigerant lines should be repaired or replaced.

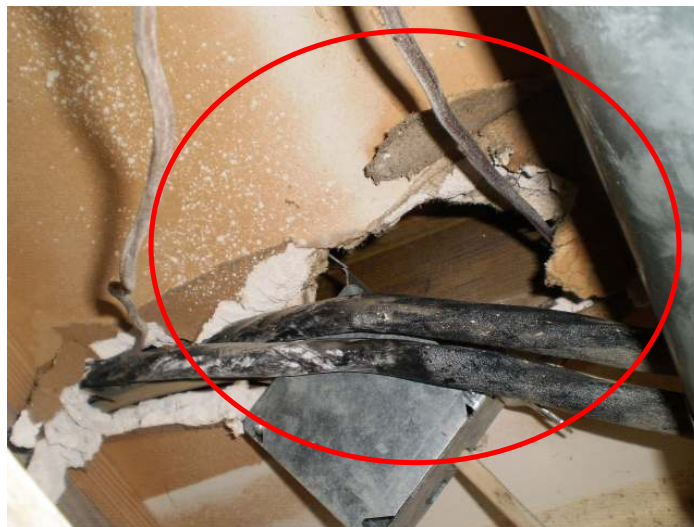
There are openings in the main air return chase that could allow outside air to be pulled into the HVAC system. This should be corrected to help maintain good air quality.

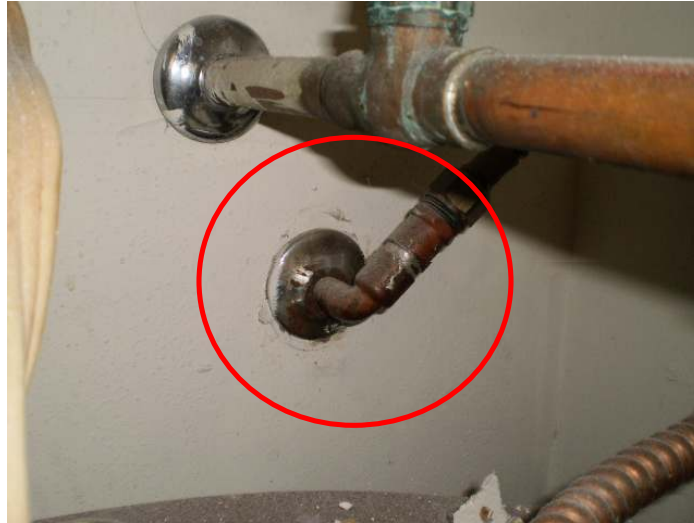
The temperature and pressure relief (TPR) valve discharge pipe has been downsized. The TPR discharge pipe should be no smaller than 3/4-inch at any point.

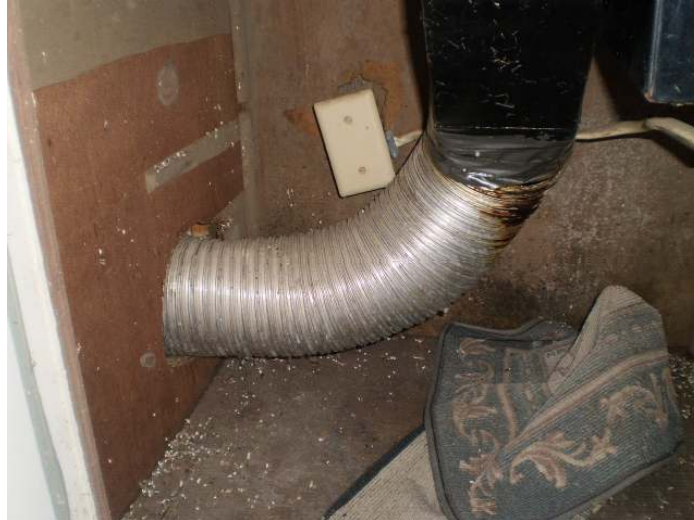
There is aluminum ductwork in place for the exterior range hood vent. Under current installation standards, aluminum flex ducting should not be used for the range exhaust vent connection.
