PROPERTY INSPECTION REPORT

Concerning: Georgetown, TX 78633
(Address or Other Identification of Inspected Property)

By: Kyle Nunnallee TREC #6371
(Name and License Number of Inspector) (Date)

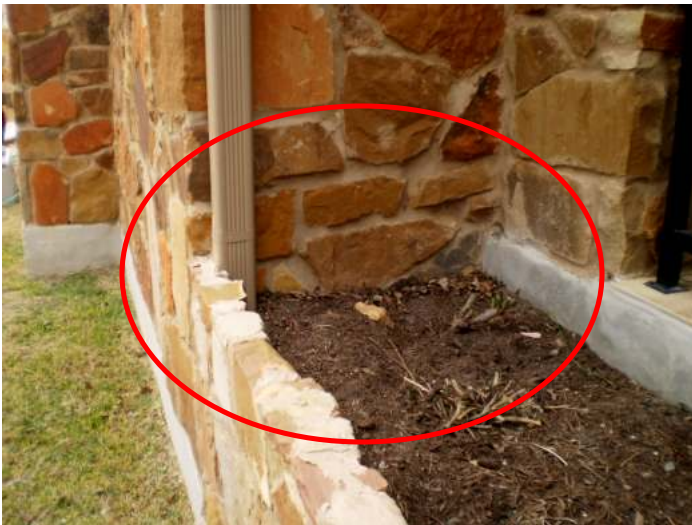
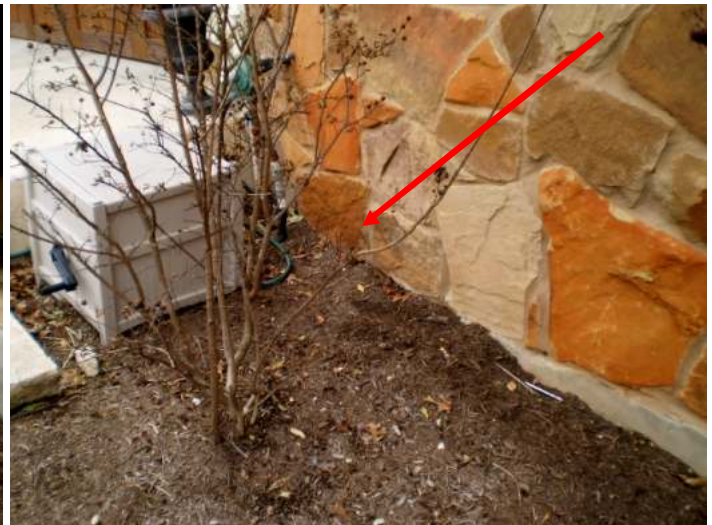
The soil line is too high on the east and south sides of the house. Under current building standards there should be at least 4-inches of foundation visible below masonry veneer and 6-inches of foundation visible below wood type veneer.

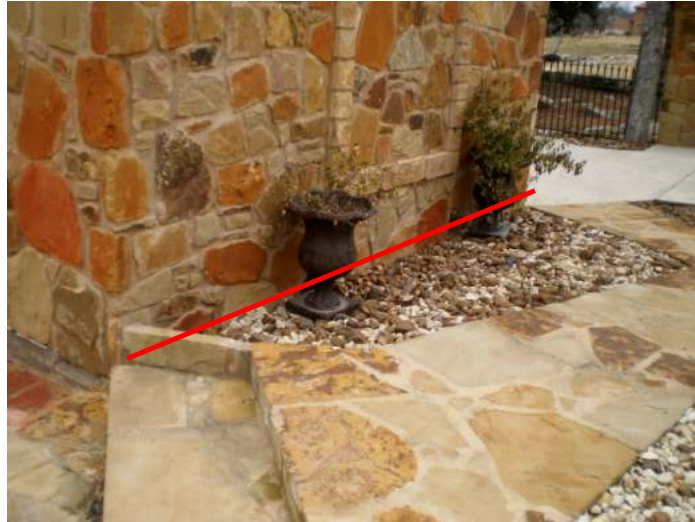
The soil line is too high on the west side of the guest house. Under current building standards there should be at least 4-inches of foundation visible below masonry veneer and 6-inches of foundation visible below wood type veneer.

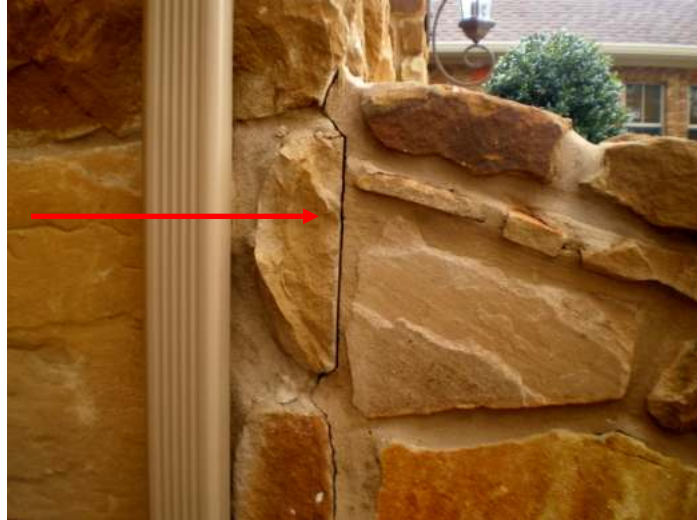
The pony walls in various locations need to re-pointed to help prevent water penetration in these areas.

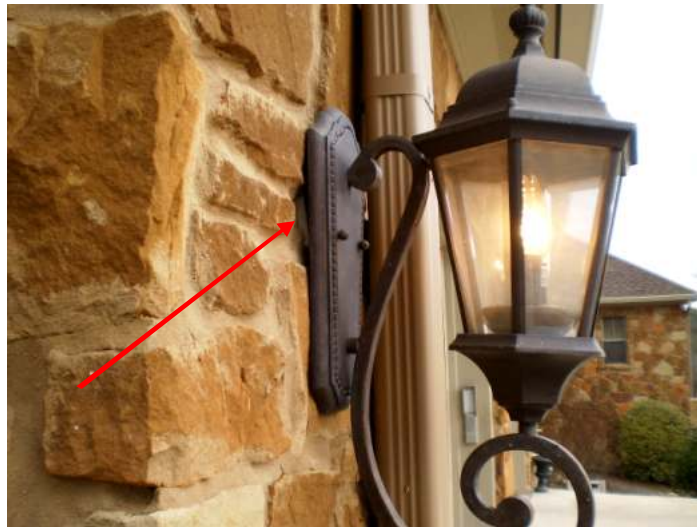
The exterior light fixtures should be sealed to the structure.

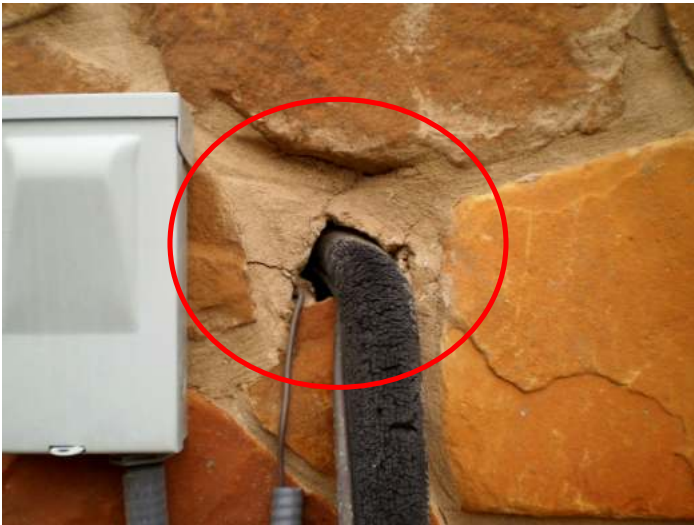
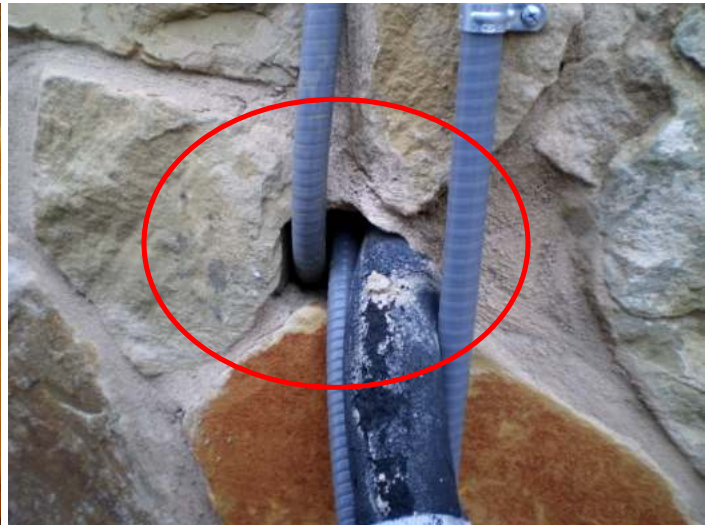
The area between the exterior veneer and the outside HVAC condenser/coils refrigerant lines needs to be properly sealed.

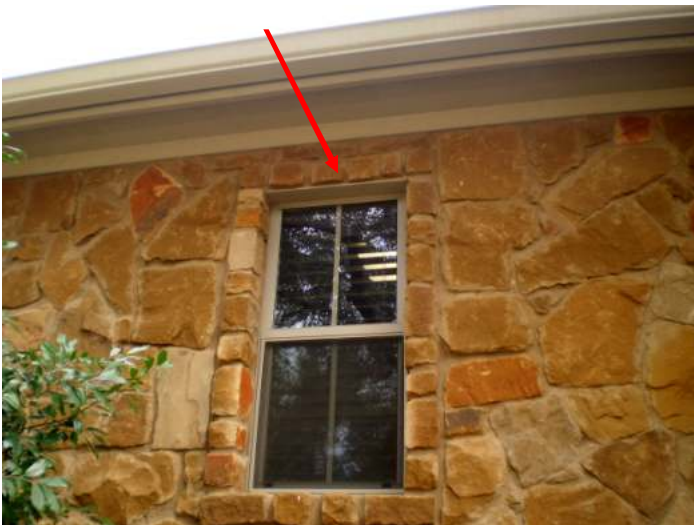
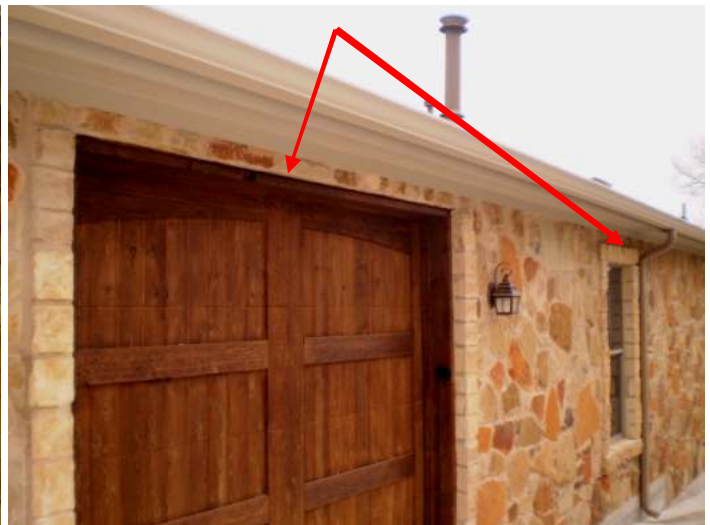
Missing weepholes observed in the low course of the exterior masonry veneer over the window lintels was observed at the front of the house and at the guest house. This condition does not meet current building standards and should be corrected as necessary.

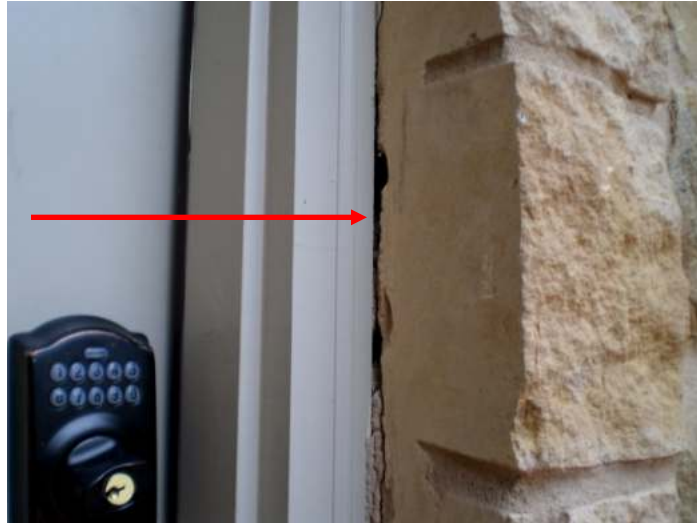
Caulking or re-pointing improvements are recommended for the area between the exterior veneer and the exterior door frame at the guest house.

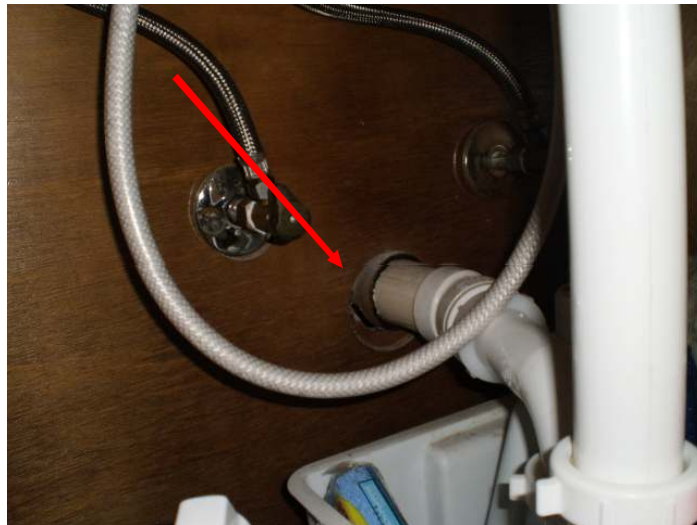
NOTE: Sealing the plumbing penetrations under the bathroom vanities will help prevent air infiltration when the air conditioning equipment is running. Sealing these areas will provide greater efficiency.

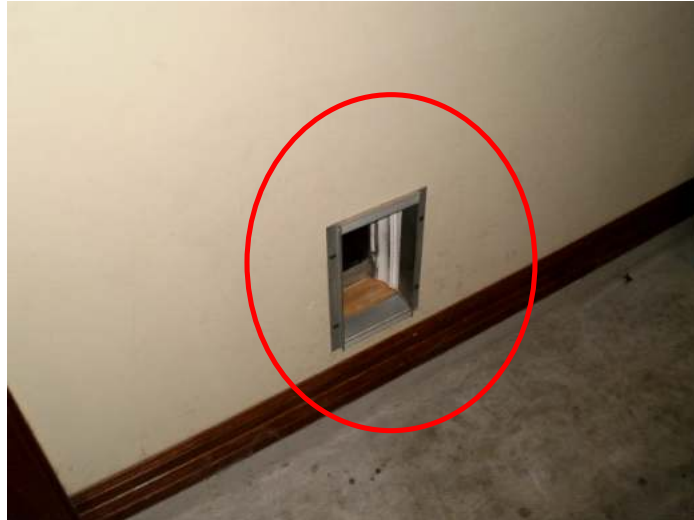
The doggie door into the garage is a breach in the firewall. This may be an "as built" condition and may have been acceptable when the home was built but per TREC standards of practice we are required to report this item as a deficiency.

2003 International Residential Code for One- and Two-Family Dwellings 309.2 Separation required.

The garage shall be separated from the residence and its attic area by not less than 1/2-inch (12.7 mm) gypsum board applied to the garage side. Garages beneath habitable rooms shall be separated from all habitable rooms above by not less than 5/8-inch (15.9 mm) Type X gypsum board or equivalent. Where the separation is a floor-ceiling assembly, the structure supporting the separation shall also be protected by not less than 1/2-inch (12.7 mm) gypsum board or equivalent.

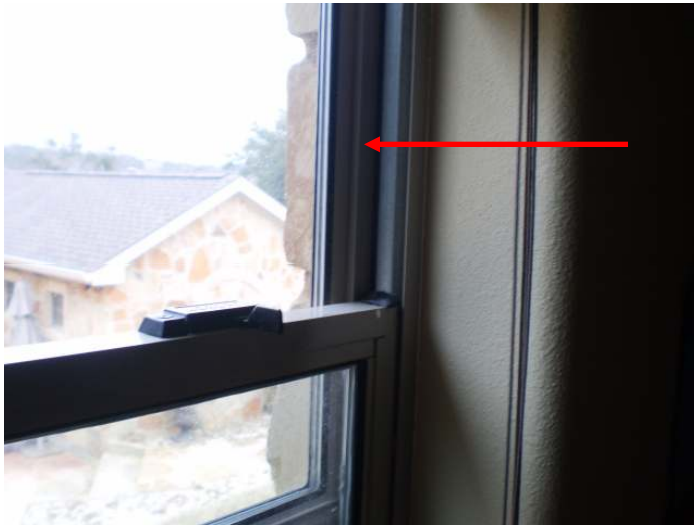
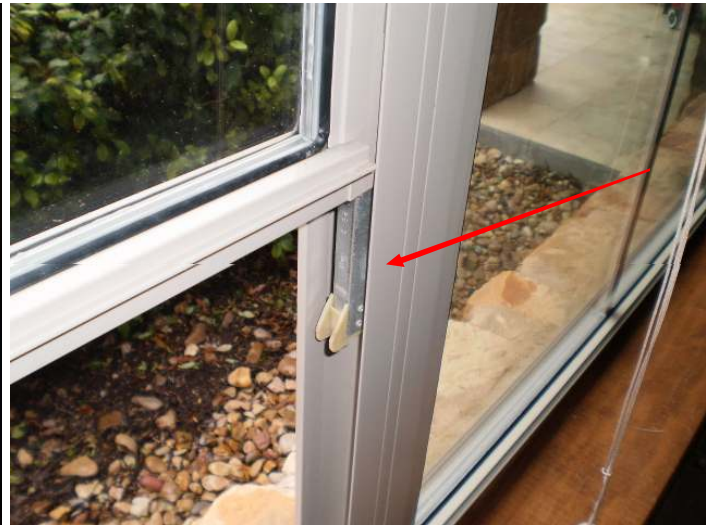
The window sash guide is damaged in the east bedroom, dining area and guest house bathroom.

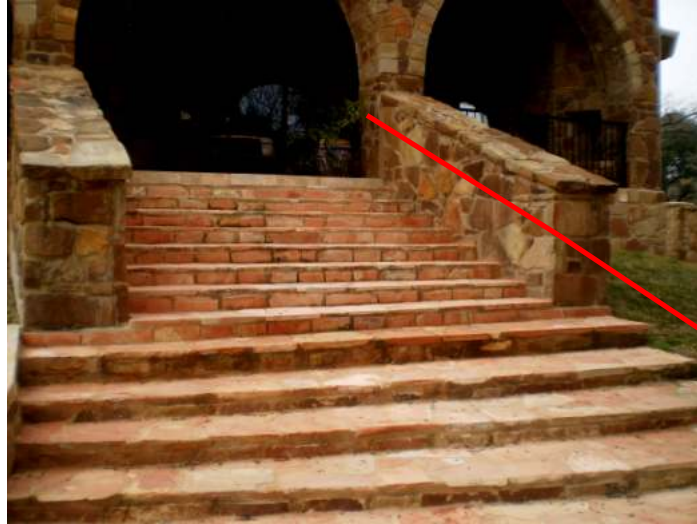
There is no handrail in place for the steps at the front of the house. Railings are sometimes left out for aesthetic reasons although hand rails are required for stairs with four or more risers. This item may not have been required at the time of construction although per TREC standards we must report as "Deficient"

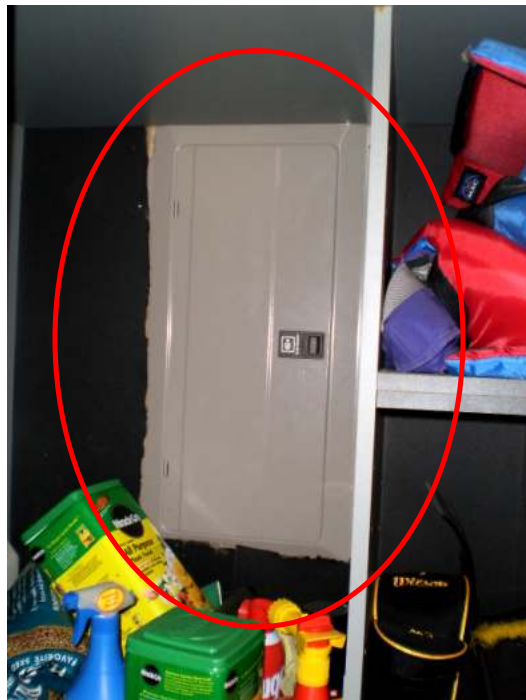
The panel box does not have proper clearance in front of the cabinet. The panel box cover plate (Dead Front) and/or cabinet should be readily accessible and cover easily removable at all times. Under current electrical standards, the accessible workspace around the panel box should be at least 36-inches in depth in front of the cabinet and 30-inches in width or the width of the equipment. Clothes, shelves, cabinets, foliage, etc should not block the workspace in front of the cabinet.

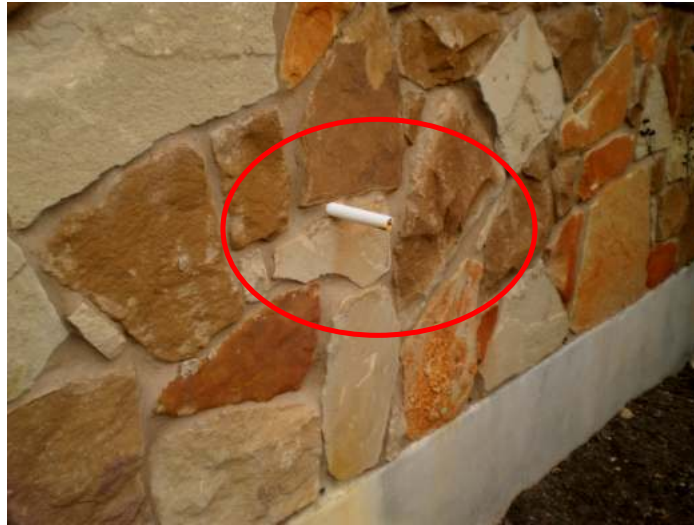
Note: A condensate drain line is terminated next to the exterior foundation perimeter beam. It is recommended that the drain line terminate further away from the foundation beam or to an approved waste system.

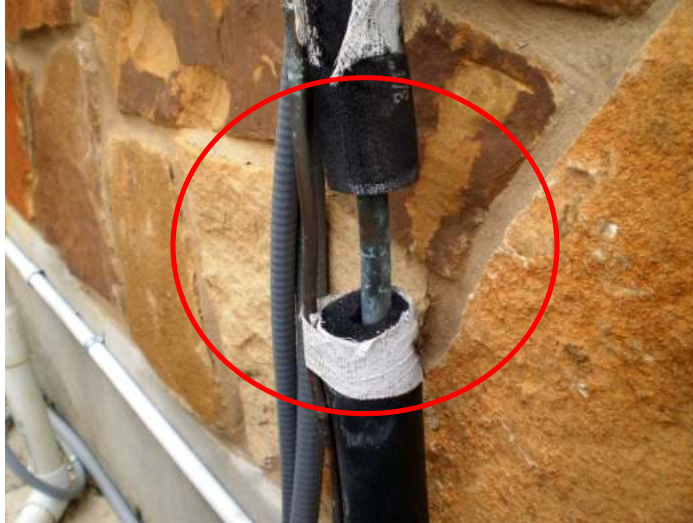
Damaged, deteriorated and/or missing insulation on the refrigerant lines should be repaired or replaced at the outside condenser.

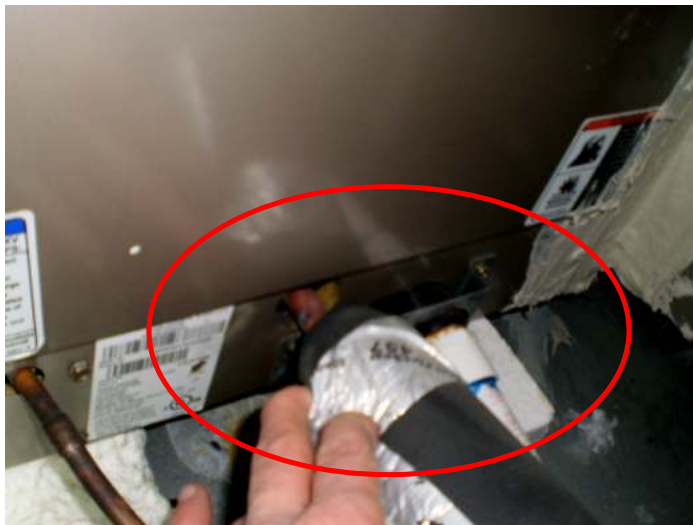
Note: Air leaks were detected at and around the indoor coil housing. The air leaks should be corrected for improved efficiency.

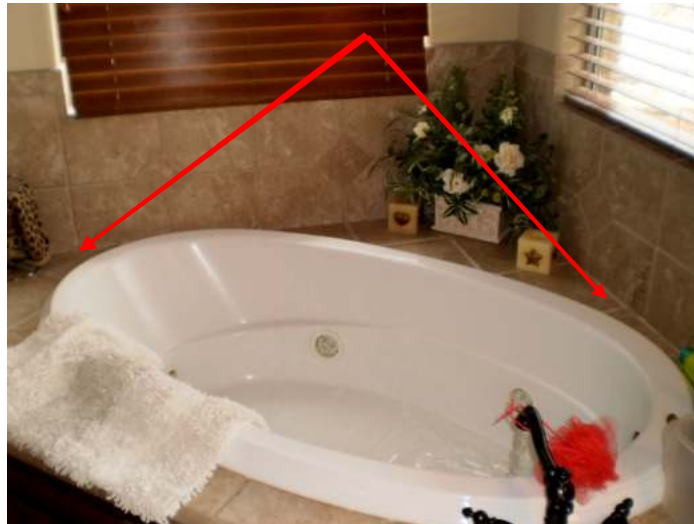
Bathtub

Cracked, deteriorated and/or missing bathtub enclosure grout and/or caulking should be repaired or replaced as necessary.

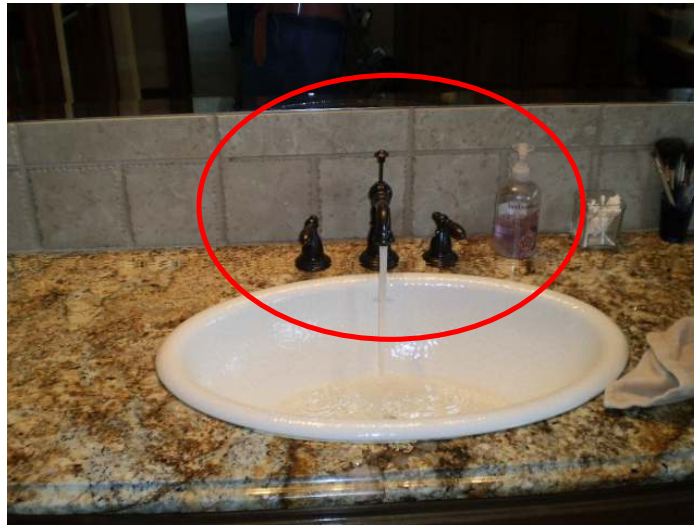
Lavatory / Sink

The faucet assembly is loose.

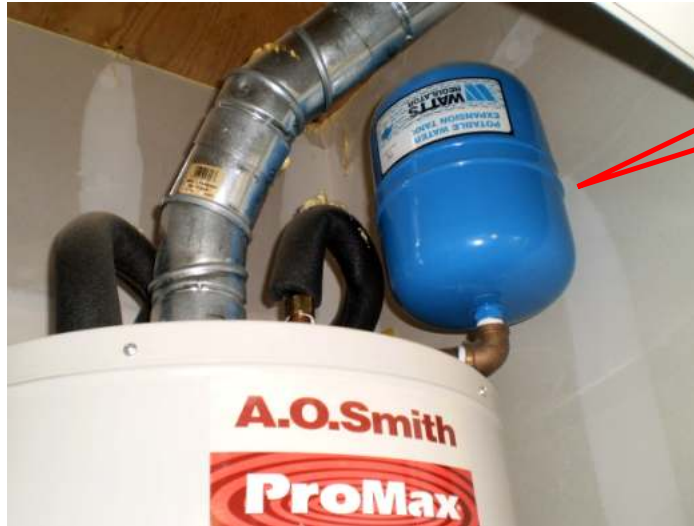
Under current building standards, when a pressure reducing valve is installed, an expansion tank at the water heater is required. This is an "as built" condition and was not required at the time of construction but per TREC standards we are required to report the lack of this item as Deficient.

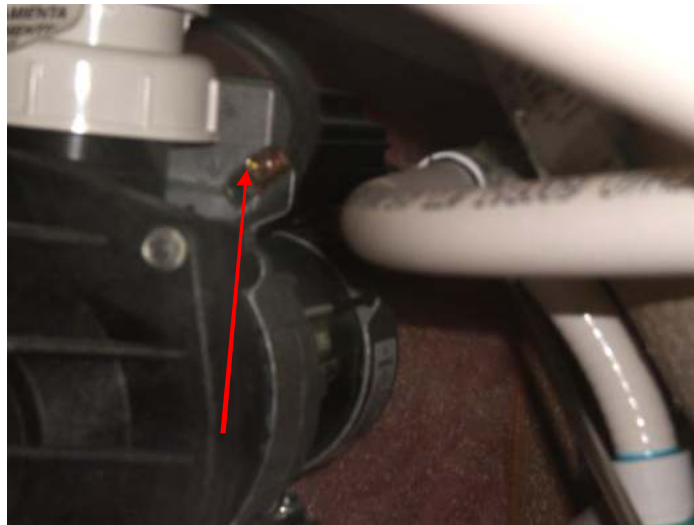
The hydro-massage therapy motor is not properly bonded to metal water piping.

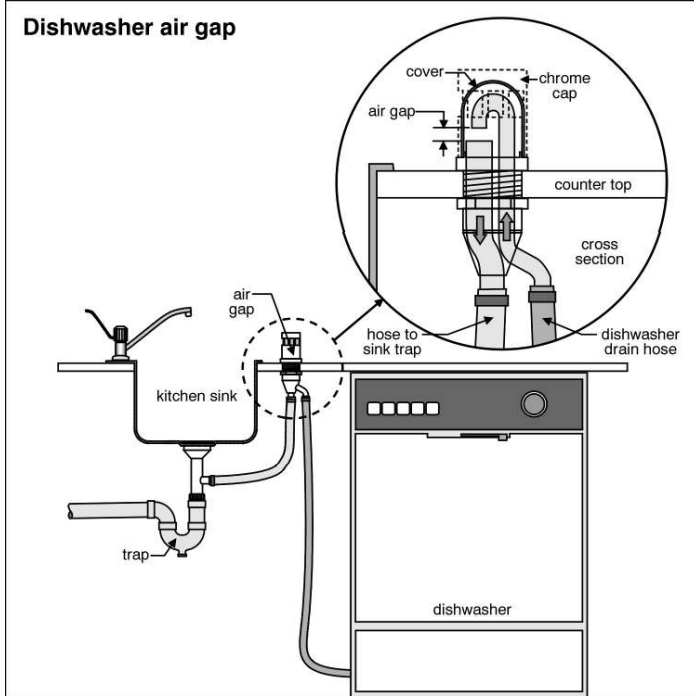
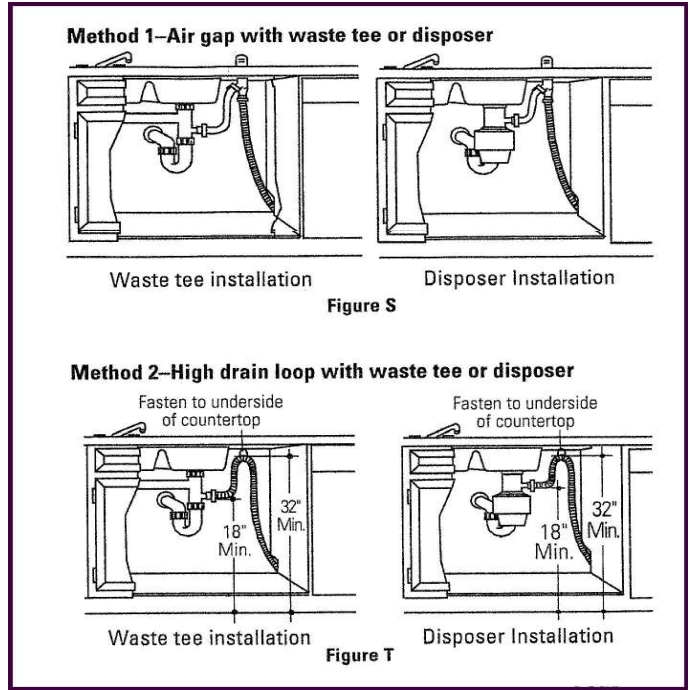
The dishwasher drain hose is not properly installed to prevent back flow or anti-siphoning. It is recommended that an air gap device or high drain loop be installed in the drain line.

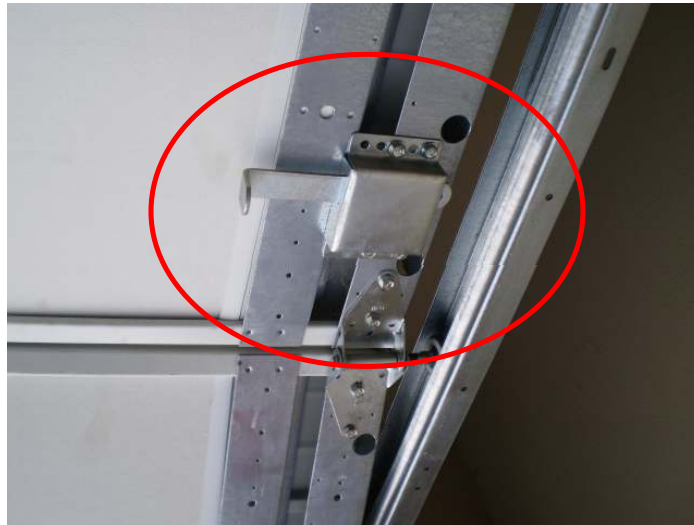
When an automatic garage door opener is in use, the manual lock should be disabled or removed.

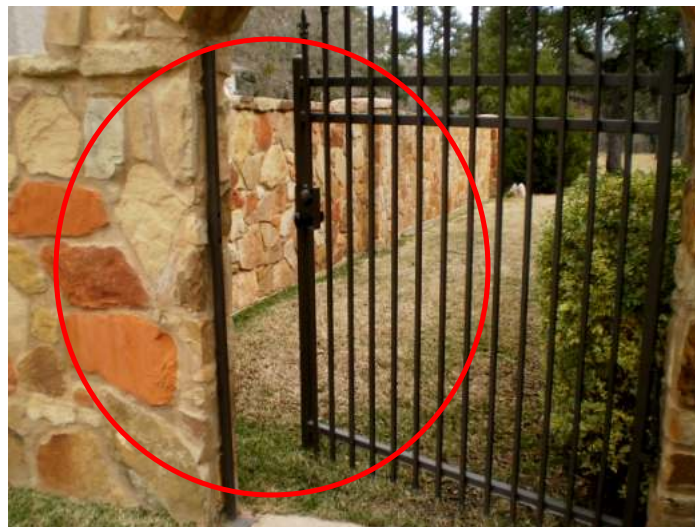
All pedestrian access gates should open outward away from the pool and should be self-closing and have a self-latching device. Where the release mechanism is located less than 54 inches from the bottom of the gate. A second release mechanism should be located on the poolside of the gate at least 3 inches below the top of the gate.
