PROPERTY INSPECTION REPORT

Nunnallee Inspections

Concerning: Austin, TX 78759
(Address or Other Identification of Inspected Property)

By: Kyle Nunnallee TREC #6371
(Name and License Number of Inspector) (Date)

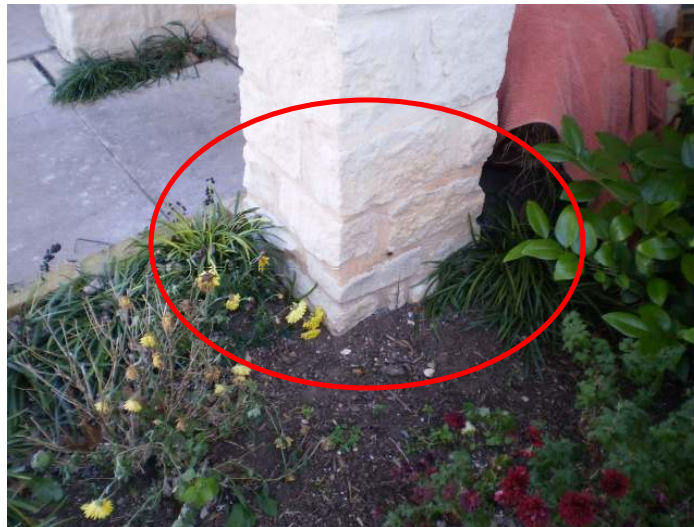
The soil line is too high on the north side of the house. Under current building standards there should be at least 4-inches of foundation visible below masonry veneer and 6-inches of foundation visible below wood type veneer.

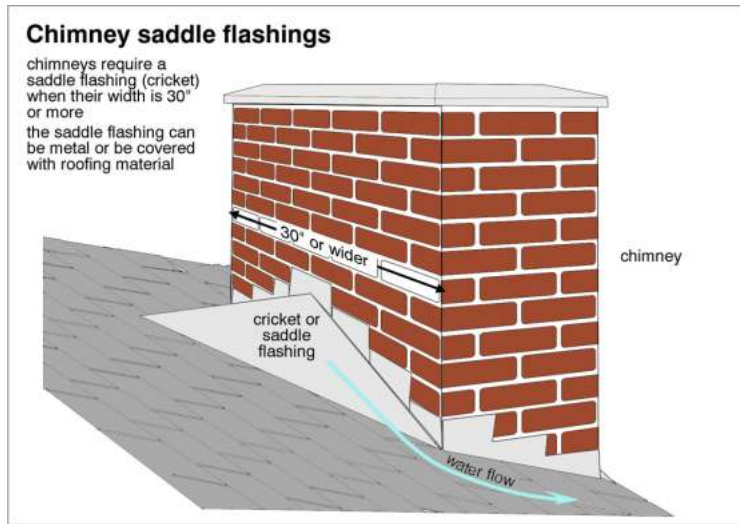
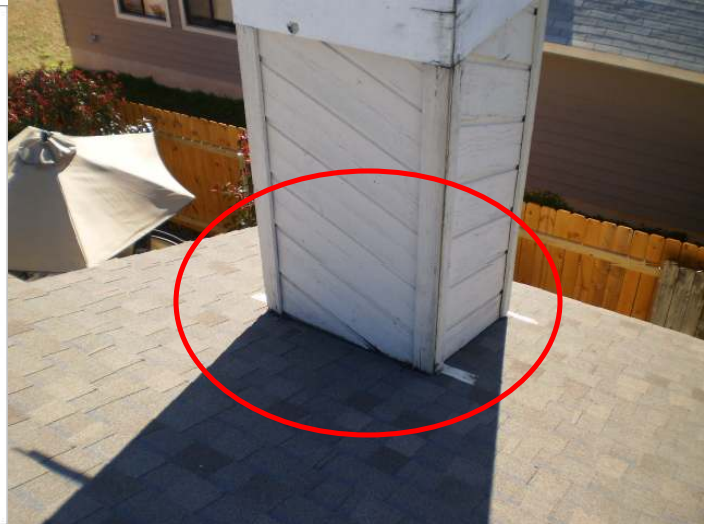
There is no cricket / saddle in place behind the roof level chimney structure. Under current building standards, there should be a cricket or saddle installed behind the ridge side of any chimney greater than 30 inches wide.

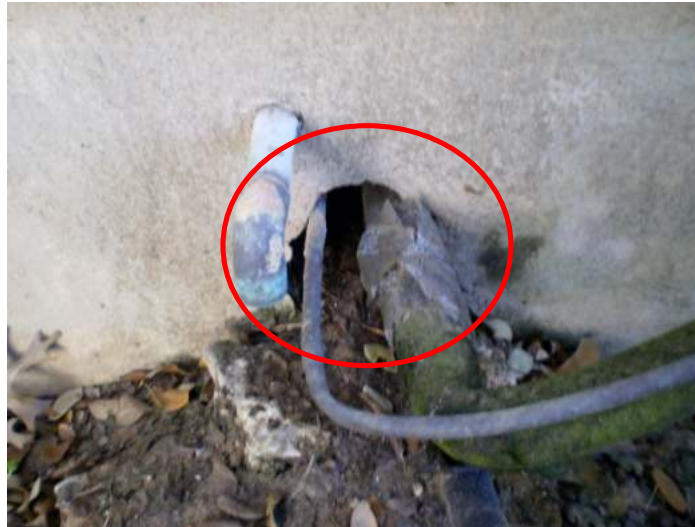
The area between the exterior veneer and the outside HVAC condenser/coils refrigerant lines needs to be properly sealed.

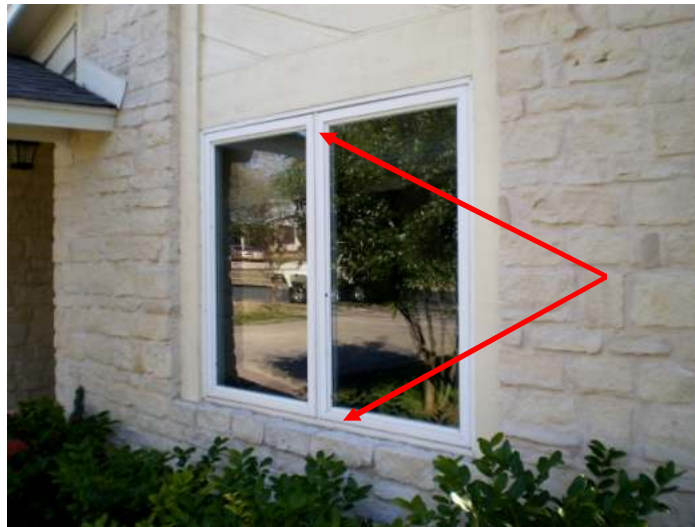
Caulking improvements are recommended for the area between the exterior veneer and the window frame at the front of the house.

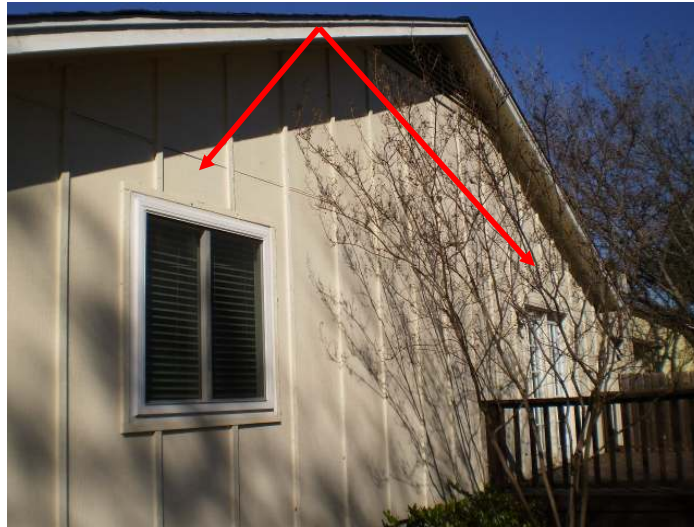
I was unable to locate or observe head flashing details above the projected wood trim on the exterior walls over the window openings. Under current building standards, there should be through-wall flashing continuously above all projected wood trim on the exterior wall veneer over window openings to help prevent water intrusion from occurring at these points. This may not have been required when the home was built, although per TREC standards we are required to report this as deficient.

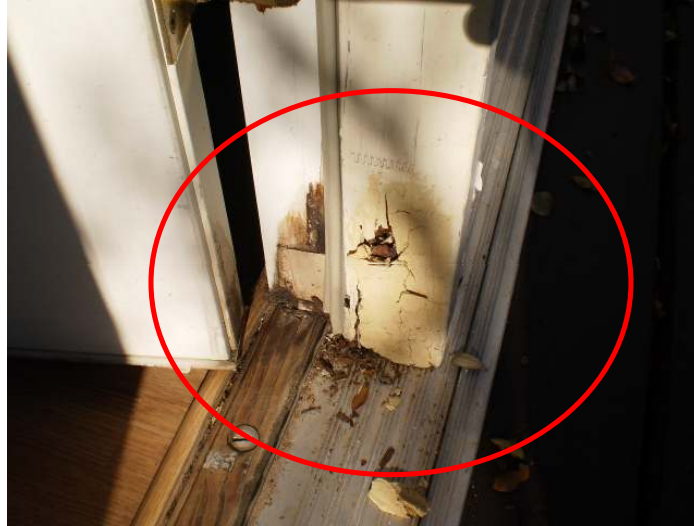
The exterior door frame has some deterioration and/or damage to the master bedroom.

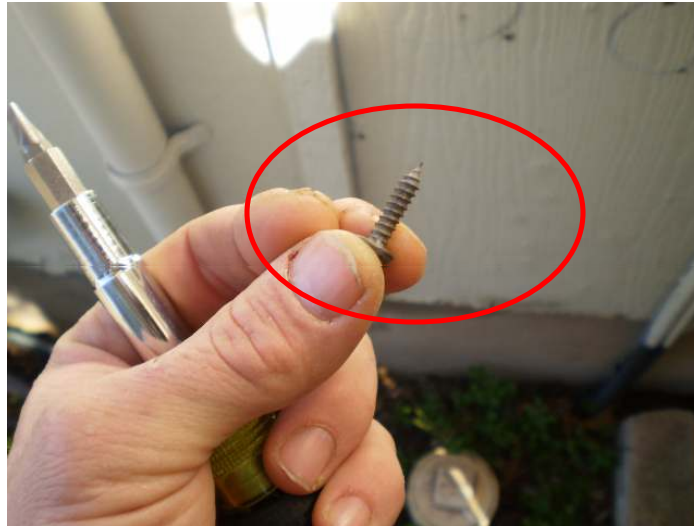
The electrical cabinet cover plate (dead front) should be installed with blunt tip screws and not sharp wood type screws for reasons of safety.

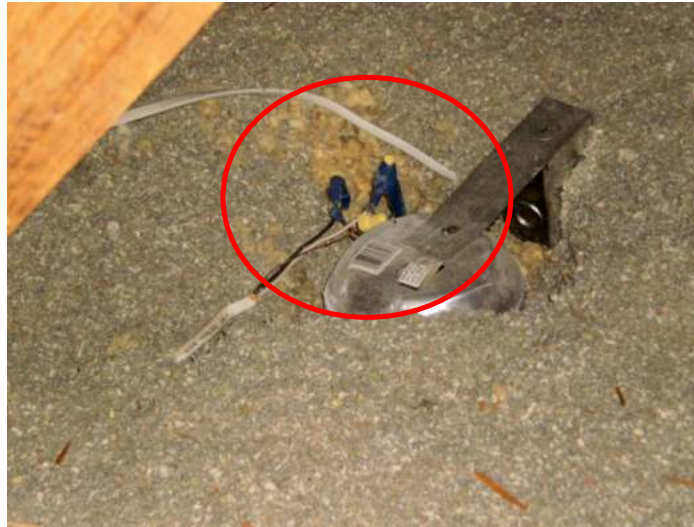
Spliced electrical wires were observed in the attic area. Spliced wires in the attic should be properly enclosed in junction box(es) and secured to the ceiling joist.

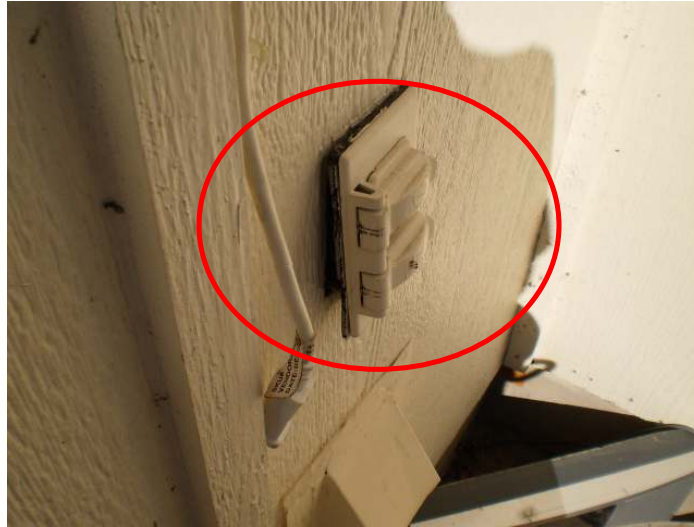
One or more of the receptades were observed to be loose at the exterior wall mount.

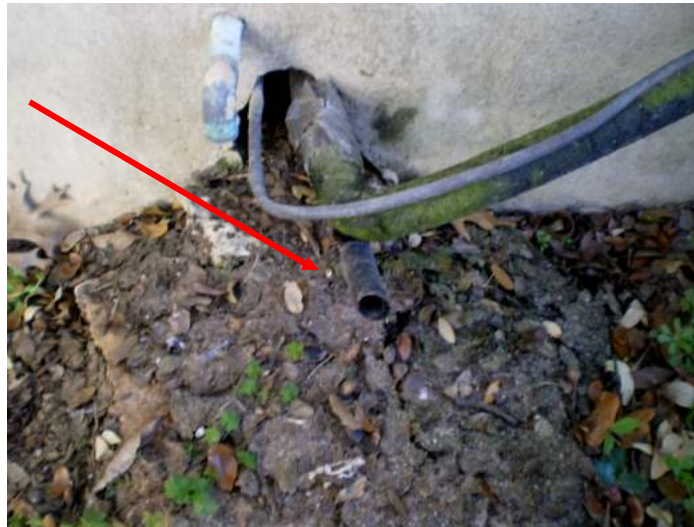
Note: The primary condensate drain line is terminated next to the exterior foundation perimeter beam. It is recommended that the drain line terminate further away from the foundation beam or to an approved waste system.

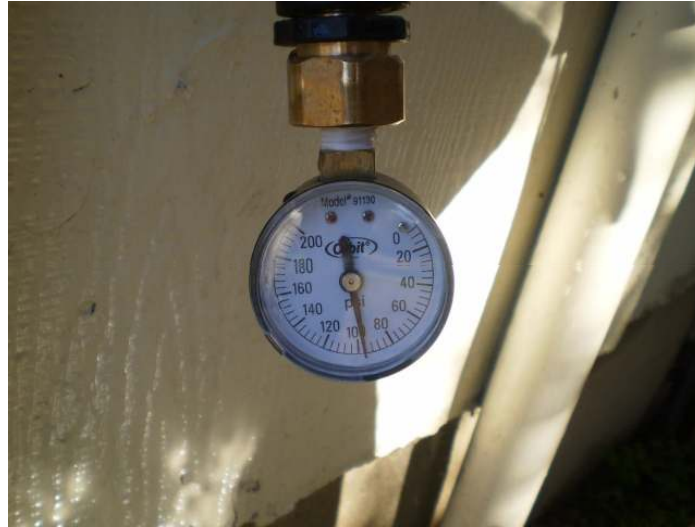
The water pressure was observed to be above 80 psi at the time of this inspection. Under current plumbing standards the maximum water pressure should be 80 psi. This condition should be further evaluated and corrected as necessary.

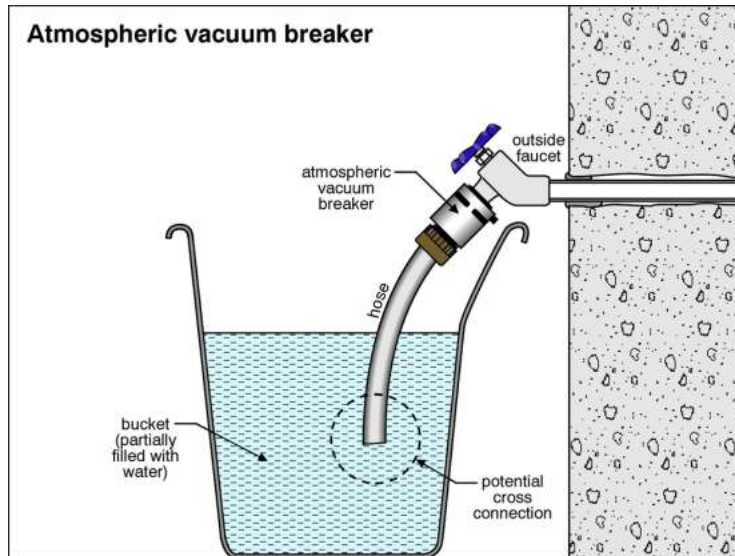
One or more of the exterior water hose bibbs (faucet) do not have a back-flow or anti-siphon device (Vacuum Breakers) in place. **Note:** This is not uncommon to observe with a home of this age.

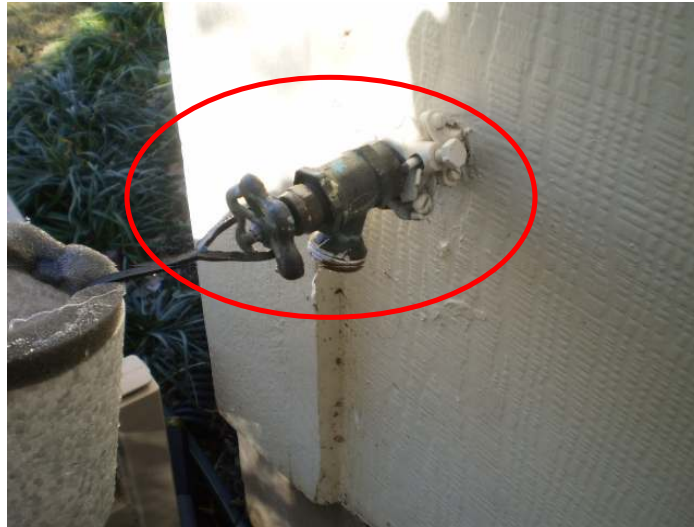
The exterior water hose bibb (faucet) leaks when turned off on the north side of the house.

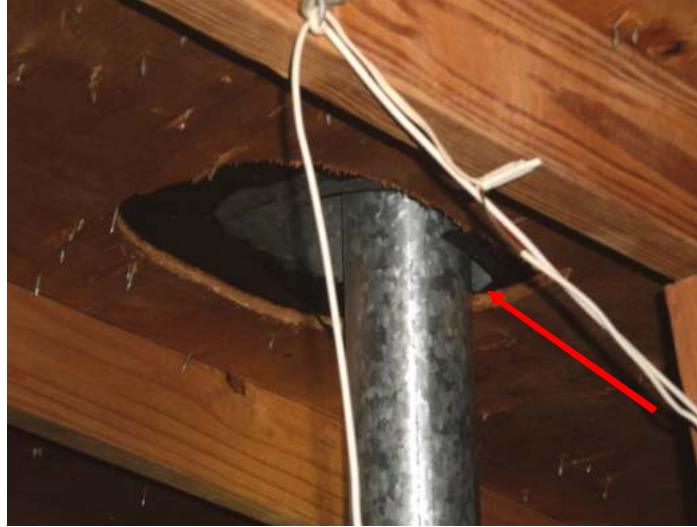
The water heater flue (vent pipe) has inadequate clearance from combustible materials. Double walled vent pipes should have at least 1-inch of clearance and single walled vent pipes should have at least 6-inches of clearance from combustible material.

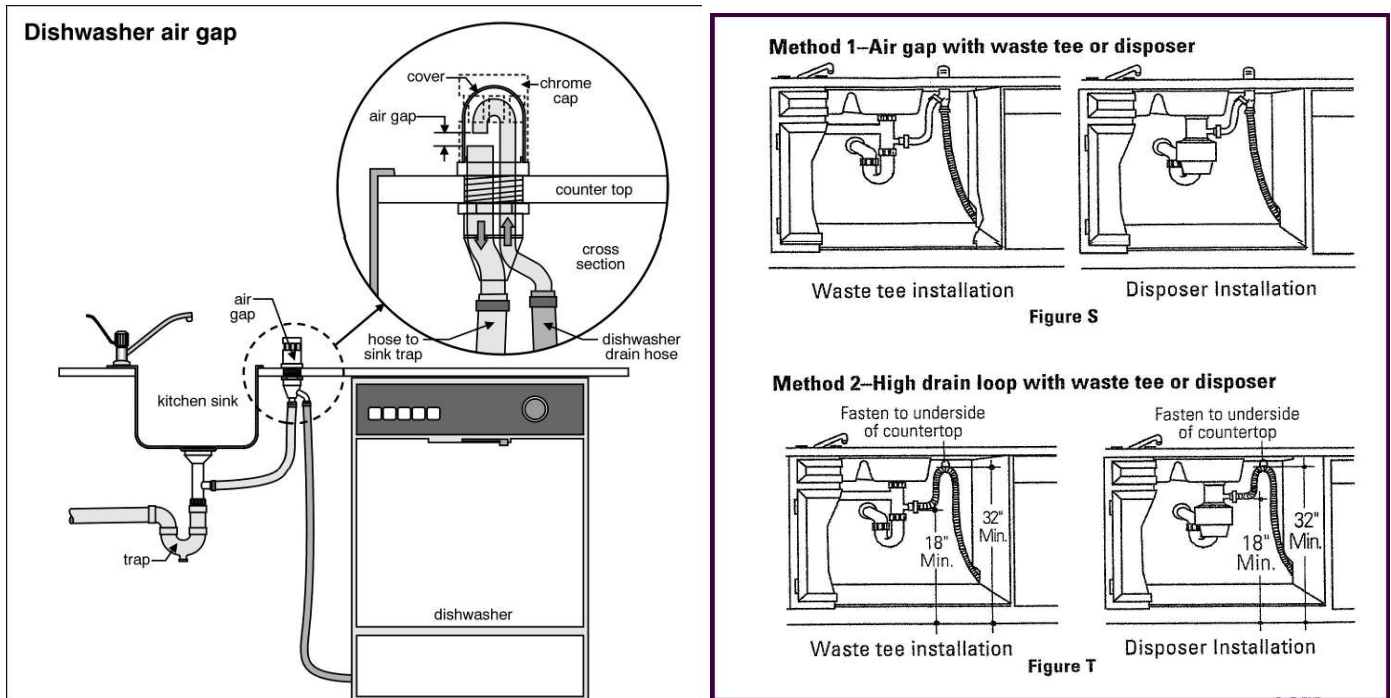
The dishwasher drain hose is not properly installed to prevent back flow or anti-siphoning. It is recommended that an air gap device or high drain loop be installed in the drain line.

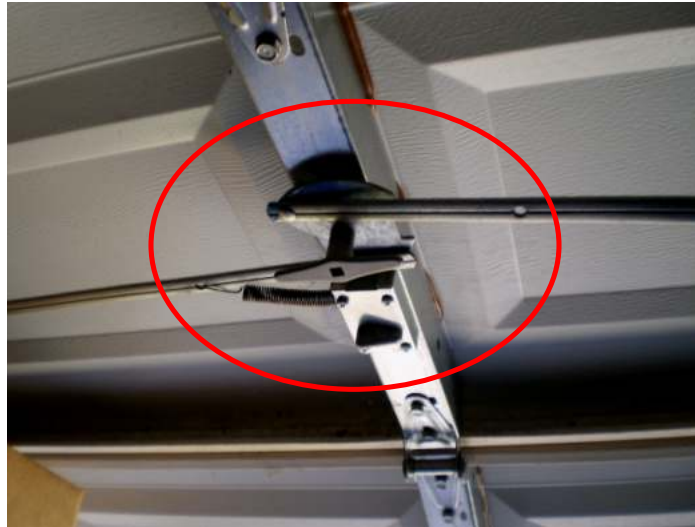
When an automatic garage door opener is in use, the manual lock should be disabled or removed.

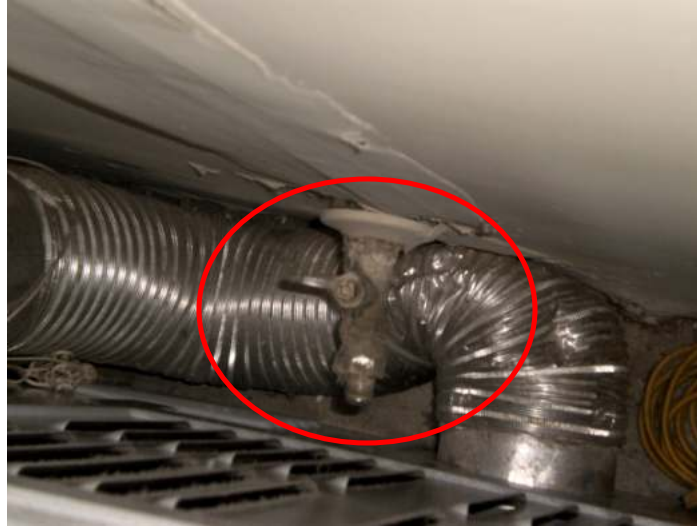
All unused gas valve ends should be capped off for safety purposes.
