PROPERTY INSPECTION REPORT

Concerning: Marble Falls, TX 78654
(Address or Other Identification of Inspected Property)

By: Kyle Nunnallee TREC #6371
(Name and License Number of Inspector) (Date)

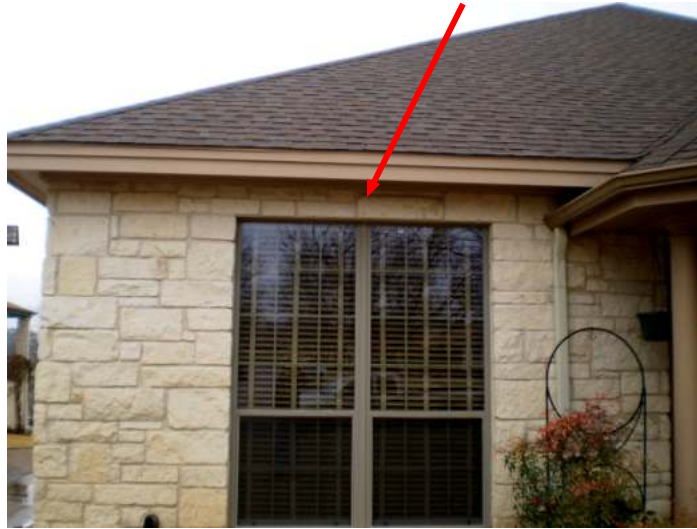
There were no weepholes observed in the low course of the exterior masonry veneer over the window and door steel lintels. This condition does not meet current building standards and should be corrected as necessary.

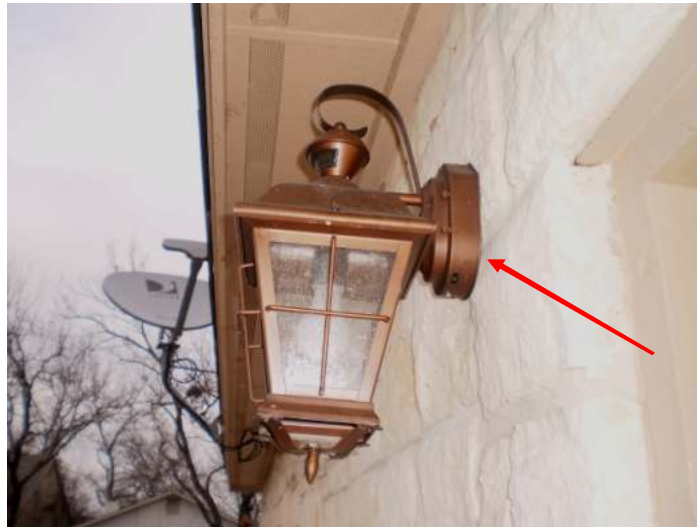
Exterior light fixtures should be sealed to the structure.

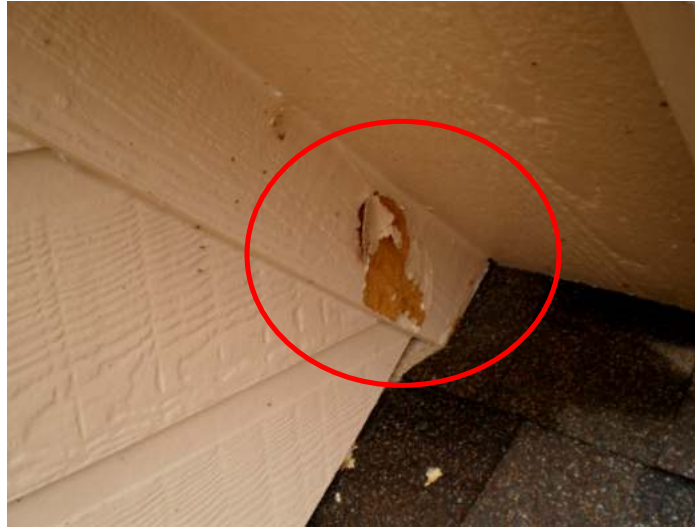
A trim board at the front of the house needs touch-up paint.

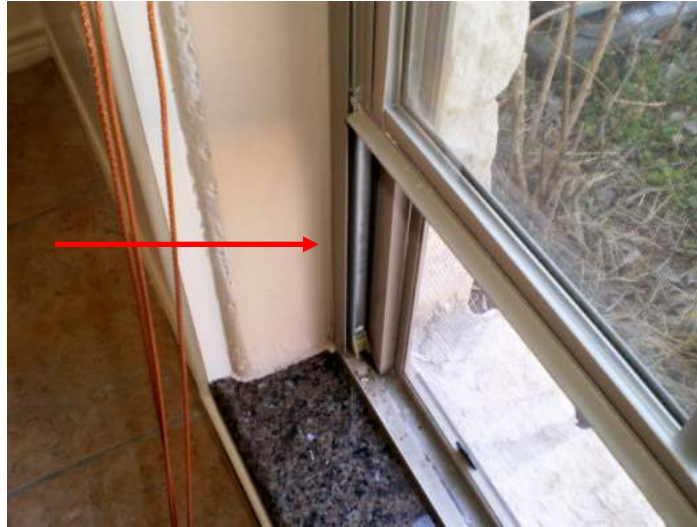
Cracked and/or broken window glass was observed in the northeast corner bedroom. The window sash guide is damaged in the northeast corner bedroom and the dining area.

9. Cracked and/or broken window glass was observed in the northeast corner bedroom.
10. The window sash guide is damaged in the northeast corner bedroom and the dining area.

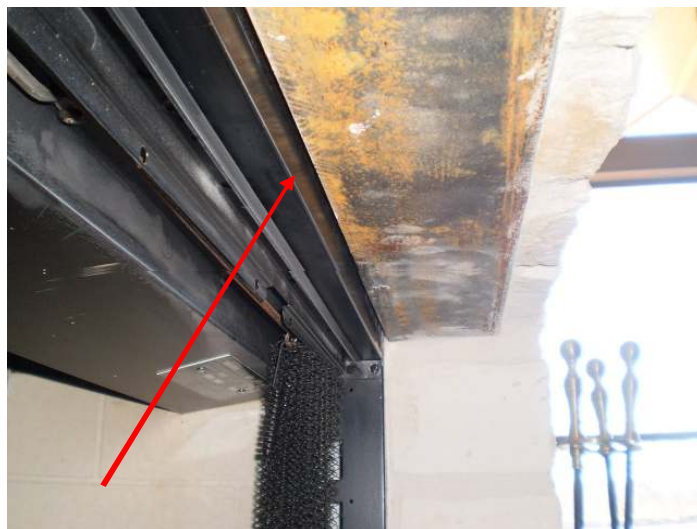
Area between the fireplace hearth steel lintel and the manufactured firebox needs to be properly sealed.

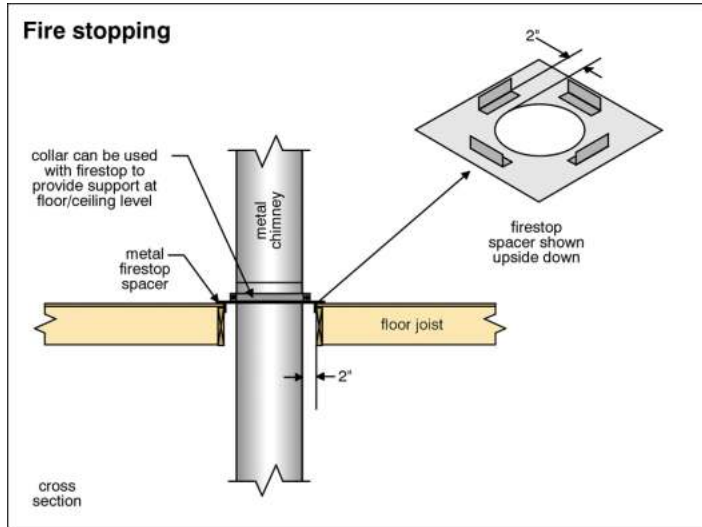
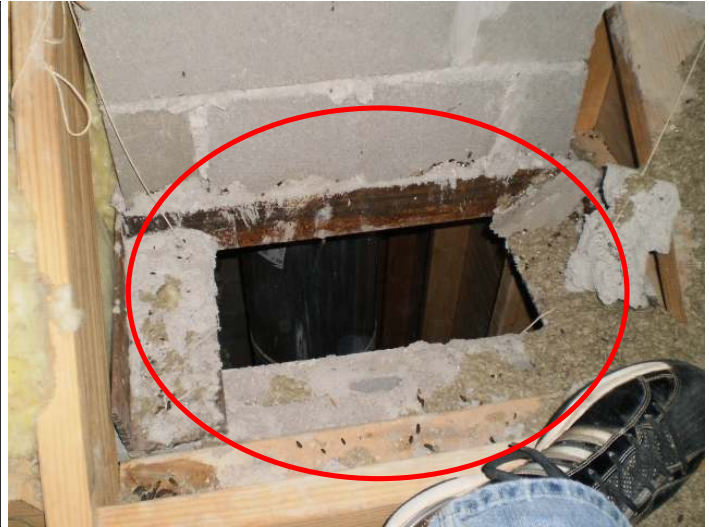
There was an insufficient fire block observed around the chimney flue at the ceiling penetration in the attic area. The firebox wall void is opened into the attic space and should be enclosed for reasons of safe fire blocking purposes.

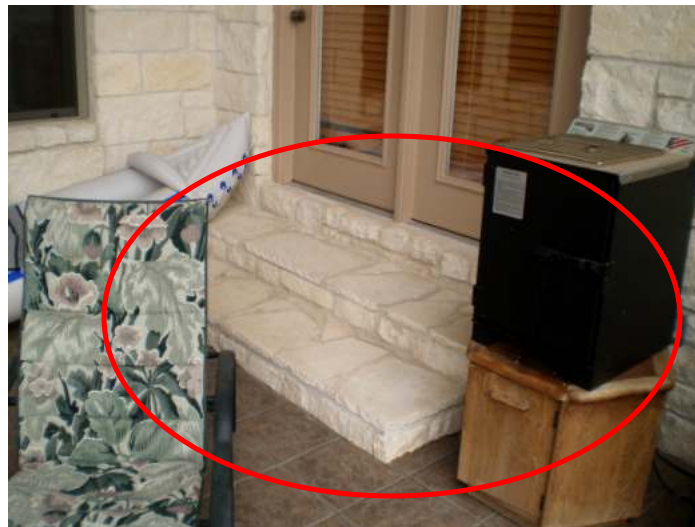
Under current building standards, a landing should be present for the stairs at the rear entry doors. This may not have been required when the home was built although should be noted.

13. Under current building standards, a landing should be present for the stairs at the rear entry doors. This may not have been required when the home was built although should be noted.

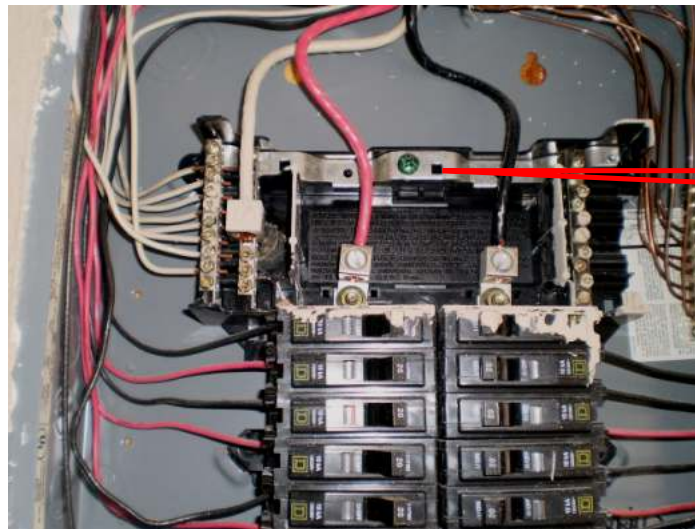
Bonding Screw

The ground wires and the neutral wires are not properly separated in the sub-panel electrical cabinet. The neutral wires should be on their own isolated bus bar and the ground wires should be connected to the sub-panel cabinet. Although the sub-panel is functional, it does not meet current National Electrical Code standards.

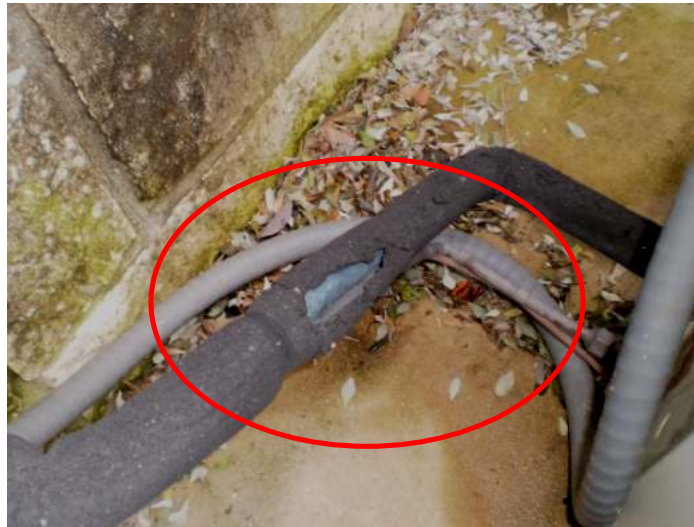
East Unit

Damaged, deteriorated and/or missing insulation on the refrigerant lines should be repaired or replaced at the outside condenser.

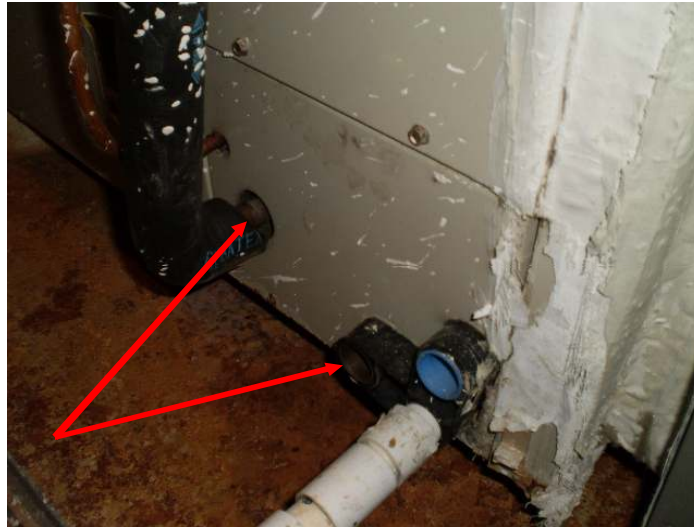
Note: Air leaks were detected at and around the indoor coil housing. The air leaks should be corrected for improved efficiency.

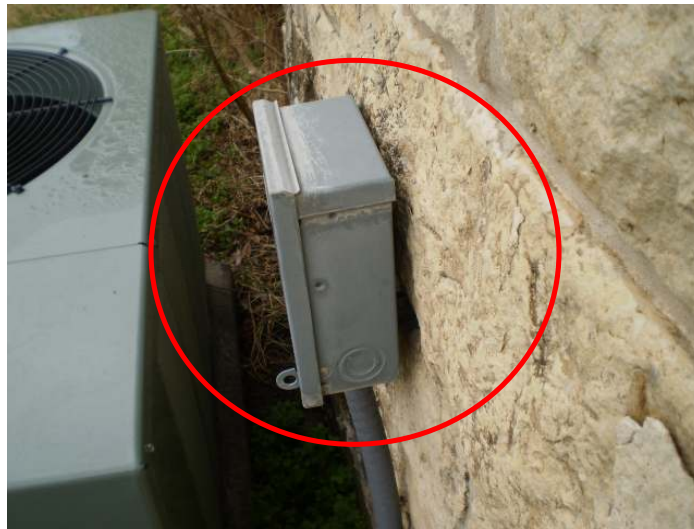
The outside condenser/coil service disconnect box should be sealed to the structure and openings sealed as necessary.

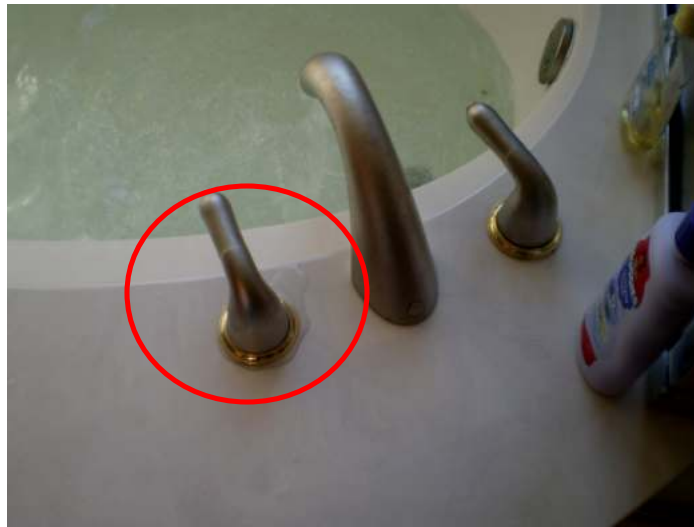
Master Bathroom

The faucet leaks at the handle when on.

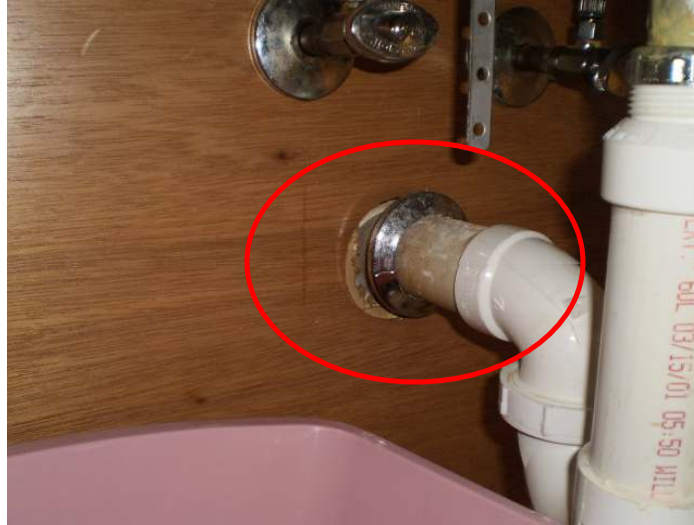
NOTE: Sealing the plumbing penetrations in these areas will help prevent air infiltration when the HVAC equipment is running and will improve efficiency.

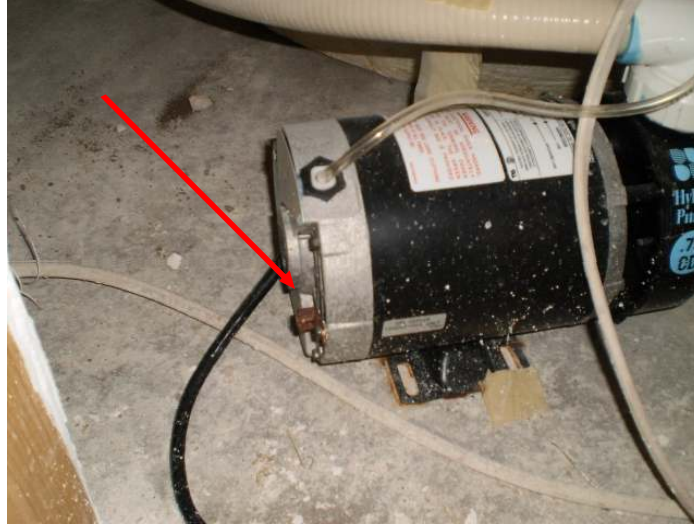
The hydro-massage therapy motor is not properly bonded to metal water piping.

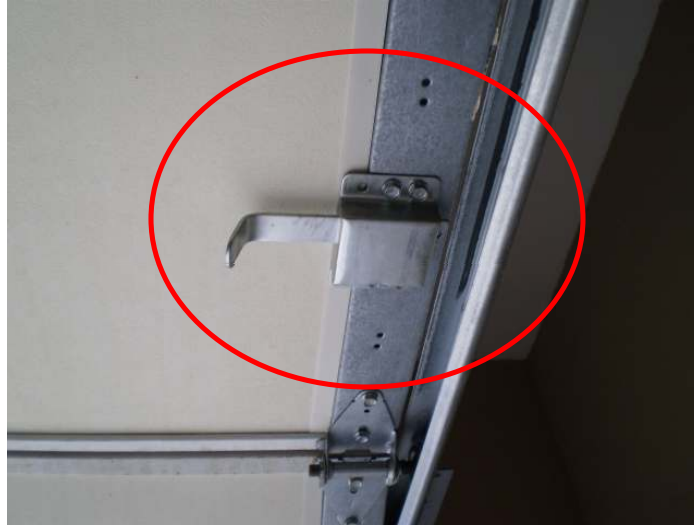
When an automatic garage door opener is in use, the manual lock should be disabled or removed.

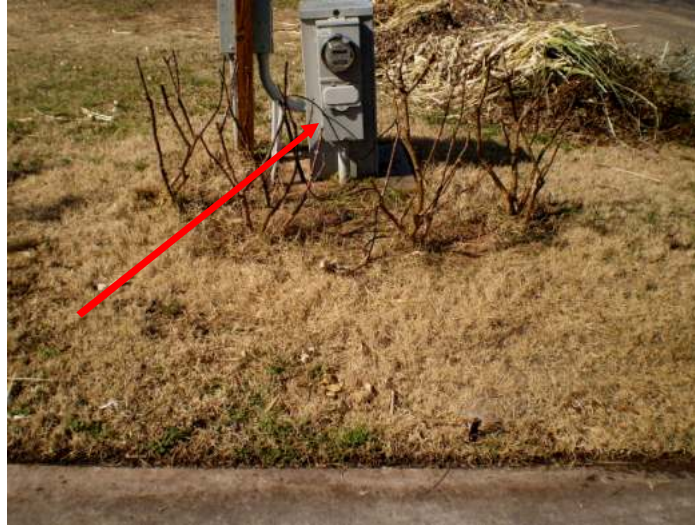
A sprinkler head adjacent the driveway should be altered or eliminated. The head is spraying onto the main electrical disconnect.

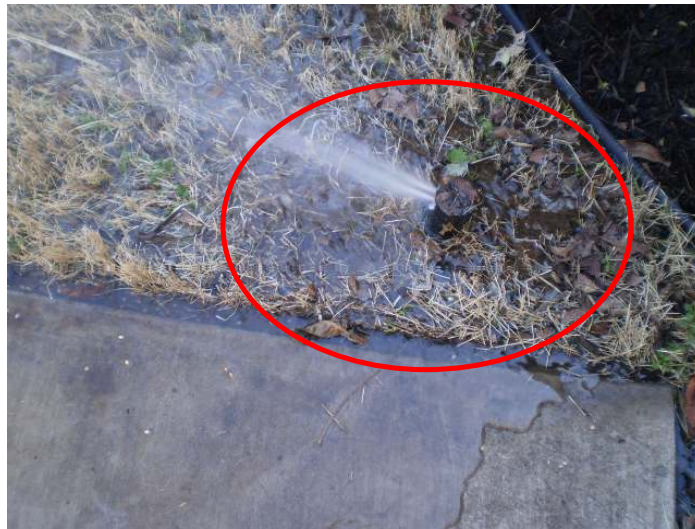
Station 1

One or more of the sprinkler heads in this station appear to be leaking at the base of the head. The cause and remedy should be further evaluated and corrected as necessary.
