PROPERTY INSPECTION REPORT

Nunnallee Inspections

Round Rock, TX 78664
(Address or Other Identification of Inspected Property)

Kyle Nunnallee TREC #6371
(Name and License Number of Inspector) (Date)

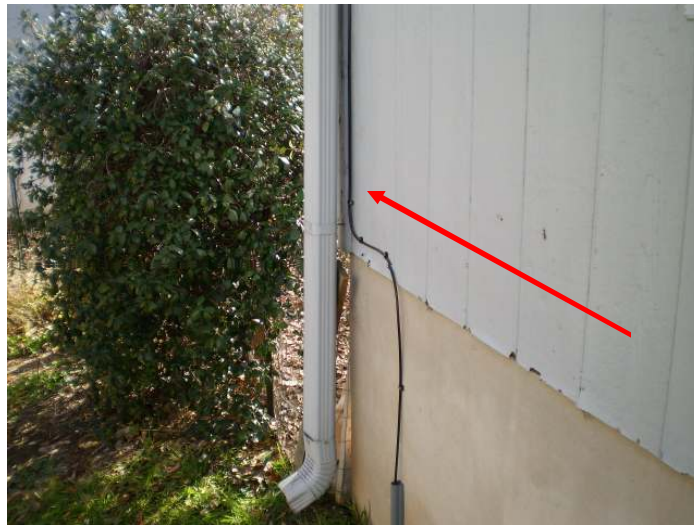
The guttering system downspout is loose on the east side of the house.

2. The guttering system downspout is loose on the east side of the house.
3. **Note:** The gutters require cleaning.
4. The attic ladder was observed to be installed with improper fasteners. This condition should be further evaluated and corrected as necessary.

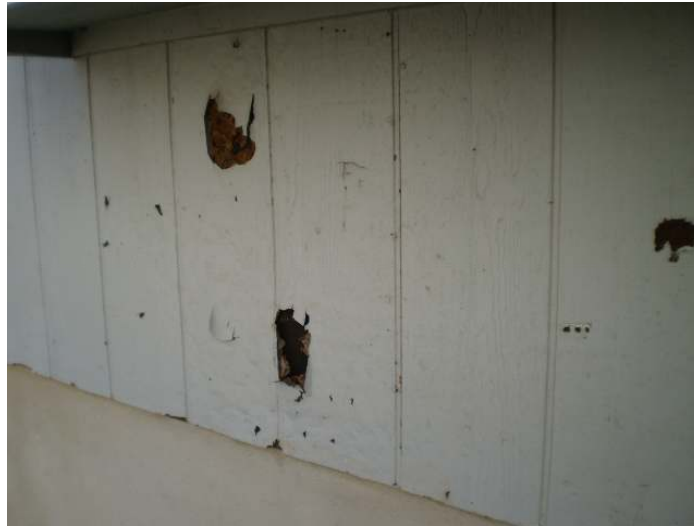
The wood veneer has some deterioration and/or damage on the north and east sides of the house.

5. The wood veneer has some deterioration and/or damage on the north and east sides of the house.
6. There were no weepholes observed in the low course of the exterior masonry veneer over the window and door steel lintels. This condition does not meet current building standards and should be corrected as necessary.

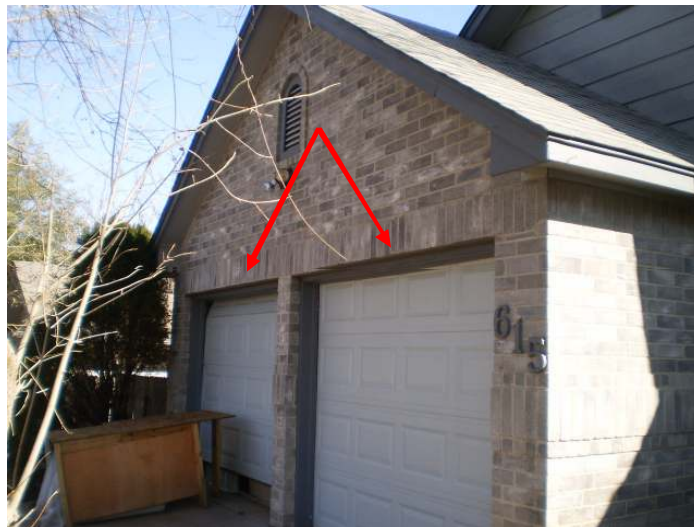
There were no weepholes observed in the low course of the exterior masonry veneer over the window and door steel lintels. This condition does not meet current building standards and should be corrected as necessary.

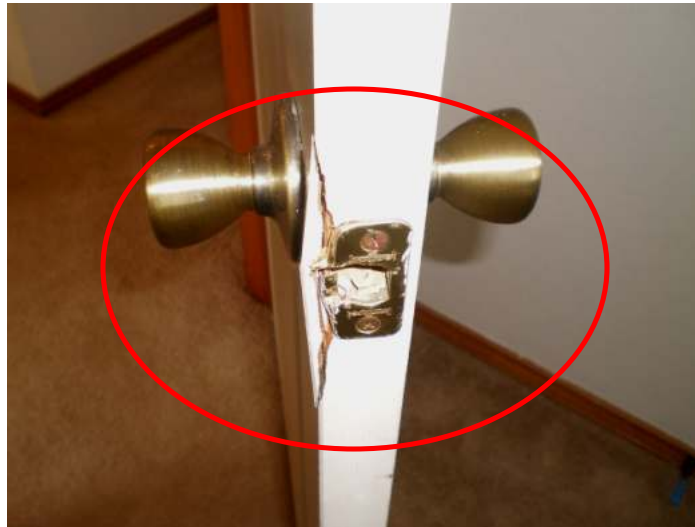
A damaged interior door was observed at the time of this inspection.

8. A damaged interior door was observed at the time of this inspection.

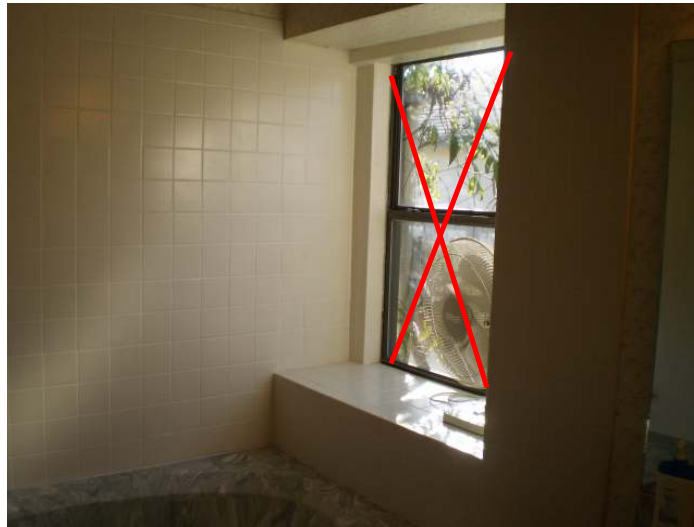
One or more of the thermal pane windows were observed to have lost their seals. This has resulted in condensation or a fog like film to develop between the panes of glass. The thermal pane windows no longer function as designed when they loose their seal and replacement may be necessary. The windows that have noticeably lost their seals are listed but may not be limited to the following:

(Numerous windows throughout the home).

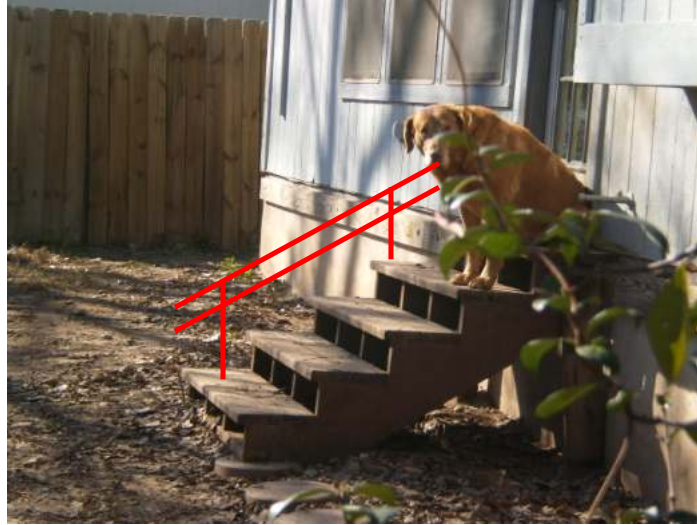
There is no handrail in place for the steps at the front of the house. Railings are sometimes left out for aesthetic reasons although hand rails are required for stairs with four or more risers. This item may not have been required at the time of construction although per TREC standards we must report as "Deficient"

15. There is no handrail in place for the steps at the front of the house. Railings are sometimes left out for aesthetic reasons although hand rails are required for stairs with four or more risers. This item may not have been required at the time of construction although per TREC standards we must report as "Deficient"

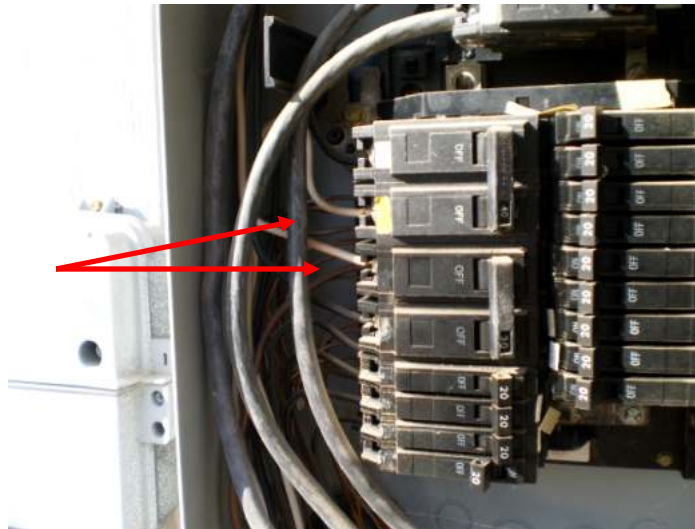
White wires in the main panel being used as a hot lead should be properly marked. This is usually achieved using colored electrical tape. Color coated wires is universal and helps electricians identify hot, neutral and ground and does effect the manner or procedure in which they work. This condition should be improved.

21. White wires in the main panel being used as a hot lead should be properly marked. This is usually achieved using colored electrical tape. Color coated wires is universal and helps electricians identify hot, neutral and ground and does effect the manner or procedure in which they work. This condition should be improved.

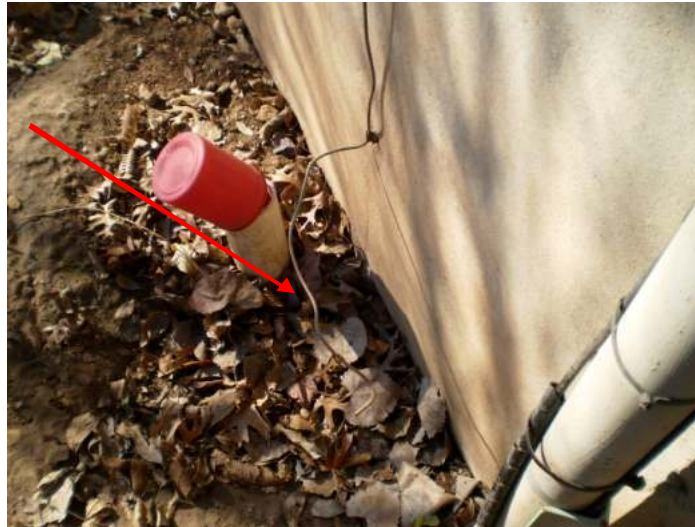
The bonding wire connection to the ground electrode rod has pulled loose and needs to be repaired as necessary.

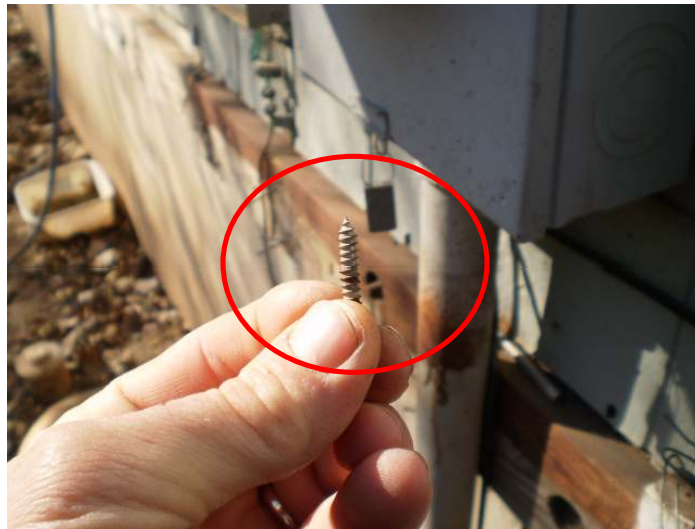
The electrical cabinet cover plate (dead front) should be installed with blunt tip screws and not sharp wood type screws for reasons of safety.

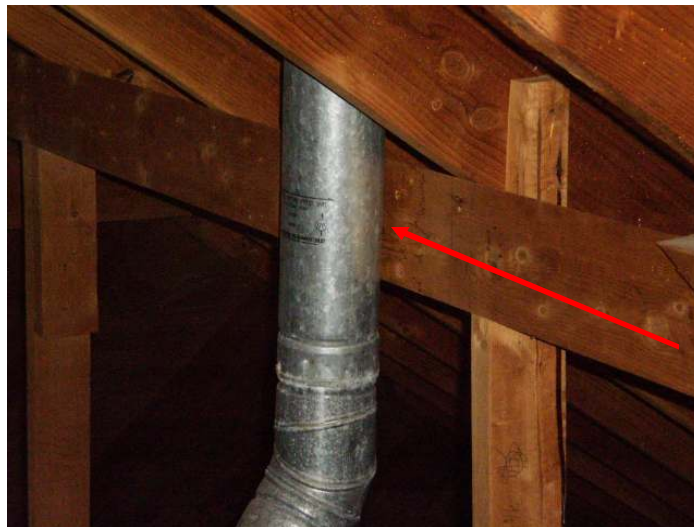
The heating unit flue (vent pipe) has inadequate clearance from combustible materials. Double walled vent pipes should have at least 1-inch of clearance and single walled vent pipes should have at least 6-inches of clearance from combustible material.

29. The heating unit flue (vent pipe) has inadequate clearance from combustible materials. Double walled vent pipes should have at least 1-inch of clearance and single walled vent pipes should have at least 6-inches of clearance from combustible material.

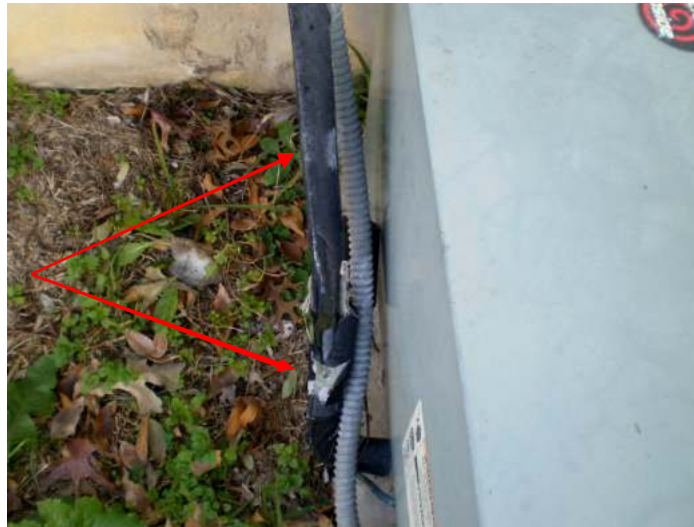
Damaged, deteriorated and/or missing insulation on the refrigerant lines should be repaired or replaced at the outside condenser.

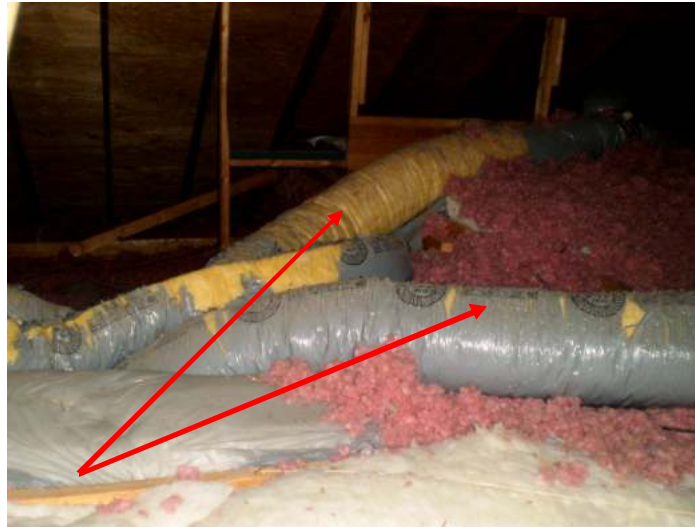
Note: The covering on the ductwork that is in place has been known to deteriorate with direct and/or indirect UV light.

Damage to the plastic covering was observed.

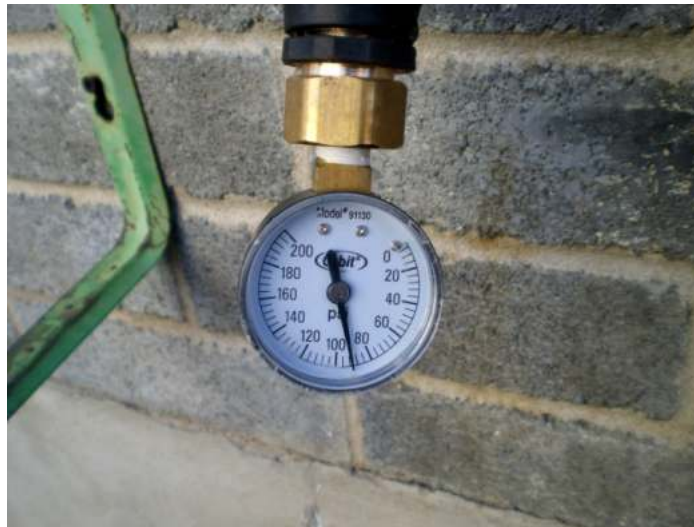
The water pressure was observed to be above 80 psi at the time of this inspection. Under current plumbing standards the maximum water pressure should be 80 psi. This condition should be further evaluated and corrected as necessary.

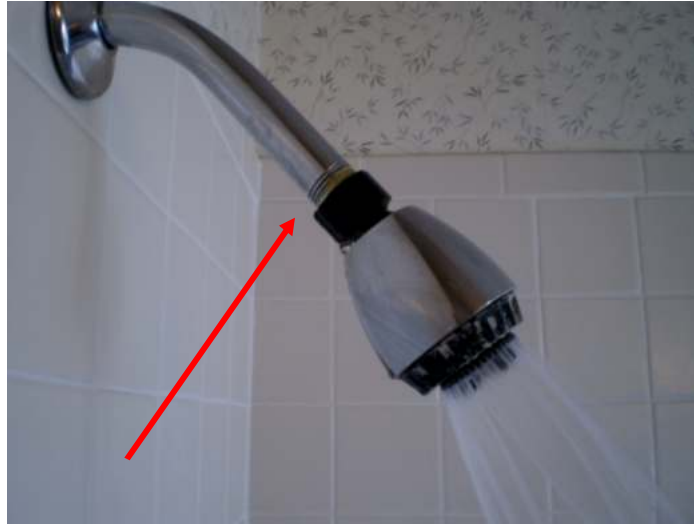
Master Bathroom

The shower spout is leaking at the neck connection.

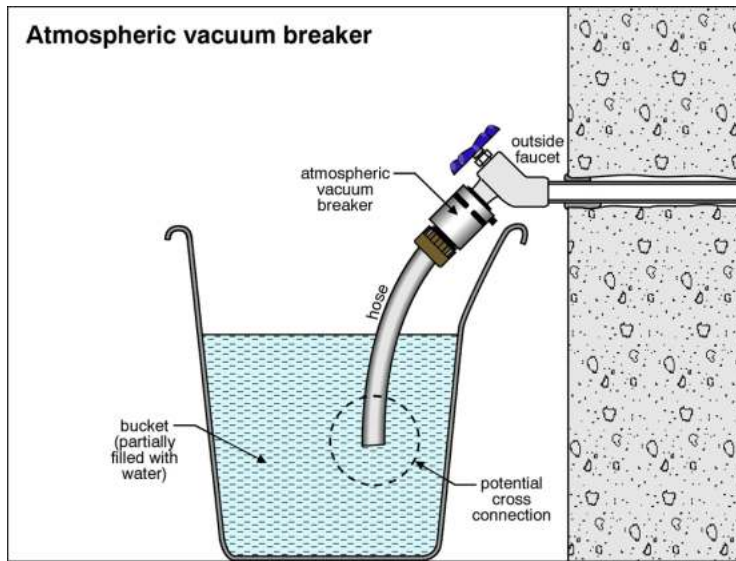
One or more of the exterior water hose bibbs (faucet) do not have a back-flow or anti-siphon device (Vacuum Breakers) in place. **Note:** This is not uncommon to observe with a home of this age.

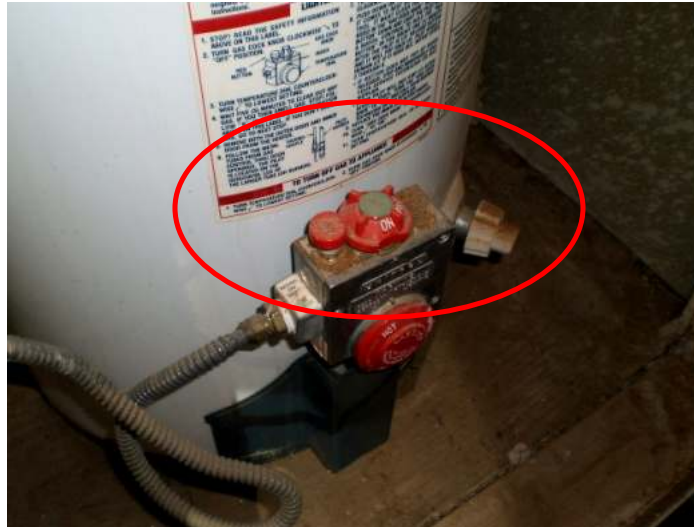
There was a gas leak detected at or around the gas pilot assembly. The inspector used a TIFF 8800 gas leak detector to locate the leak.

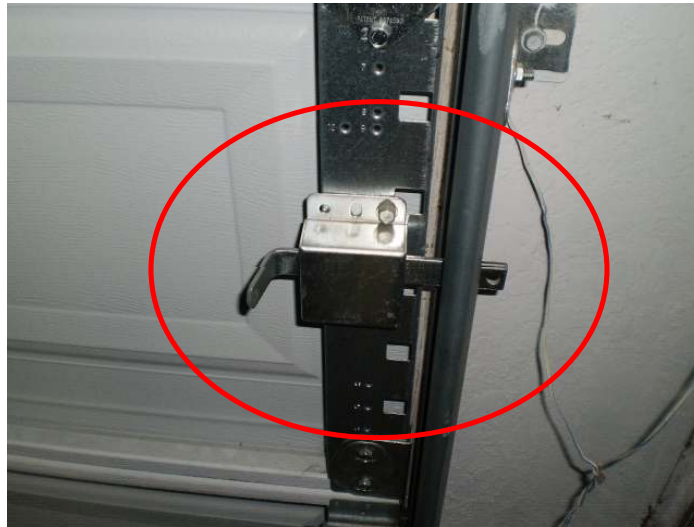
When an automatic garage door opener is in use, the manual lock should be disabled or removed.
