PROPERTY INSPECTION REPORT

Concerning: Austin, TX 78732
(Address or Other Identification of Inspected Property)

By: Kyle Nunnallee TREC #6371 Feb 01, 2010
(Name and License Number of Inspector) (Date)

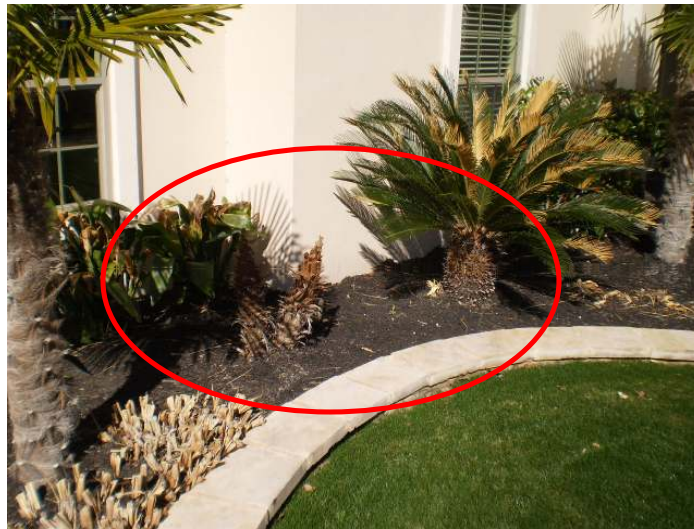
The soil line is too high on the east side of the house. Under current building standards there should be at least 4-inches of foundation visible below masonry veneer and 6-inches of foundation visible below wood type veneer.

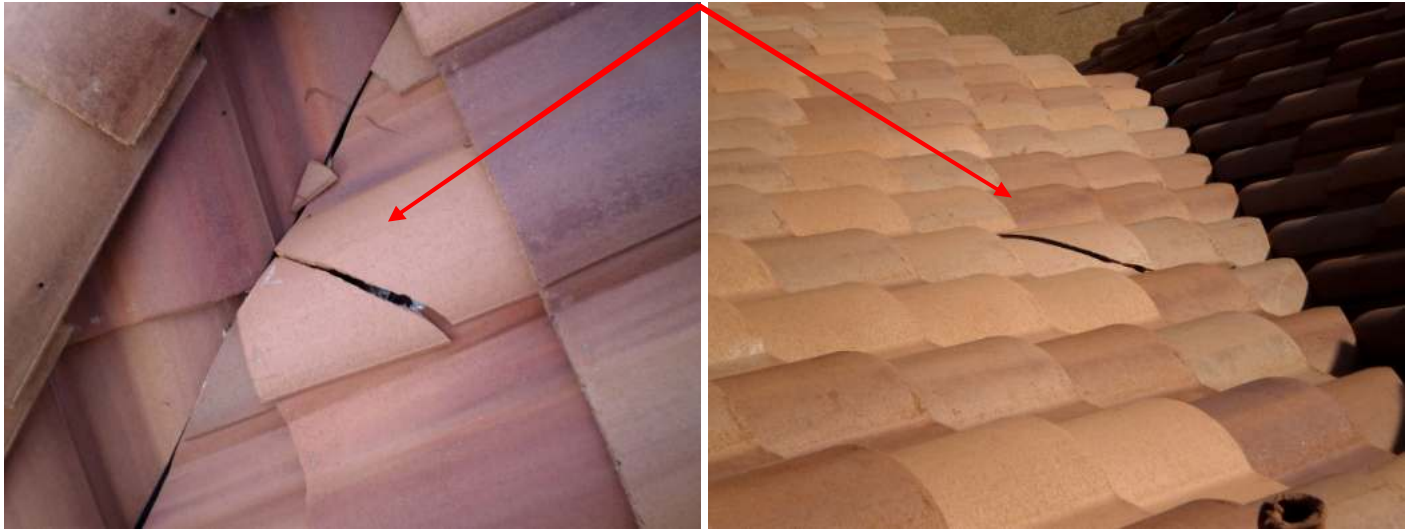
A broken tile was observed on the rear slope adjacent the patio and on the south slope.

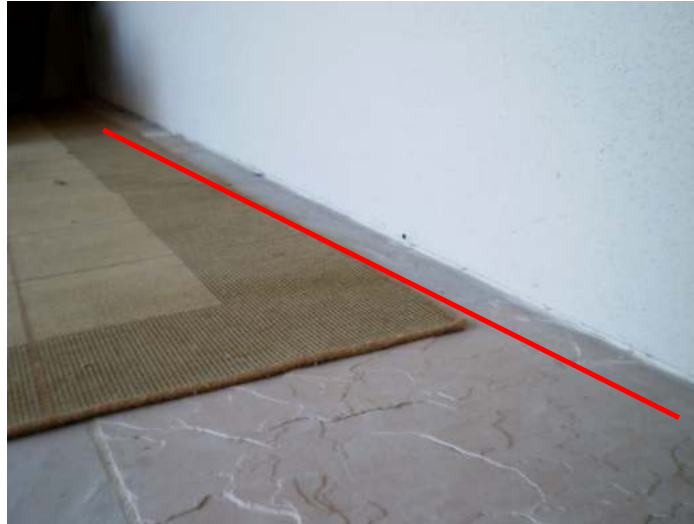
The exterior stucco type veneer/dadding has inadequate clearance from the concrete flatwork. Most manufacturers require a minimum of 2-inches of clearance from all concrete flatwork.

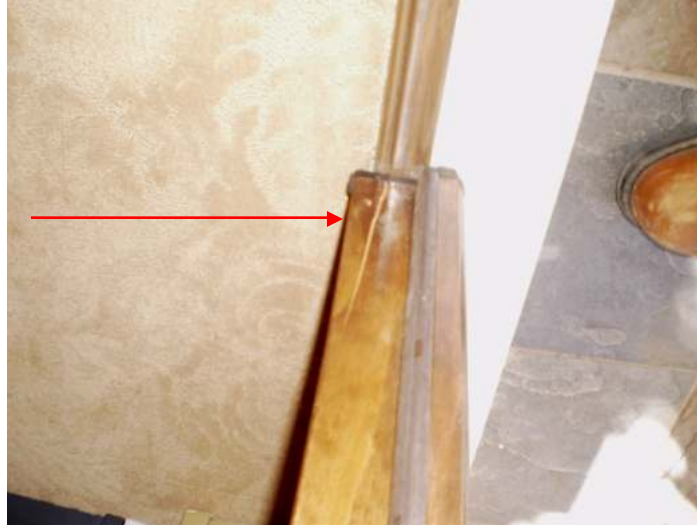
Damaged t-astragal trim at the front of the house was observed. Minor repairs needed.

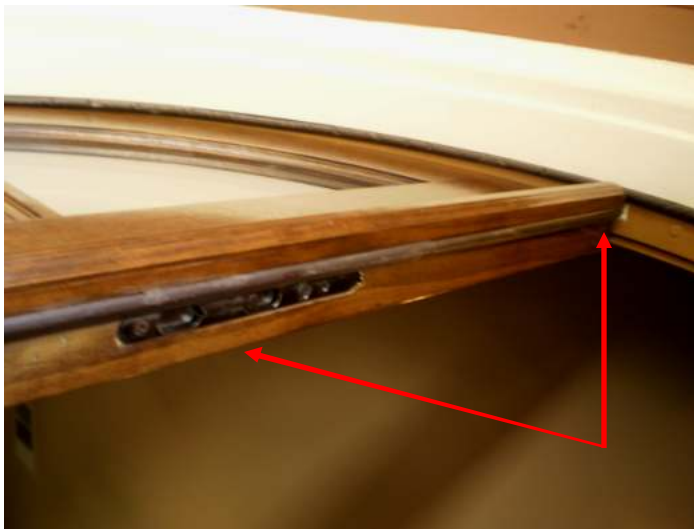
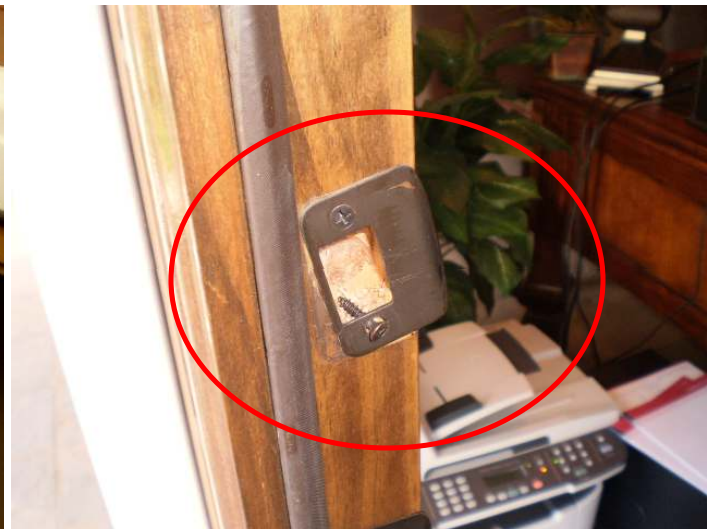
Header lock for an exterior door in the office is not working properly.
Striker plate for this door is not properly secured.
Adjustments to this door will need to be made in order to seal properly.

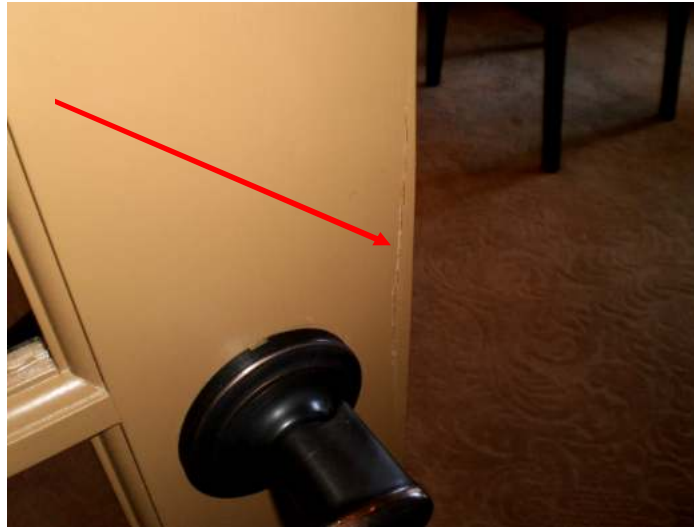
French doors into the office have minor damage to the veneer and will also need adjustments to close properly.

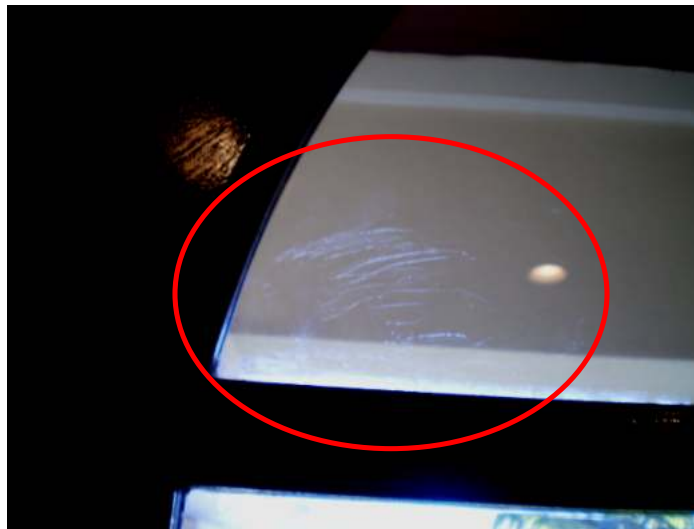
NOTE: Scratched door glass in the front office was observed.

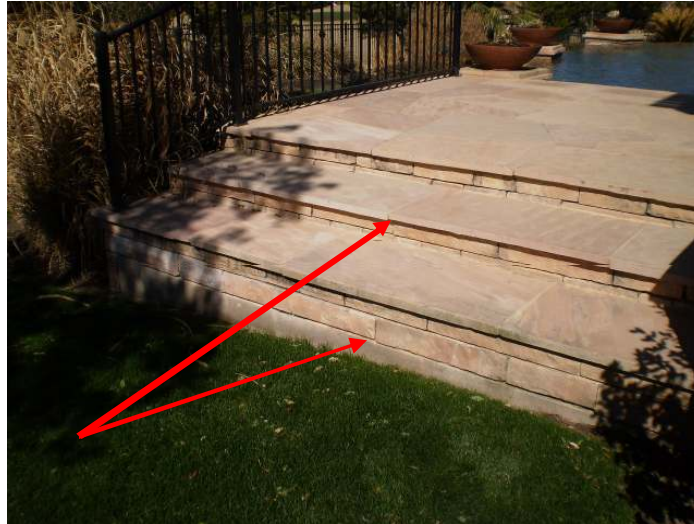
The size and/or orientation of the step "risers" in the pool area may make the stairway difficult to negotiate. This condition should be altered for improved safety.

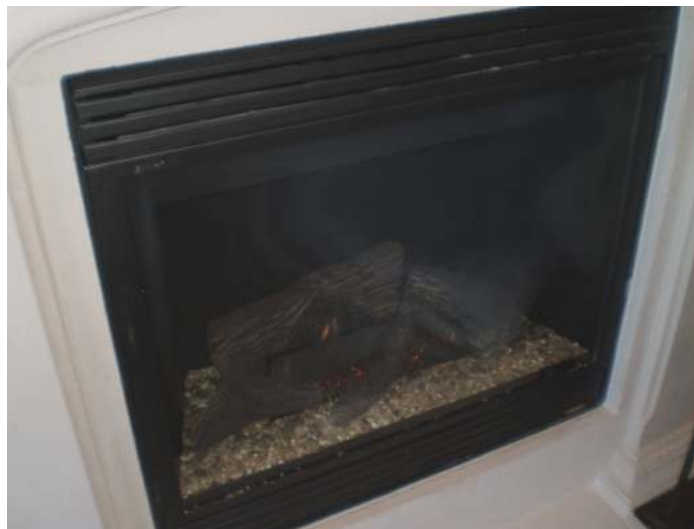
Fogged glass at the fireplace was observed and may need to be improved.

Please be aware the glass front of this fireplace will reach extreme temperatures and is a recognized hazard to small children. It is recommended to; only operate this fireplace with the presence of some type of protective screen/barrier.

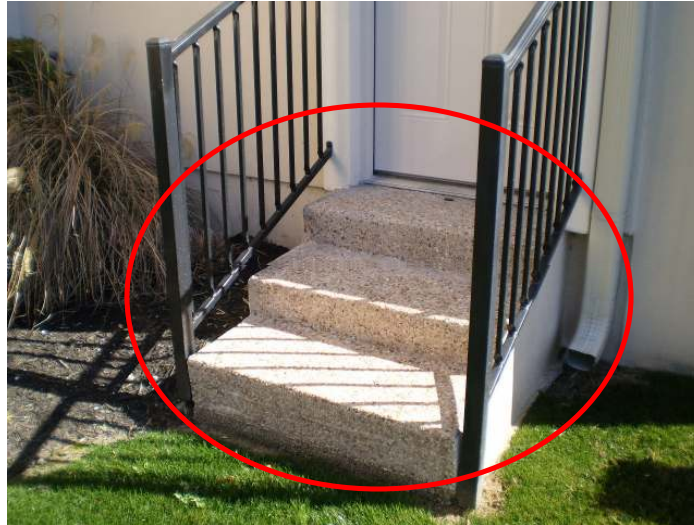
Under current building standards, a landing should be present for the stairs at the garage entry door.

**R311
MEANS OF EGRESS
311.4.3 Landings at doors.**

There shall be a floor or landing on each side of each exterior door.

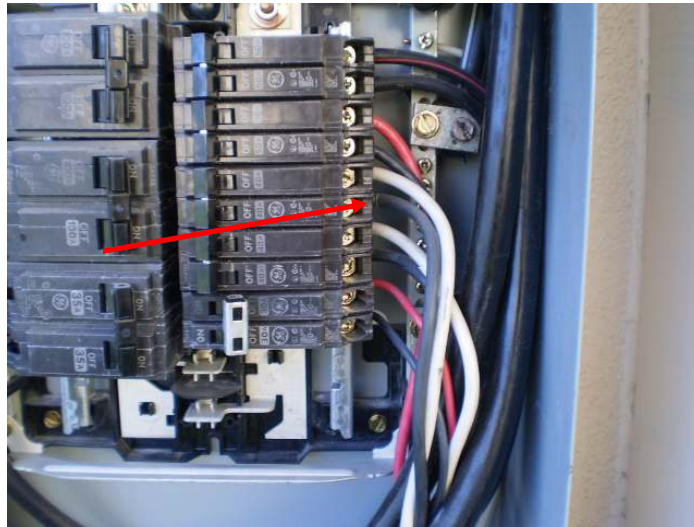
White wires in the main panel being used as a hot lead should be properly marked. This is usually achieved using colored electrical tape. Color coated wires is universal and helps electricians identify hot, neutral and ground and does effect the manner or procedure in which they work. This condition should be improved.

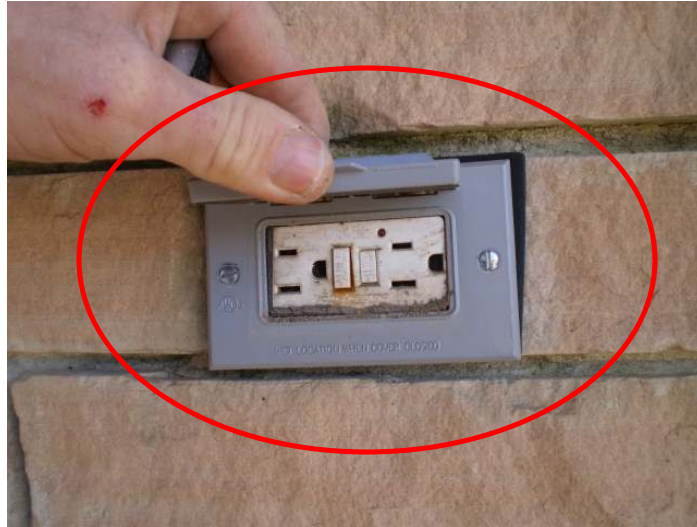
One or more of the receptades were observed to be loose at the wall mount in various locations.

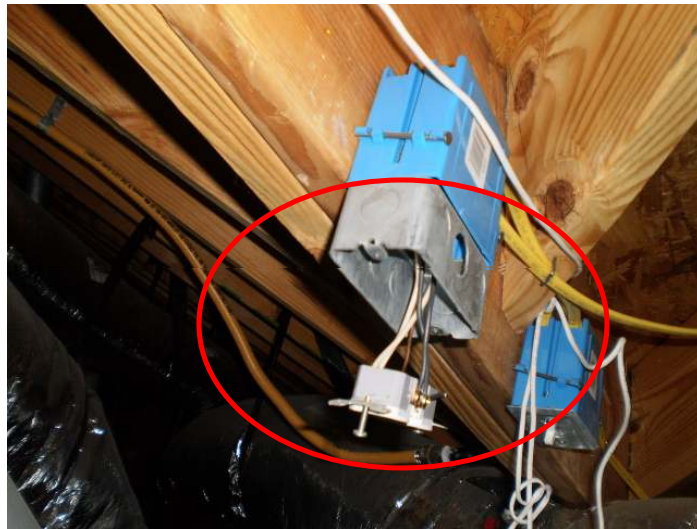
More than one receptade has not been mounted in the box. This was observed in the media room and in the attic.

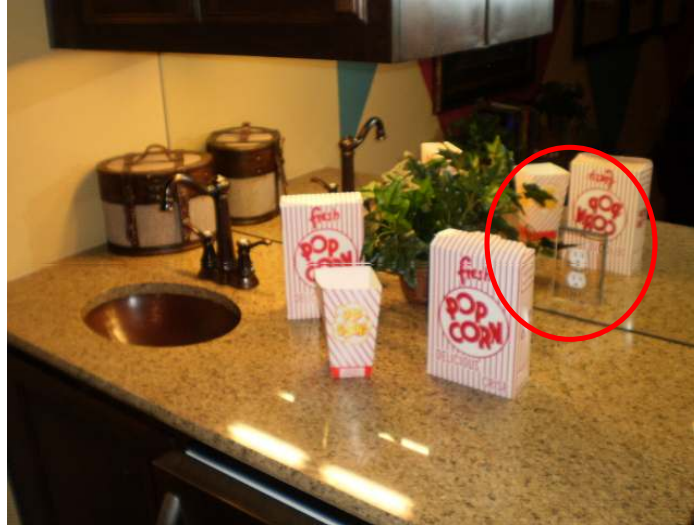
No ground fault circuit interrupter (GFCI) protection was observed for the receptacle in the media room sink.

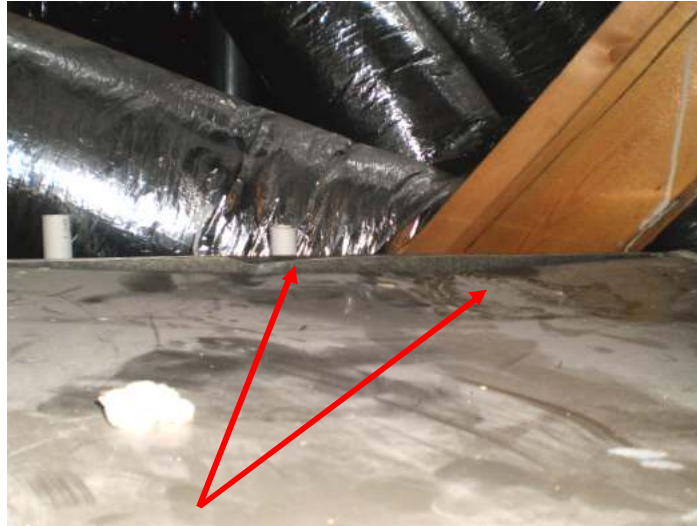
Damage to the evaporator coil housing was observed and will need to be improved.

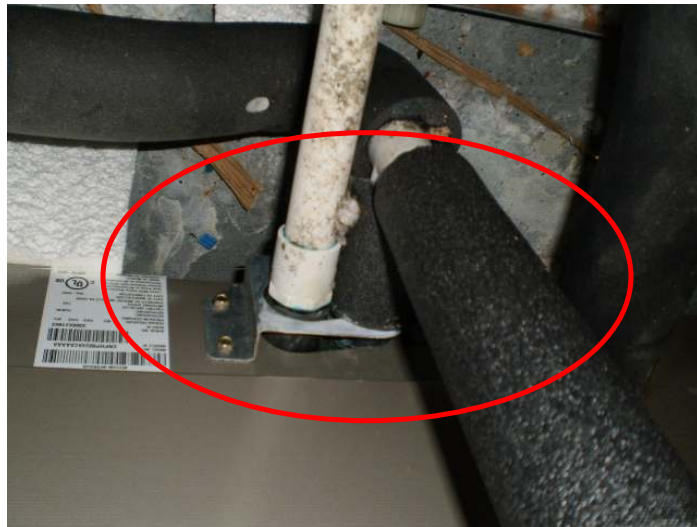
Note: Air leaks were detected at and around the indoor coil housing. The air leaks should be corrected for improved efficiency. This was observed at all units. This is a common location for air loss and is simple to improve.

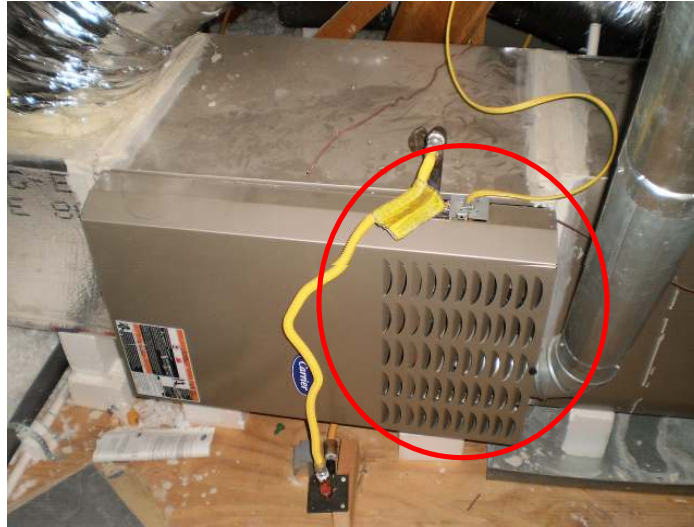
The cover to the furnace is not properly secured. Minor adjustments are needed.

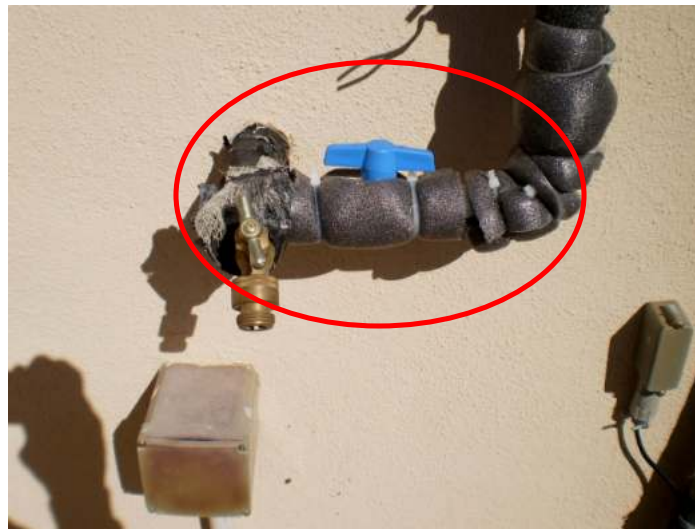
A leaking shut off valve at the pool equipment was observed. Minor repairs needed.

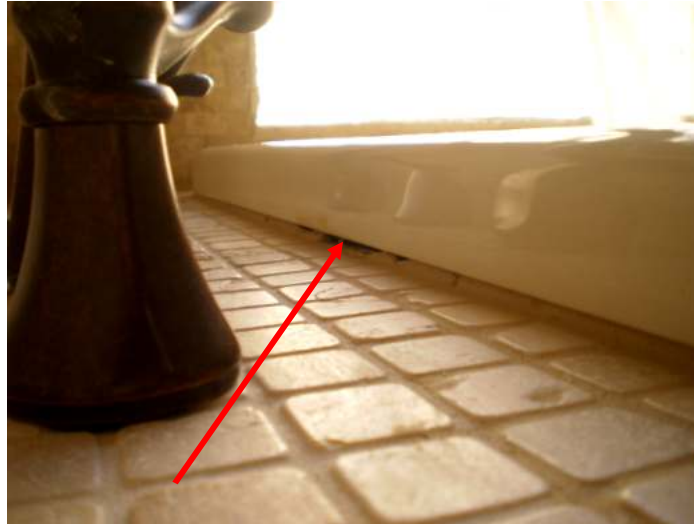
The master tub needs to be re-caulked

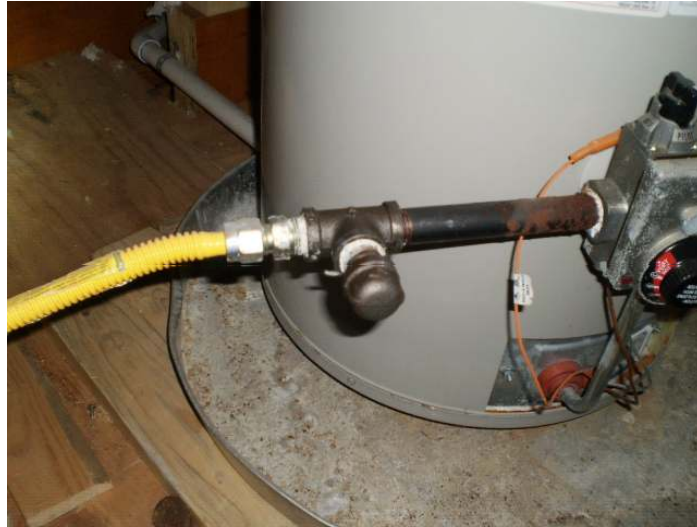
The drip (dirt) leg for the water heater gas piping should be turned down.

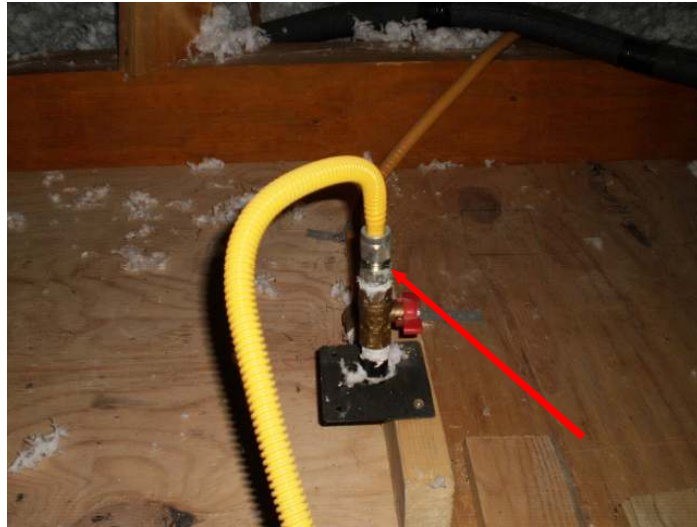
There was a gas leak detected at or around the gas flex connector for the WH furthest from the attic opening.

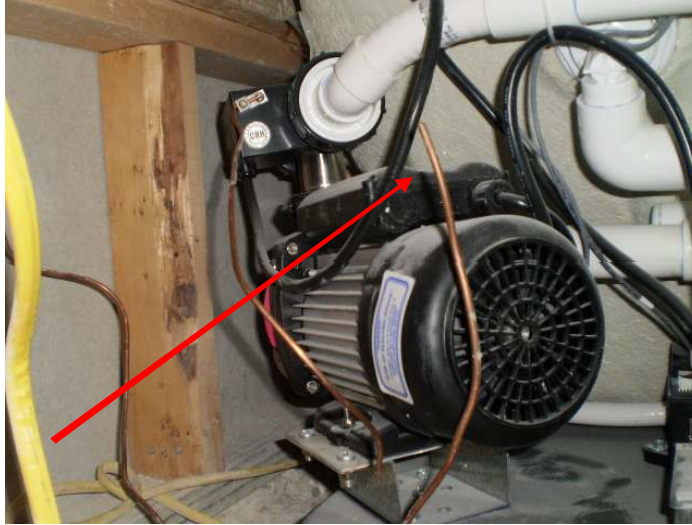
The hydro-massage therapy motor is not properly bonded.

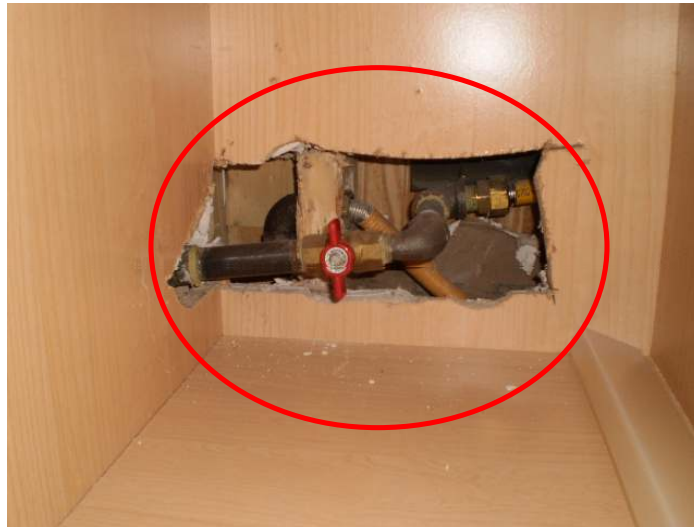
There was a gas leak detected at or around the gas shutoff valve.

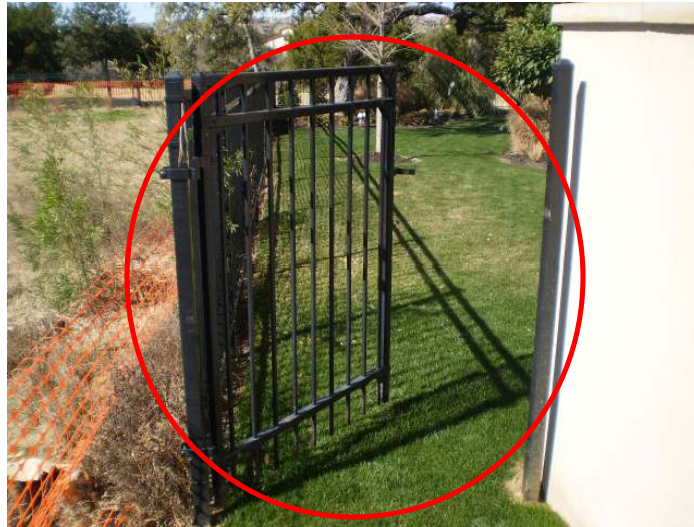
All pedestrian access gates should open outward away from the pool and should be self-closing and have a self-latching device. Where the release mechanism is located less than 54 inches from the bottom of the gate. A second release mechanism should be located on the poolside of the gate at least 3 inches below the top of the gate.

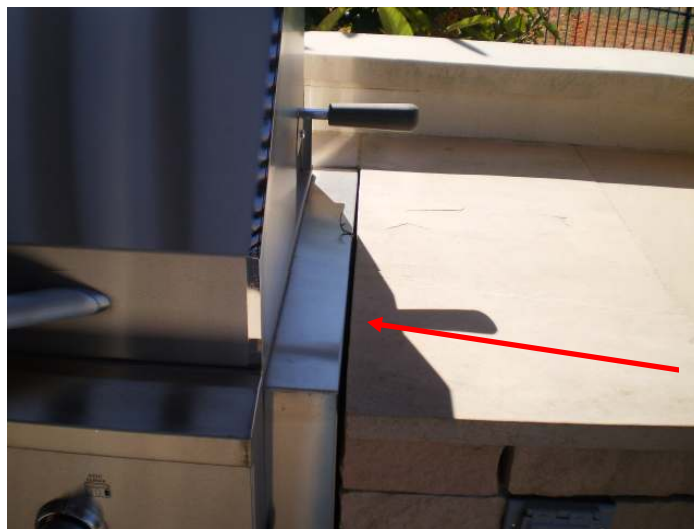
It is recommended to seal around the gas grill. This will prevent rain water from entering the access compartment below.
