# PROPERTY INSPECTION REPORT

Ausitn, TX 78717  
(Address or Other Identification of Inspected Property)

Kyle Nunnallee TREC #6371  
(Name and License Number of Inspector) (Date)

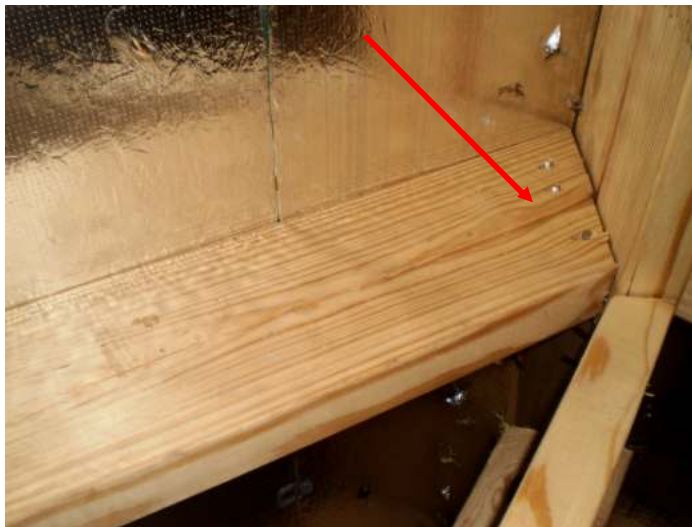
Split rafter(s) were observed in the attic area over the garage.

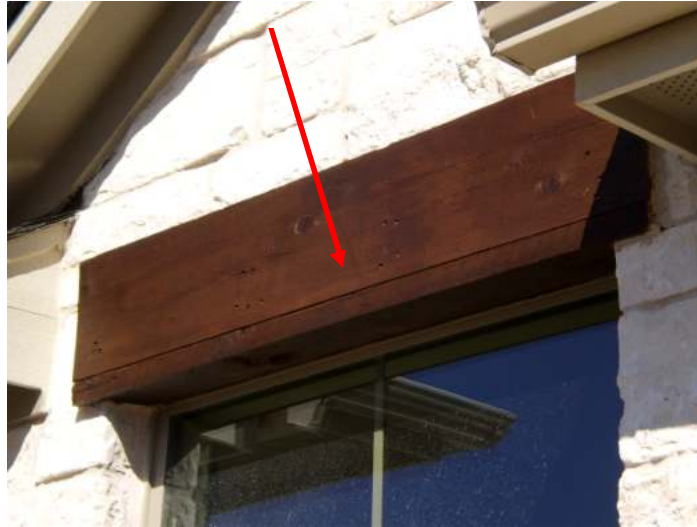
The trimming boards for the garage door header have been installed to reveal the seam/joint at the front. This is dissimilar from the neighboring homes and will promote water retention. This has been discussed with and recognized by builder.

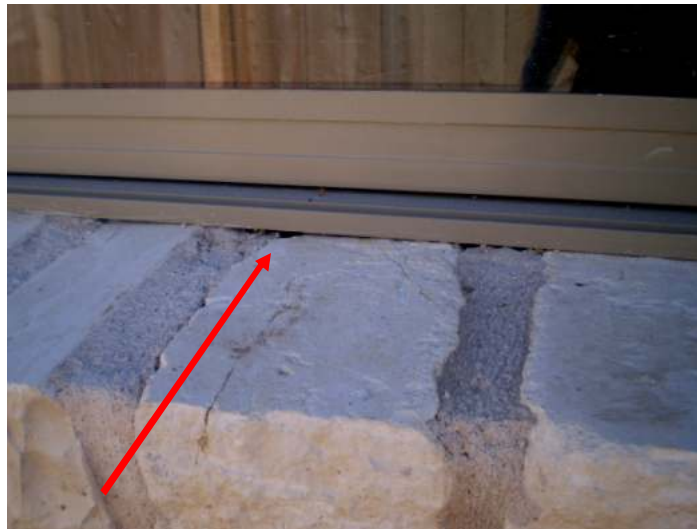
Caulking improvements are recommended for the area between the exterior veneer and the window frame on the north side of the house.

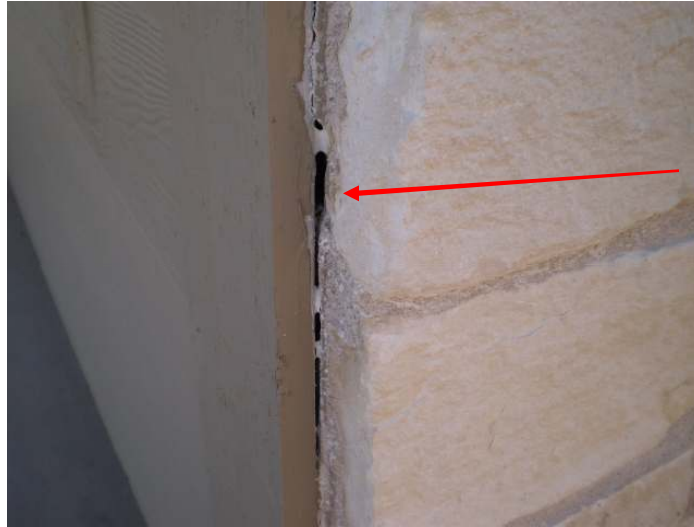
Seal trim boards at the rear of the house.

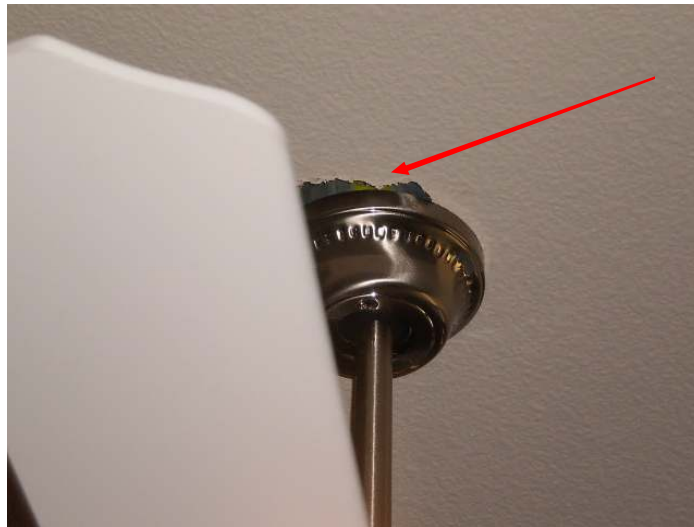
Minor sheetrock repair needed at the ceiling fan in the living area.

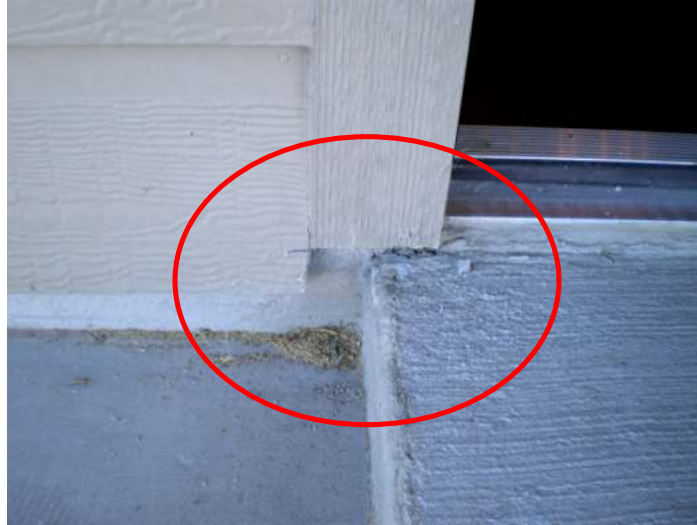
Trimming details at the rear exterior door is unsightly and needs minor improvement.

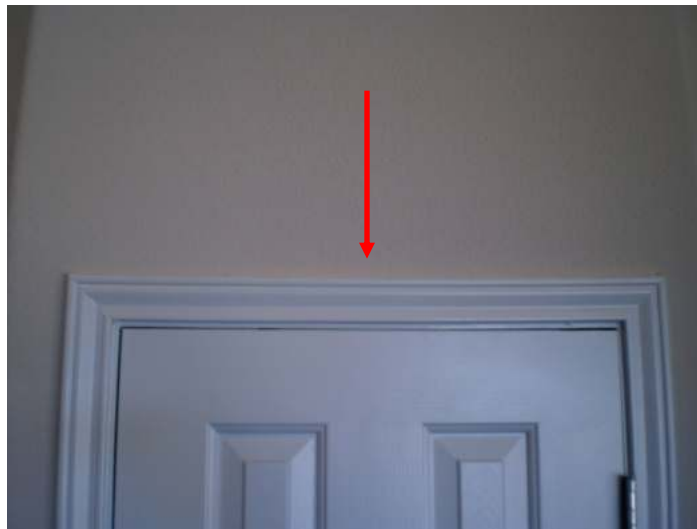
The jamb header for the pantry door needs to be raised and fastened in the middle. This will remove the belly and provide a consistent reveal.

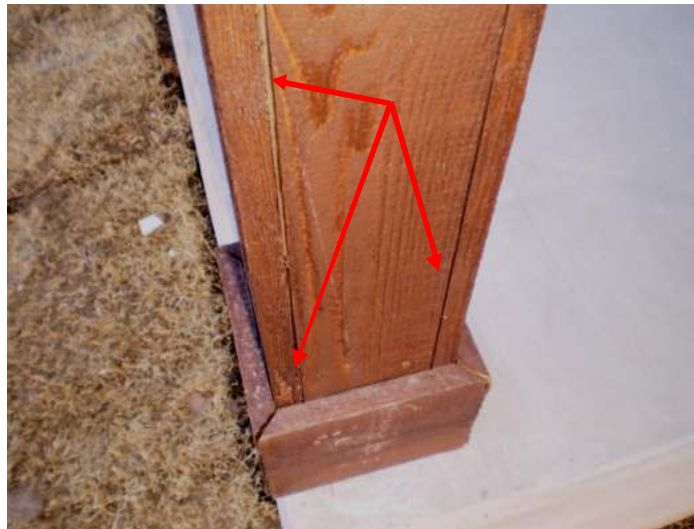
The trim-out for the rear patio columns need to be better secured in a few locations and all seams should be caulked. The integrity of the wood will not remain in its current condition. Minor improvements needed.

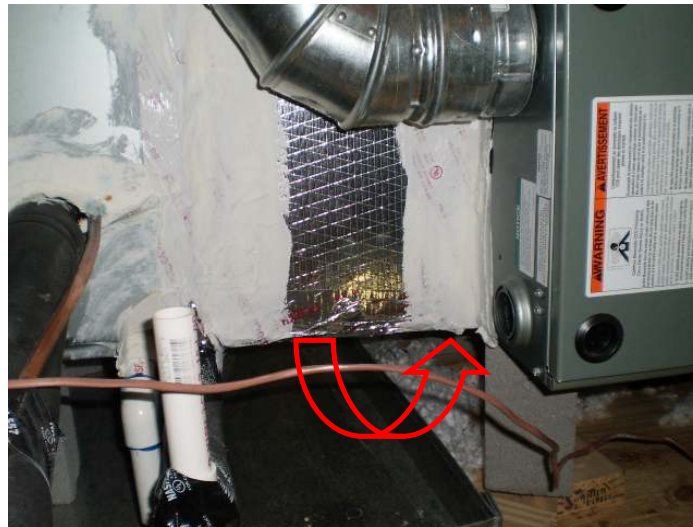
**Note:** Air leaks were detected at and around the indoor coil housing. The air leaks should be corrected for improved efficiency.

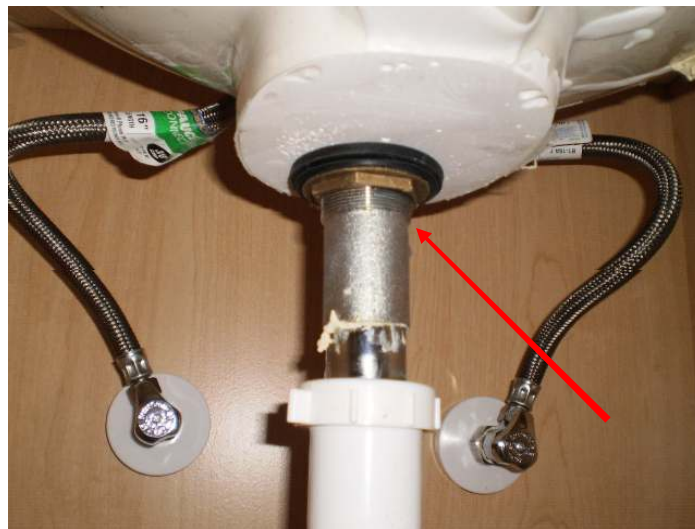
#### Hall Bathroom

The drain leaks water into the cabinet when drained under pressure.
