Nunnallee Inspections
PROPERTY INSPECTION REPORT

By: **William Kyle Nunnallee TREC # 6371**
(Name and License Number of Inspector) (Date)

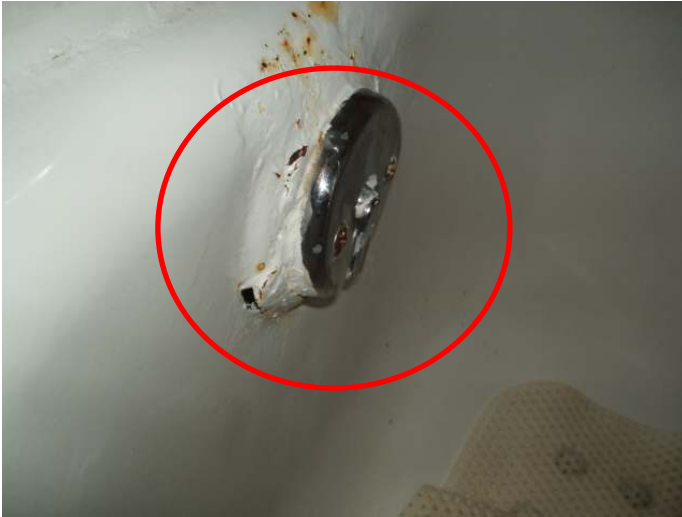
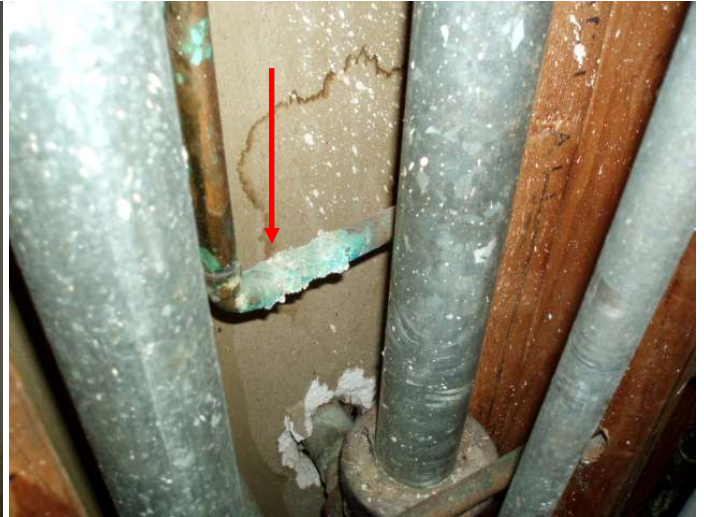
This is an example of the peeling re-finish. Although this may be one of the worse it is safe to assume the others are sure to follow. The result you see is a consequence of poor surface preparation. Even the tubs which are not peeling as of yet look good at first glance although a closer look reveals ripples and marginal workmanship.
