PROPERTY INSPECTION REPORT

Nunnallee Inspections

Round Rock, TX 78664
(Address or Other Identification of Inspected Property)

Kyle Nunnallee TREC #6371
(Name and License Number of Inspector) (Date)

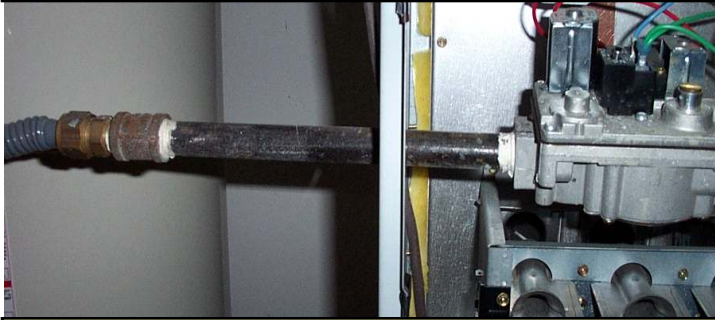
The gas supply flex connector was observed to be passing through the heating unit cabinets. Under current mechanical installation standards, this is no longer an accepted practice. Only rigid black gas pipe is allowed to pass through the heating unit cabinet.

Sample picture of the correct installation of the heating unit flex connector.

This picture is for example only and was not taken at this location.
